STOTFOLD TOWN COUNCIL

6.5. Memorial Hall Condition Survey

SUBJECT: MEMORIAL HALL CONDITION SURVEY

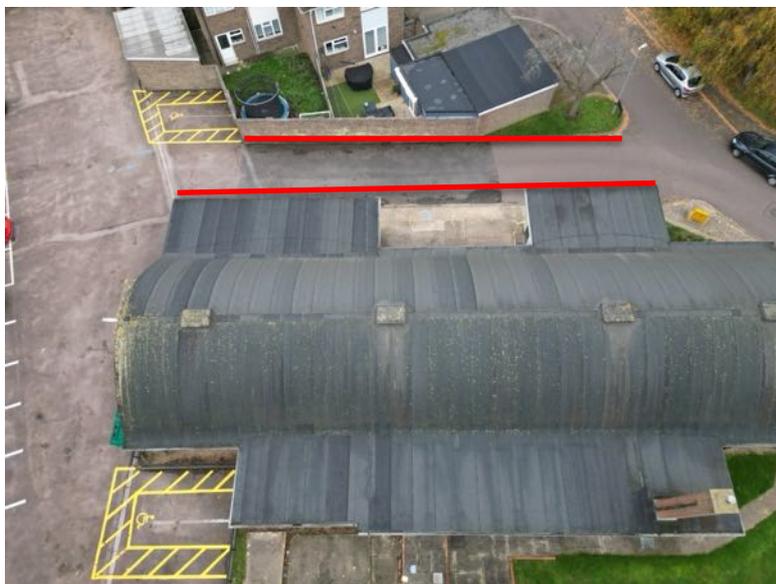
Grounds The road leading to the rear shows some minor signs of fracturing at the kerb edges however there are no immediate needs for repairs.

Photo showing road to the rear of the site leading to the car parking area.

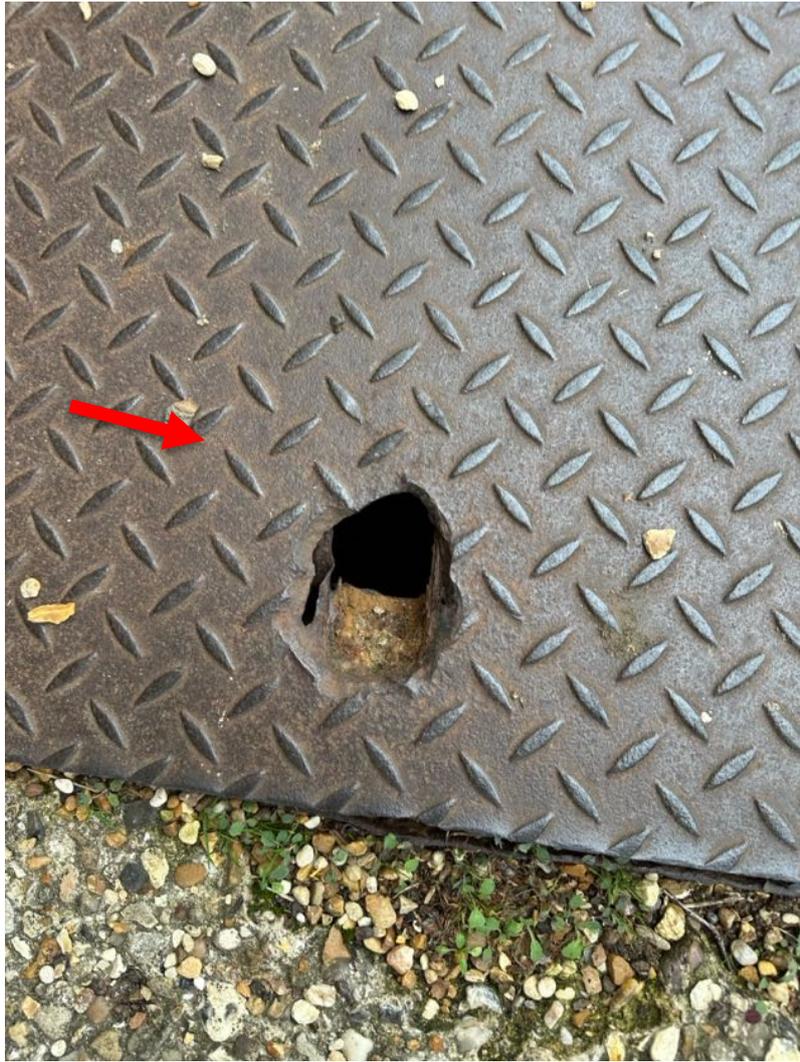
To the right hand side of the plot there is a damaged inspection chamber cover which could potentially lead to an injury from slips, trips and falls. We would suggest the replacement of this cover in the near future.

Photo showing damage to the steel inspection
Chamber cover located to the right hand side

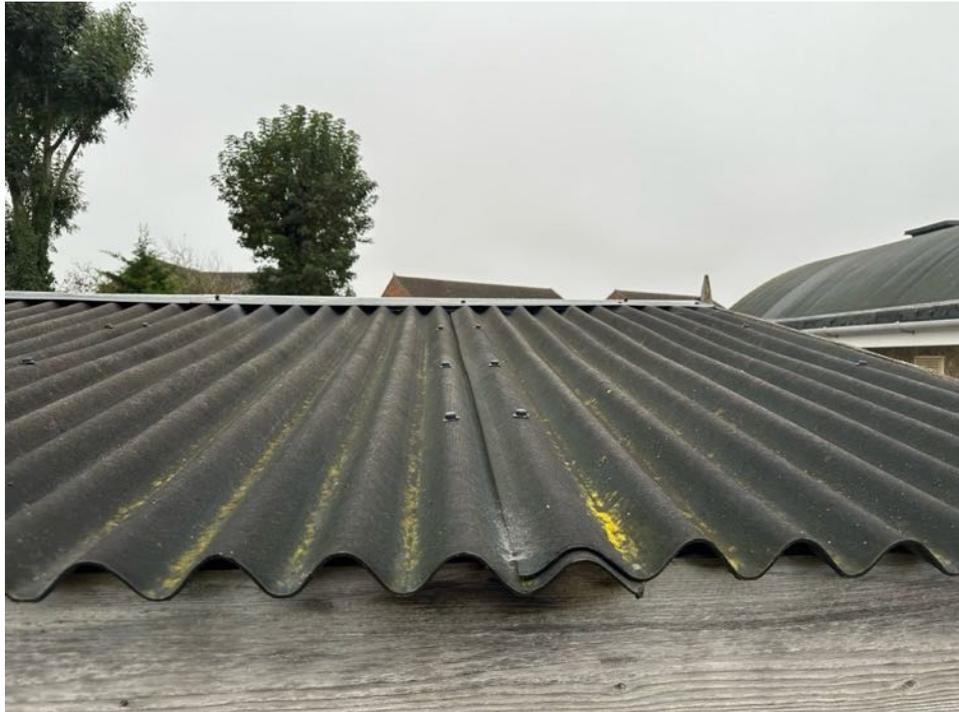
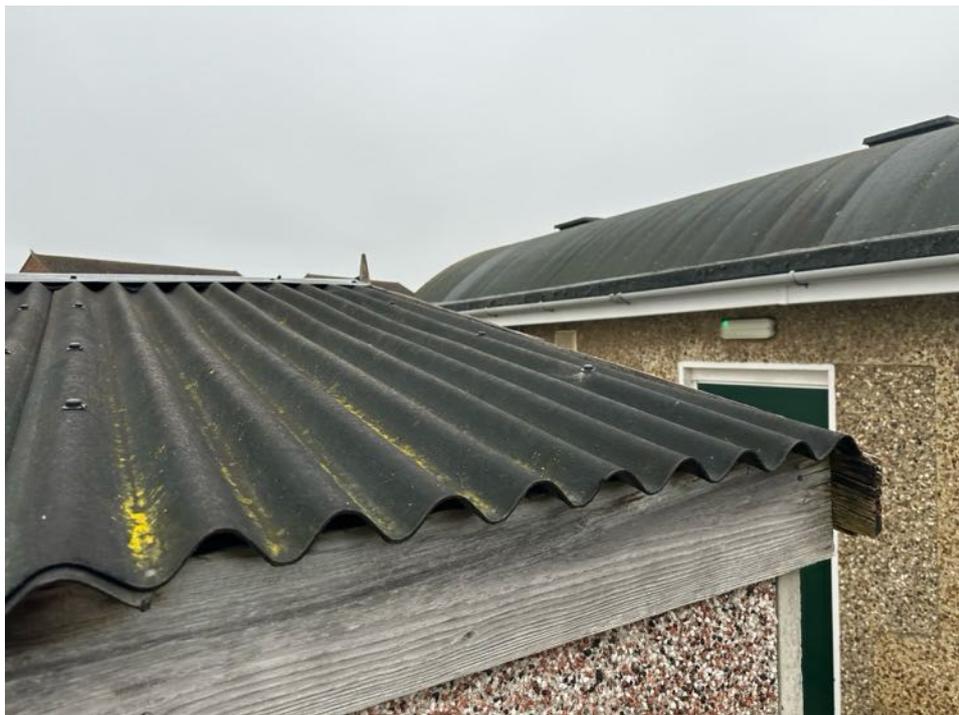
Photo showing Onduline bitumen fibre roofing showed no signs of significant undulation

Photo showing Onduline bitumen, fibre roofing showed no signs of significant undulation

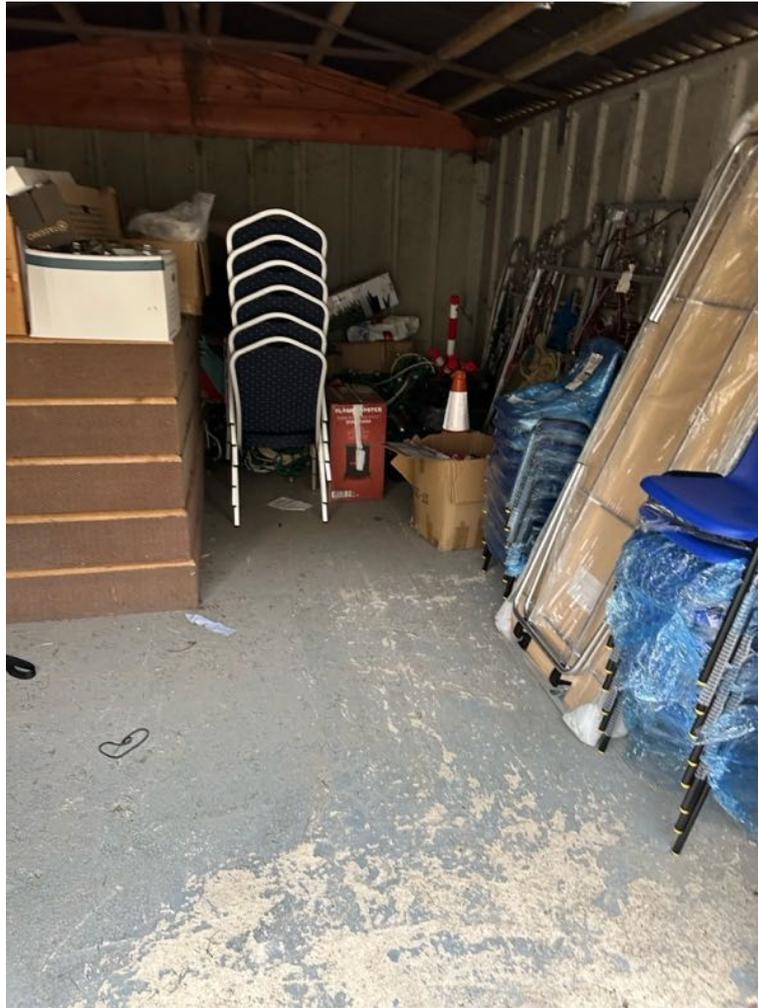
Photo showing painted garage floor slab which showed no evidence of obvious cracking. Note that we cannot comment on any defects which may be present behind the stored items here.

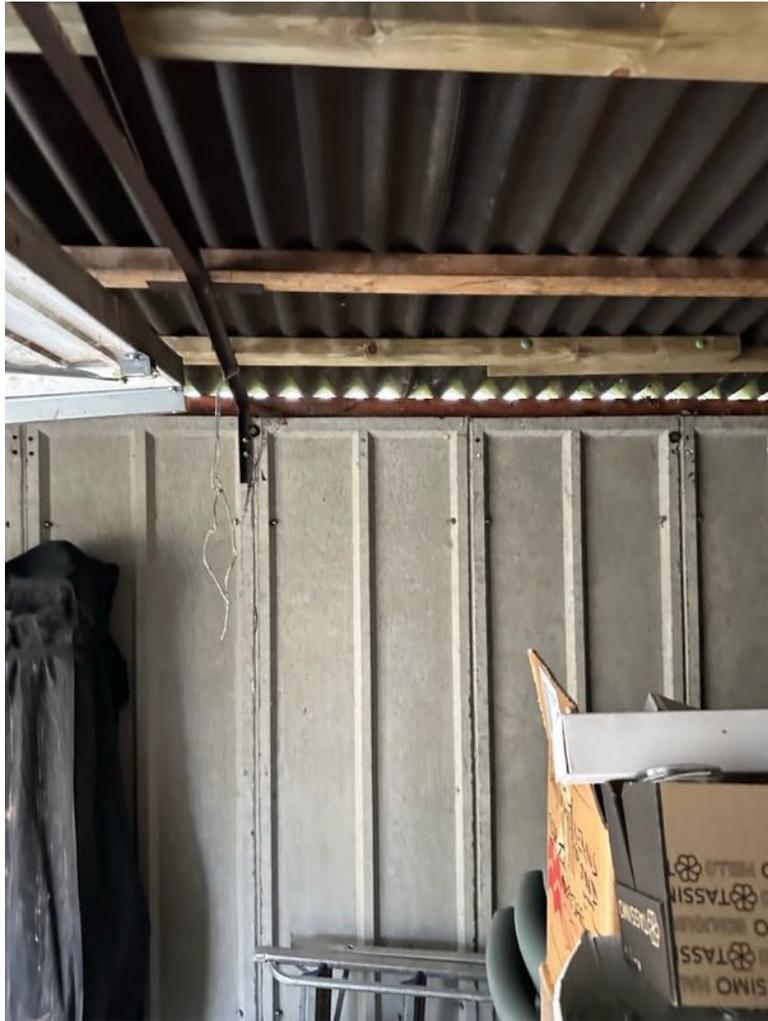
Photo showing reinforced concrete wall panels which are bolted together. For our limited viewing, we noted no evidence

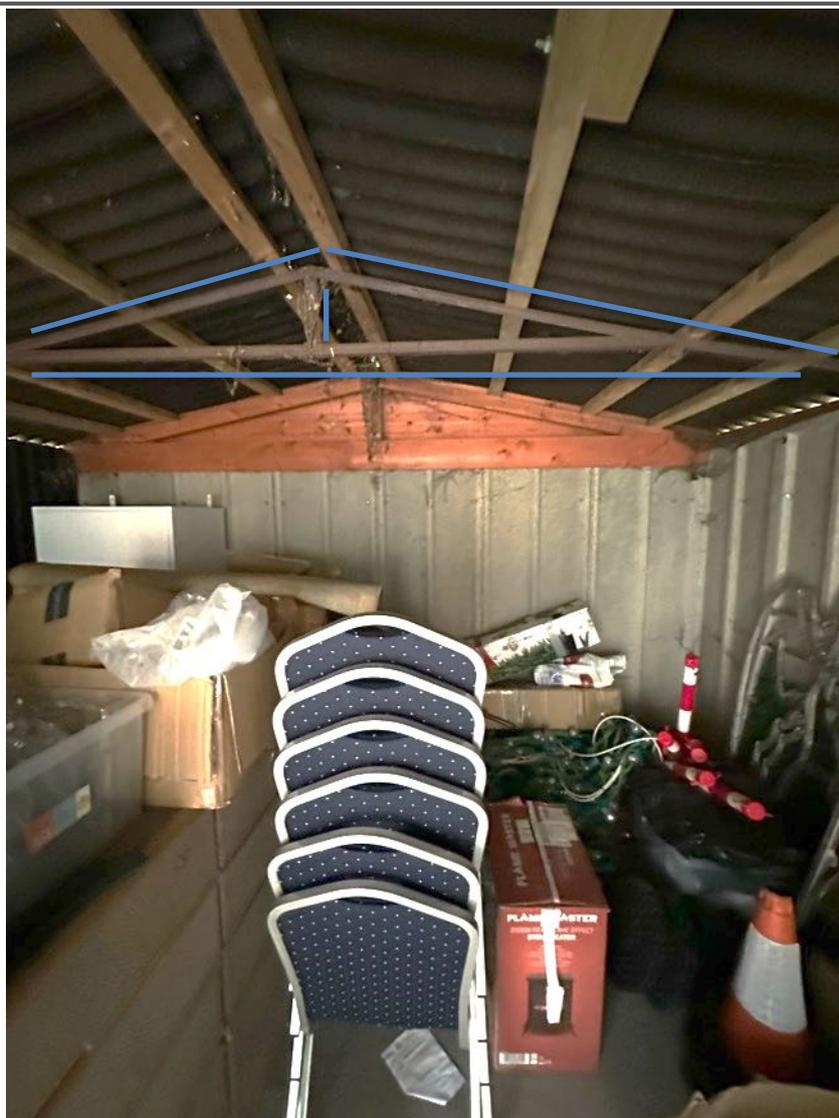
Photo showing area of trusswork (highlighted in blue) which we believe would benefit from rust treatment

Some treatment of the exposed metalwork to the truss roof would benefit from some surface rust treatment with a product like red oxide.

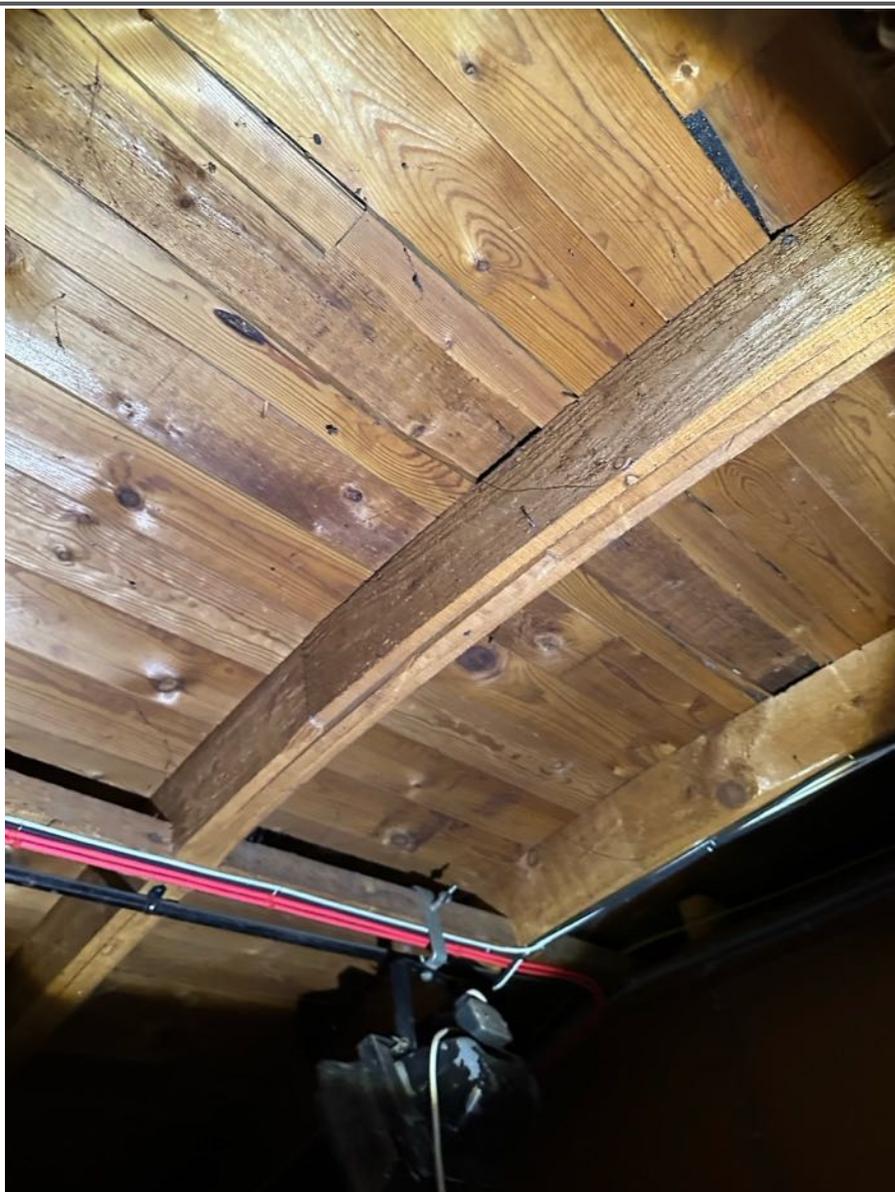
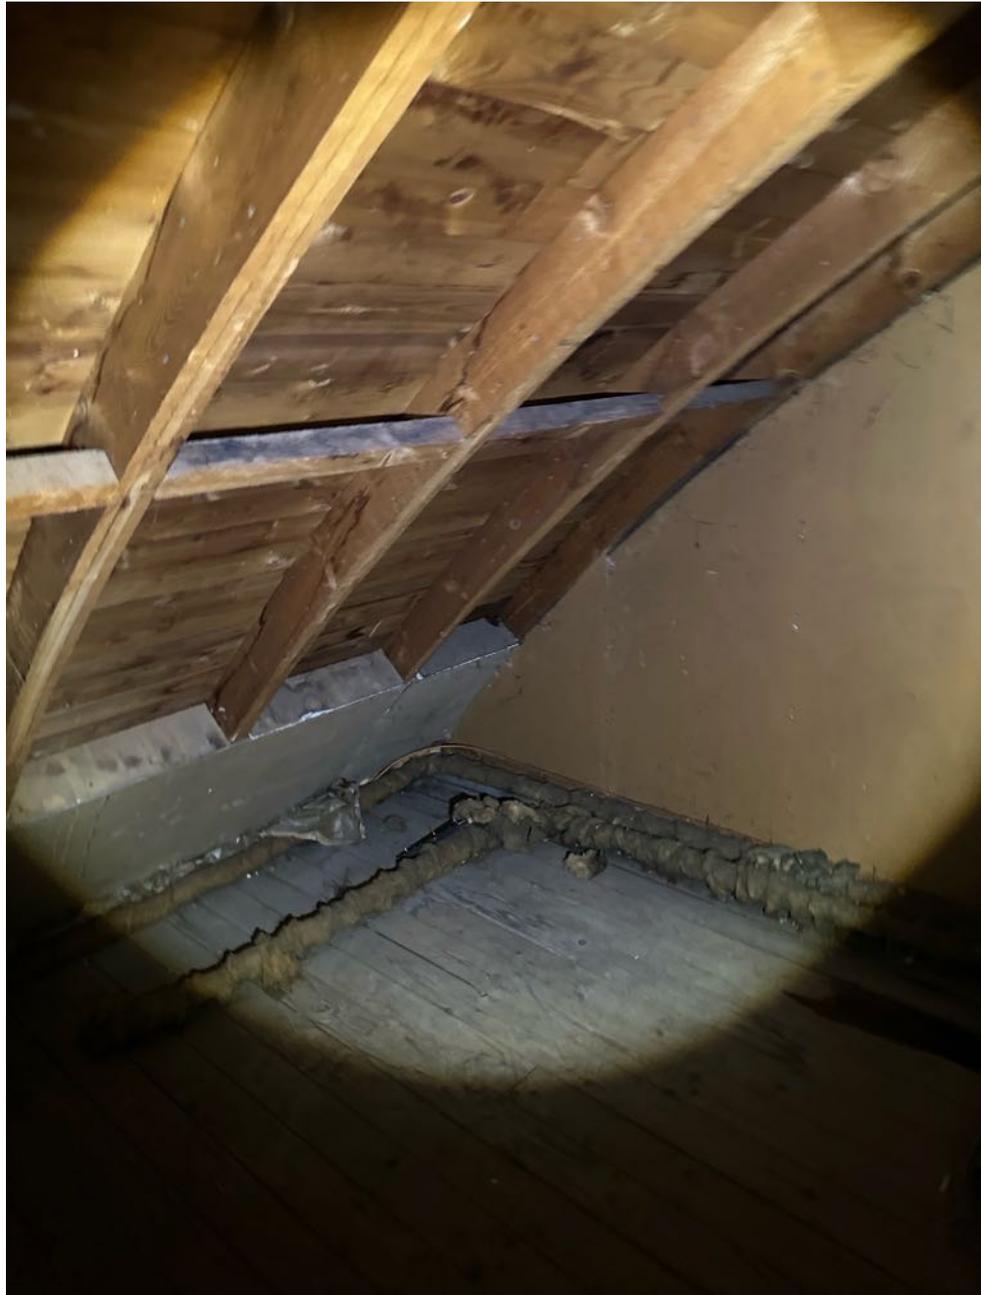
“The Mineral Felt roof covering to the hall is at the end of its useful life expectancy and we would suggest budgeting for its’ replacement in the next 2 years. Failure to do so would likely allow for water to enter the structure and cause damage to the timber sarking boards below.

Mineral felt roofing has been installed which has a life expectancy of approximately 10 to 20 years, depending on the quality of the felt and installation technique. At the time of our inspection, we noted bubbling and fissuring of the mineral which may suggest imminent failure of this covering however, we would still suggest confirming with your records as to when this roofing was installed and if it is nearing 15-20 years ago, we would suggest budgeting for its replacement. Visually, we would assume that this roof covering has a further reasonable life expectancy of around 5 years. Beyond this replacement will be required.

Photo showing timber sarking board on curved timber rafters internally

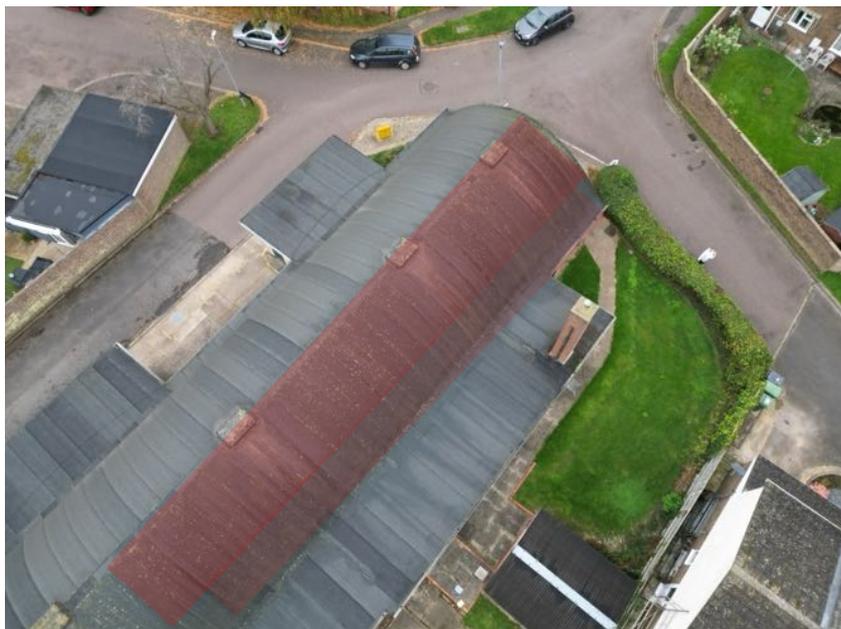
Photo showing left hand side roof slope (shaded in red) which displays a high level of surface lichen growth

This is not a defect and is common on north facing roof slopes.

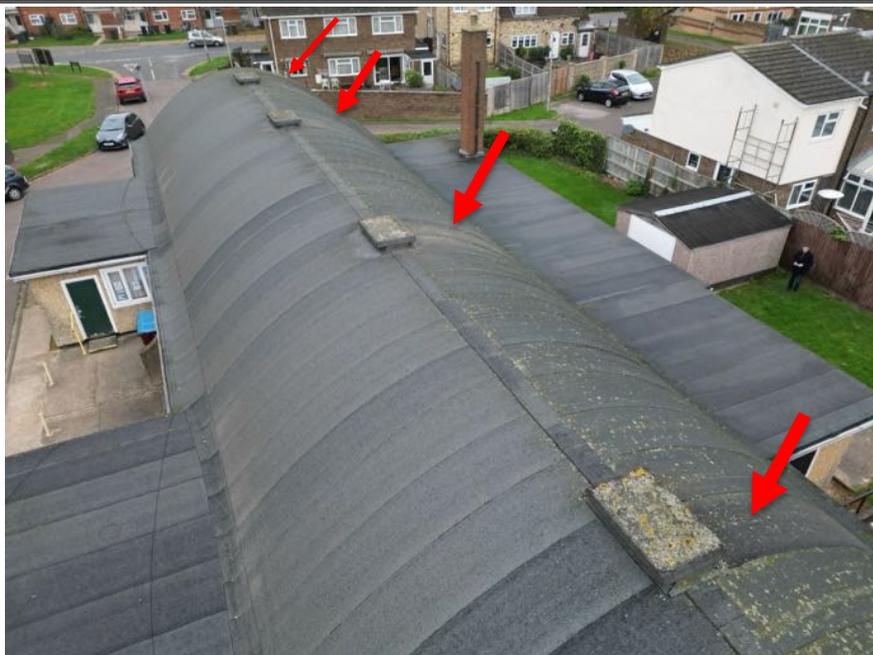
Photo showing raised vents which are providing a cross flow of ventilation to the roof

It is essential that these vents are not covered over. The addition of a fine mesh to reduce the risk of insect and vermin ingress is suggested.

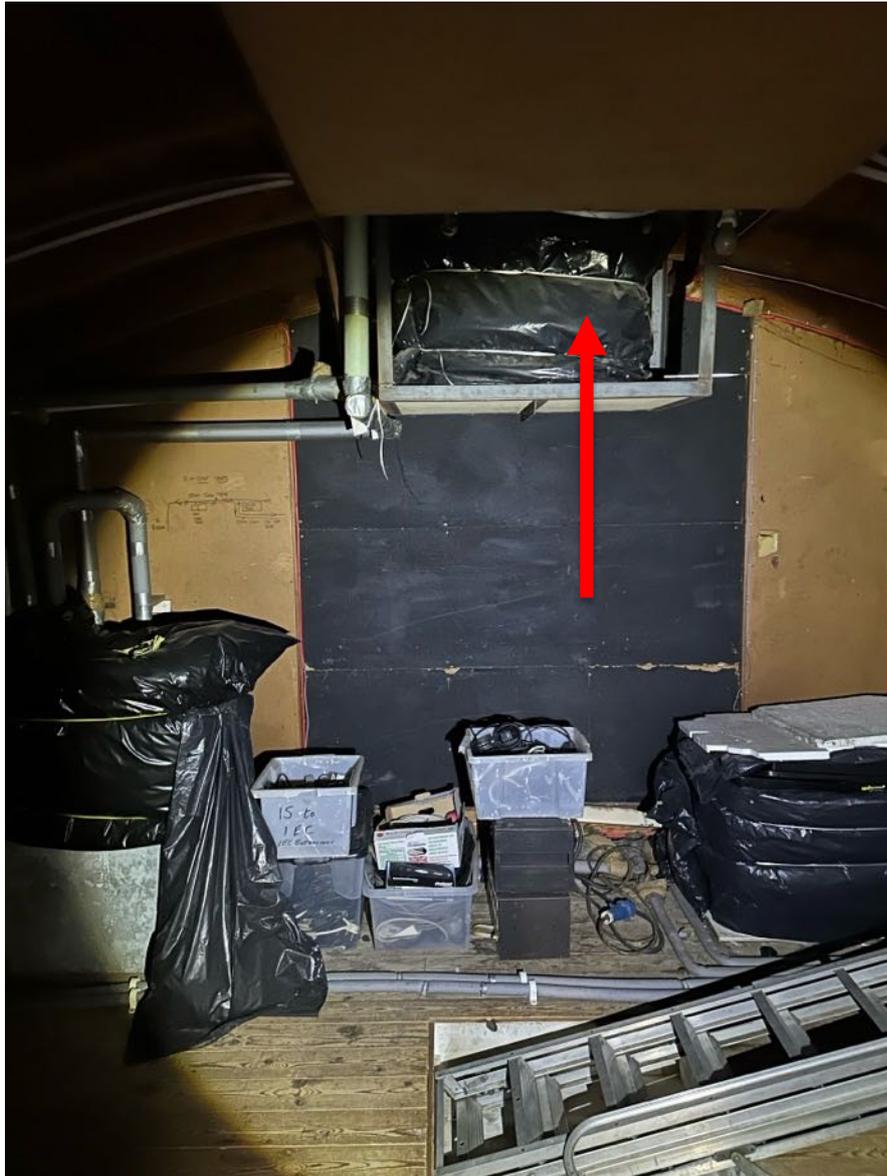
Photo showing underside of air vent as seen within the roof void below.

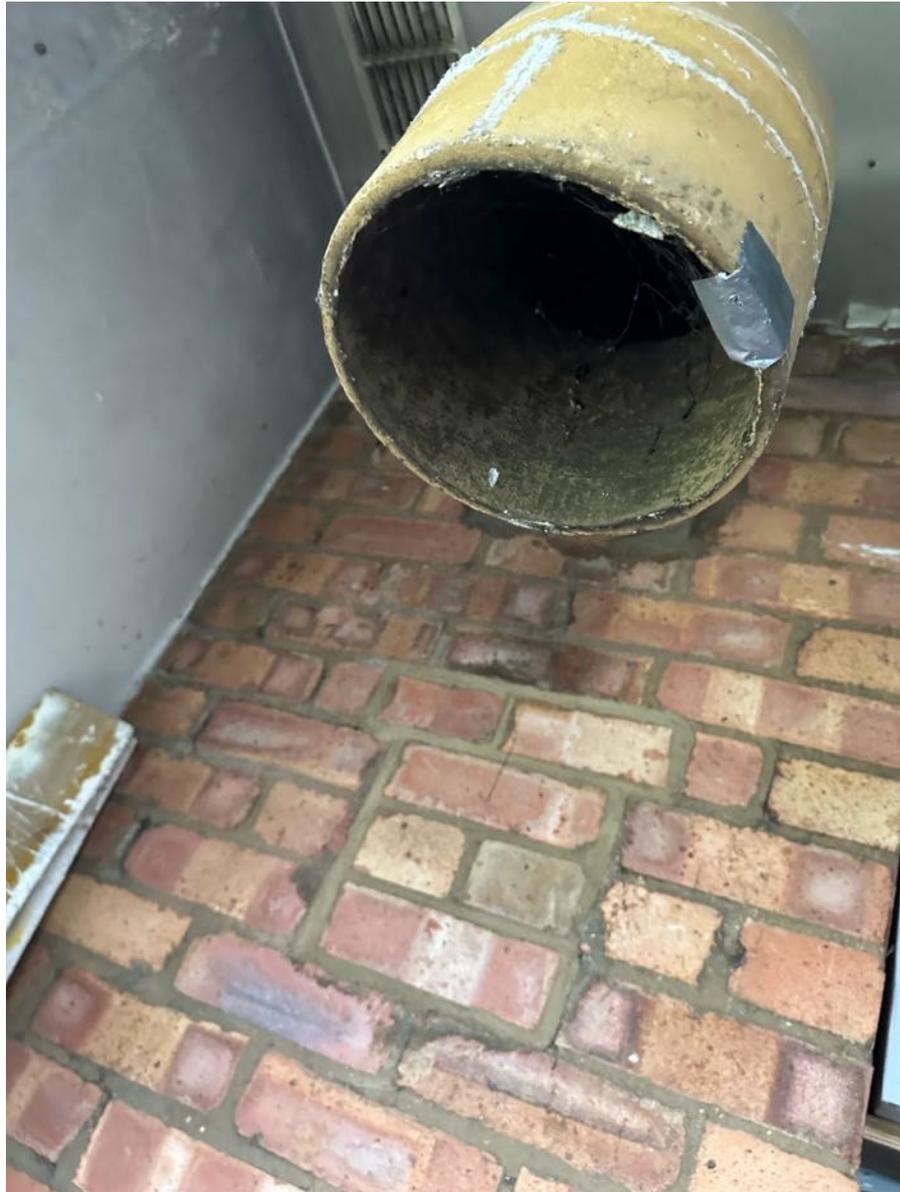
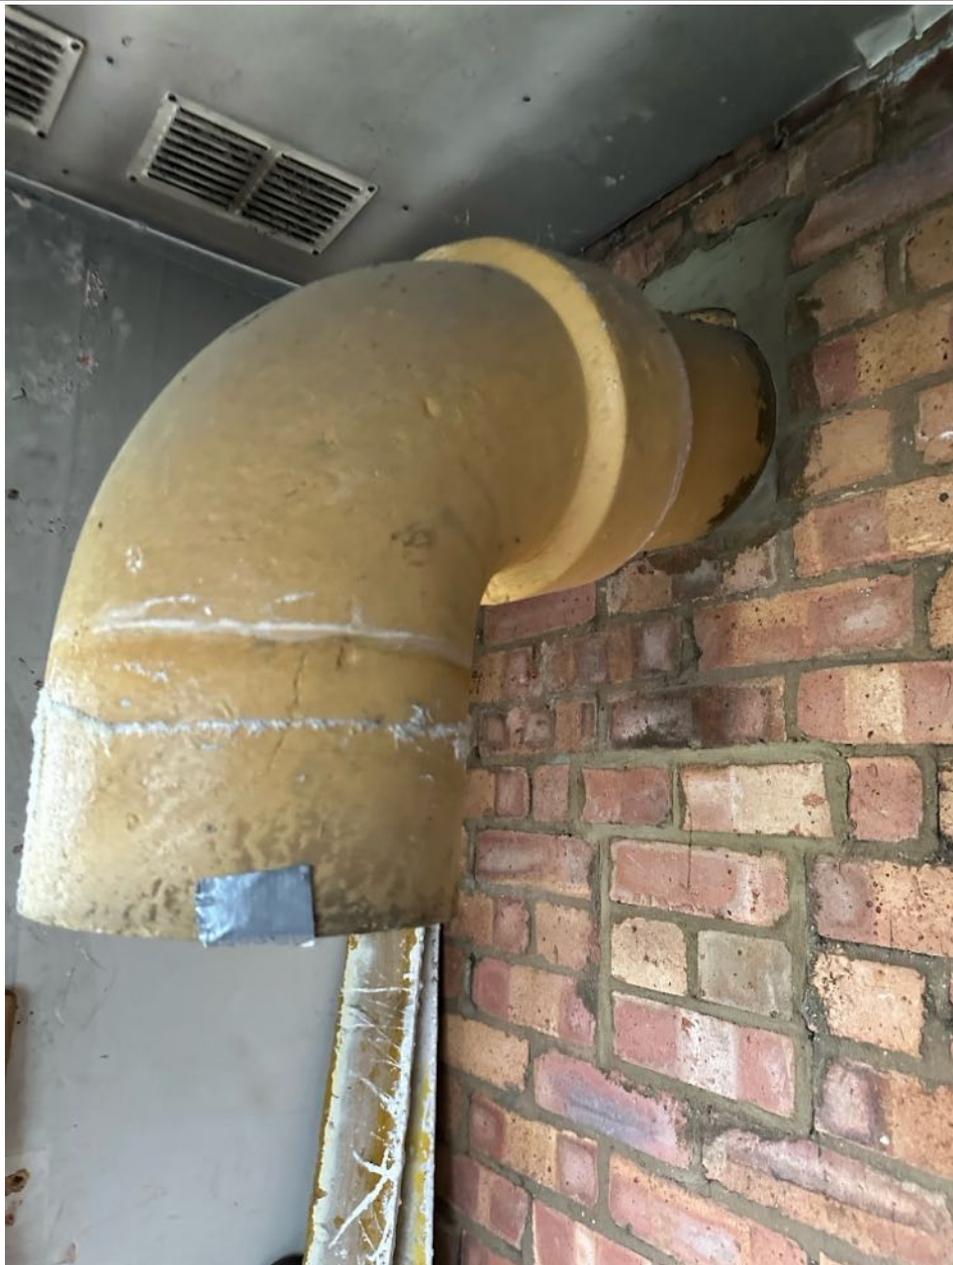
Photo showing potentially Asbestos containing flue product to the boiler room which we believe is connected to the chimney above

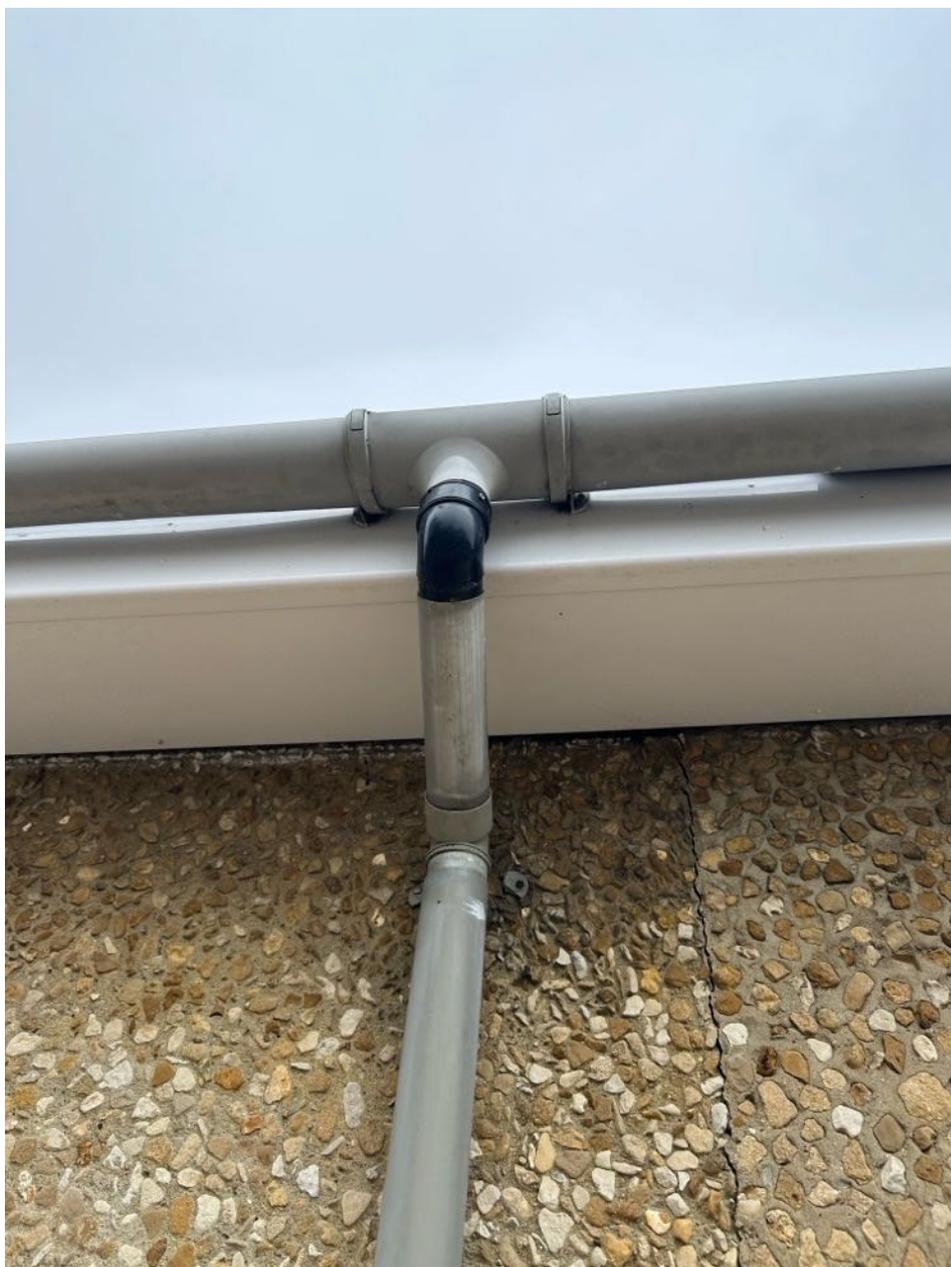
The guttering is plastic gutters on plastic fascias and soffits. There is a mixture of cast iron downpipes. There is a downpipe to the right hand side which is discharging rainwater directly onto the ground externally. Ideally slot drainage would be added to the perimeter.

Photo showing mis matched type of guttering with plastic gutters, aluminium sections and lined down pipes. Note that the gutter clips are broken.

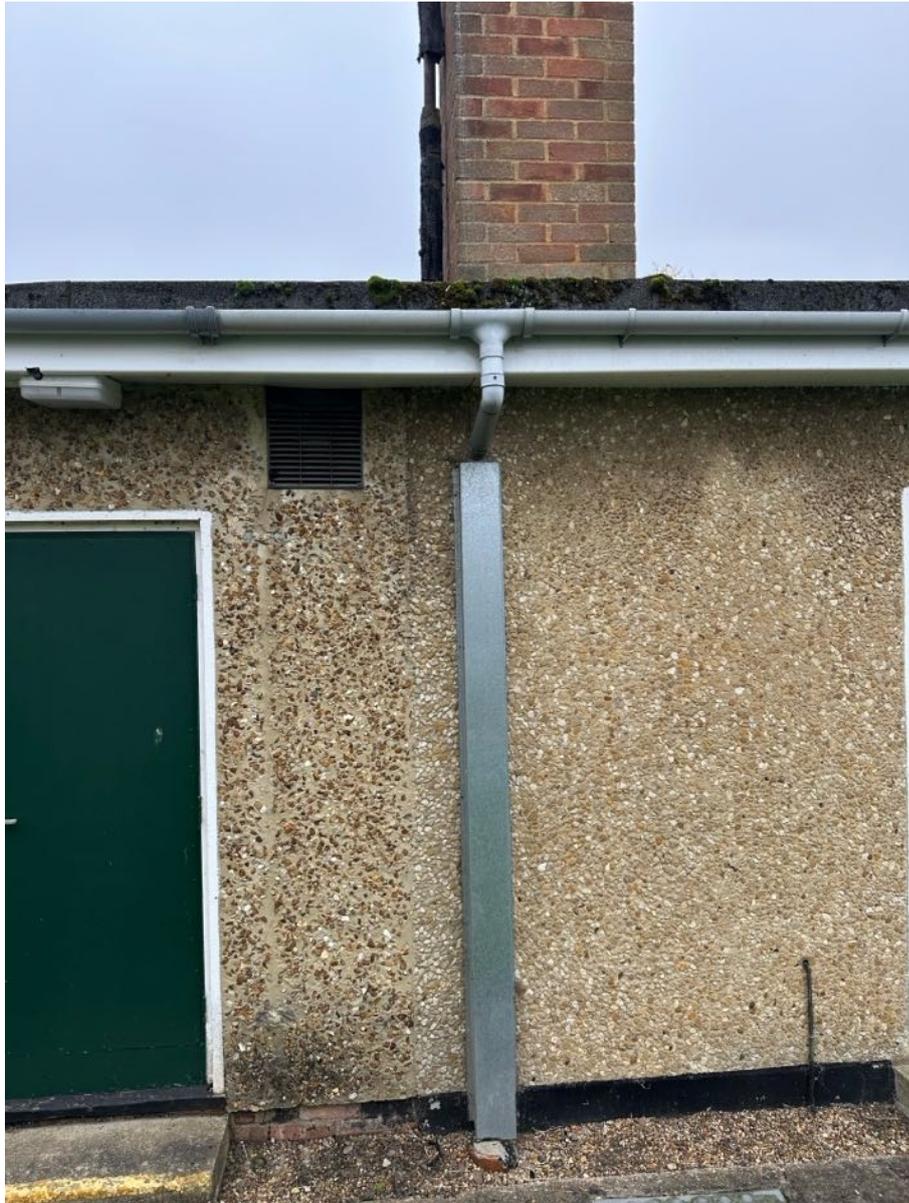
Photo showing boxed in downpipe to the left hand side which we would assume has been added to prevent vandalism. You may wish to continue this to all downpipes. Some leaking of the gutters into the left hand side was noted.

The cast iron section will need redecoration in the next 5 years. Consider the addition of anti-climb guards to the perimeter.

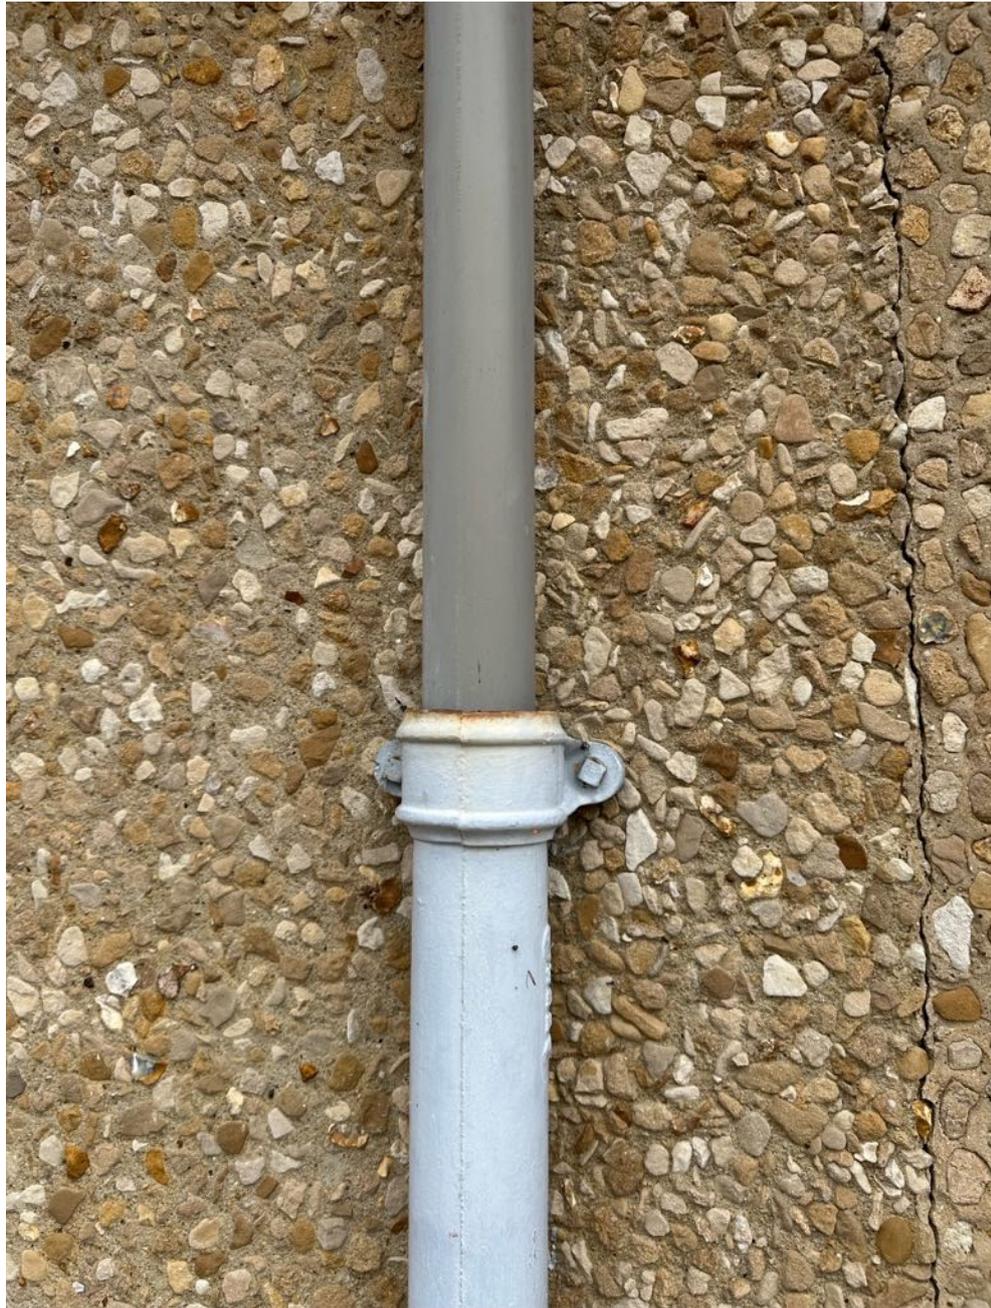
Photo showing plastic guttering discharging into cast Iron section of downpipe

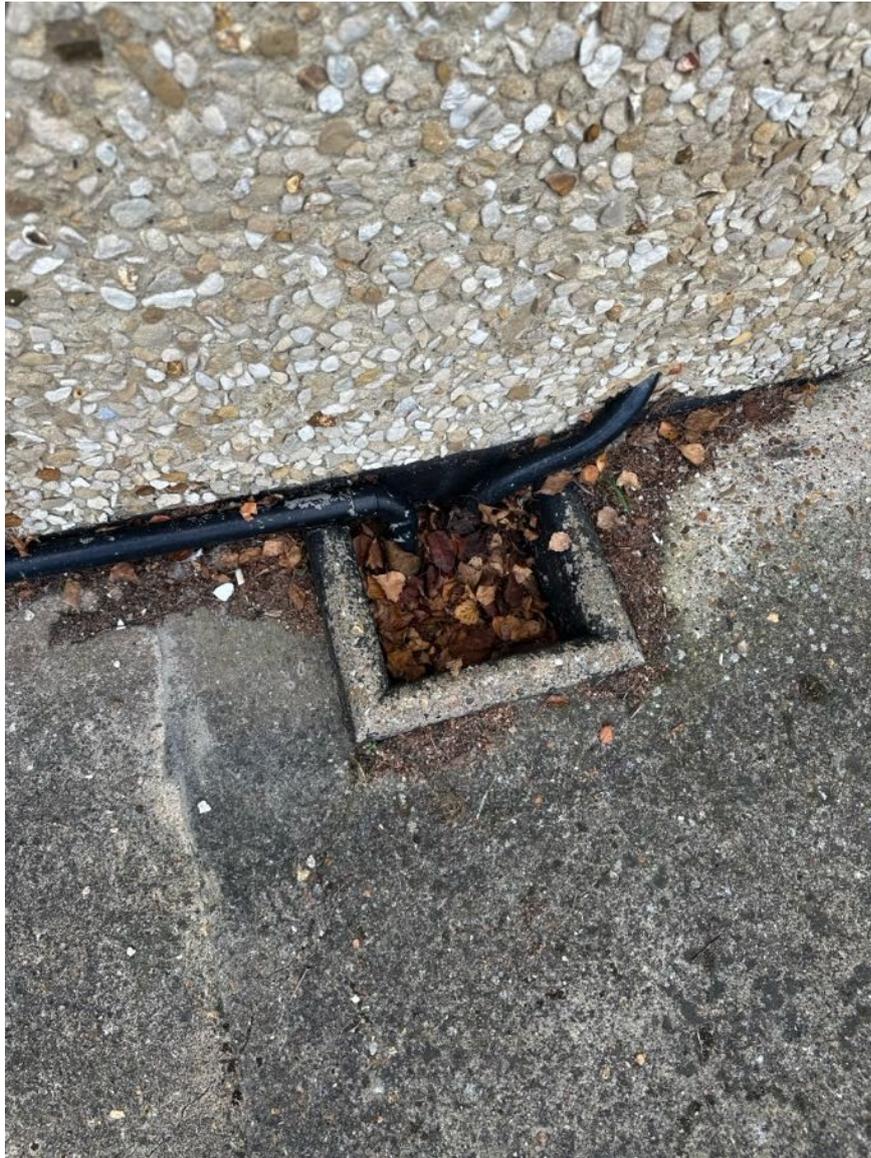
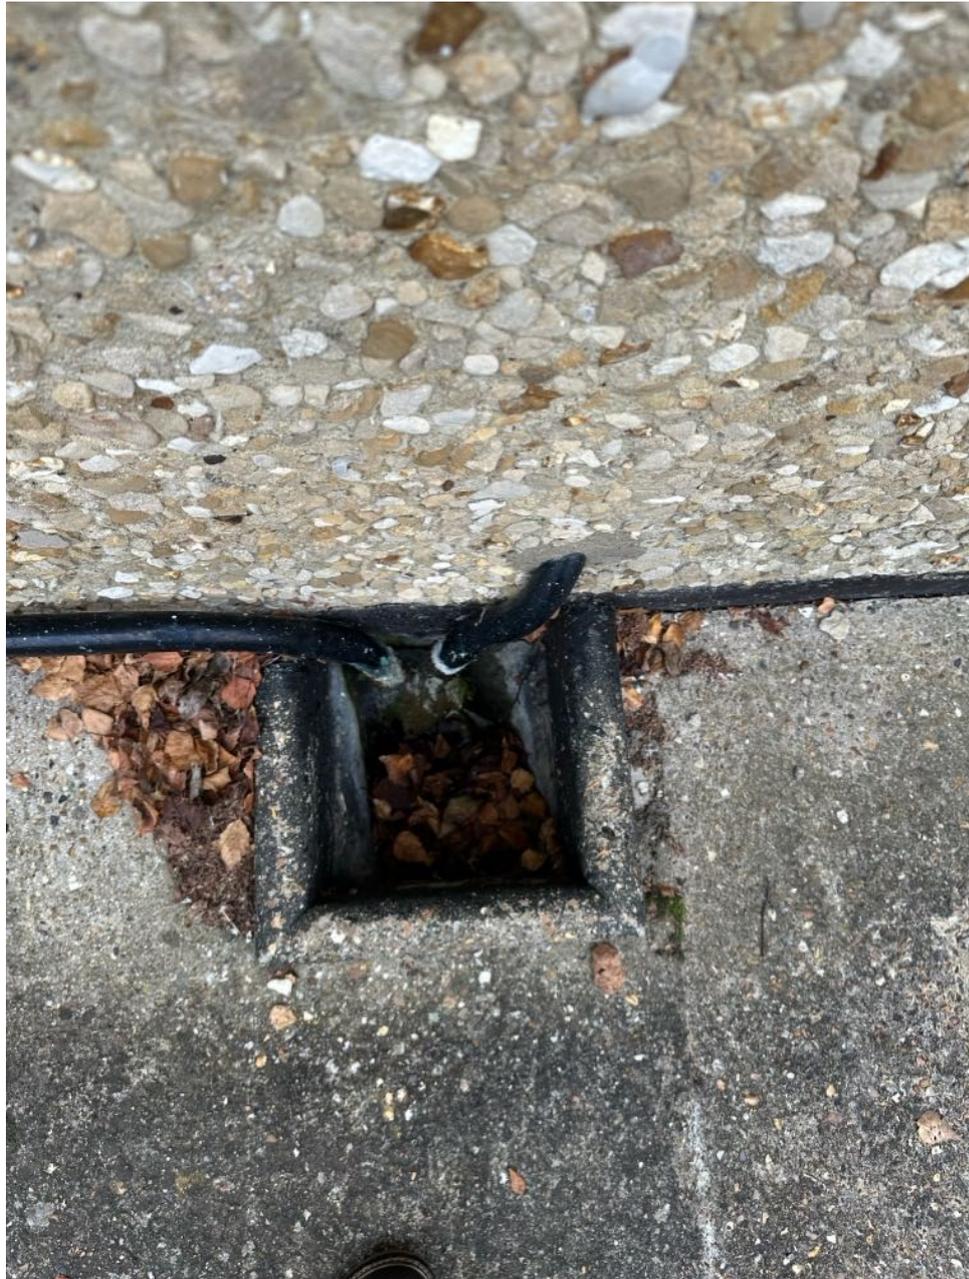
Photo showing open gullies which were blocked with leaves at the time of our visit. This could lead to some localised flooding. Consider the addition of gully covers.

Open gulleys were noted to the front elevation and would benefit from gully covers being added.

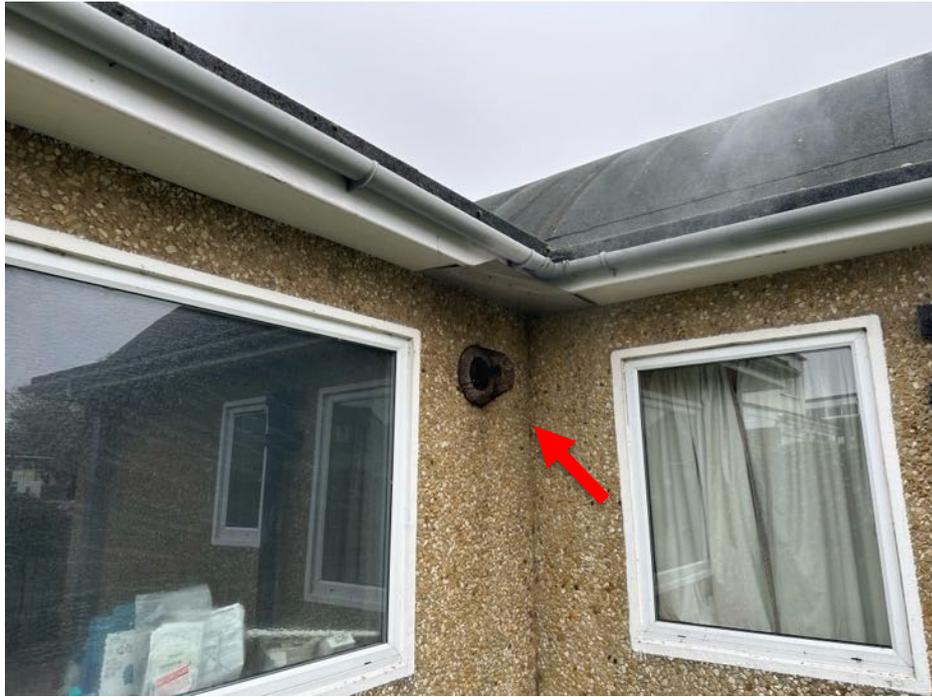
Photo showing boiler venting to the left hand side which can lead to condensation issues and issues of warping of the plastic. Consider the addition of a plume kit (periscope vent) to safely duct exhaust gases over roof height. Some thought around potential vandalism should be given here.

Where exhaust vents for boilers exit, we would suggest that periscopes vents be added to prevent the risk of condensation and melting to the soffit boards.

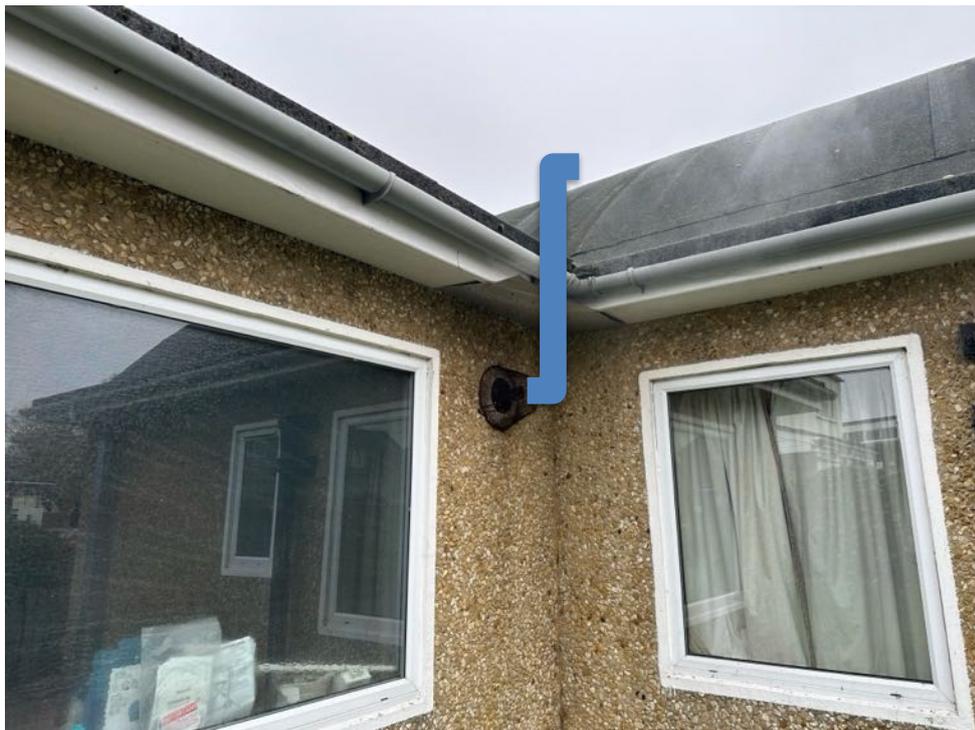
Photo showing suggestion for venting position to prevent damage to the soffit

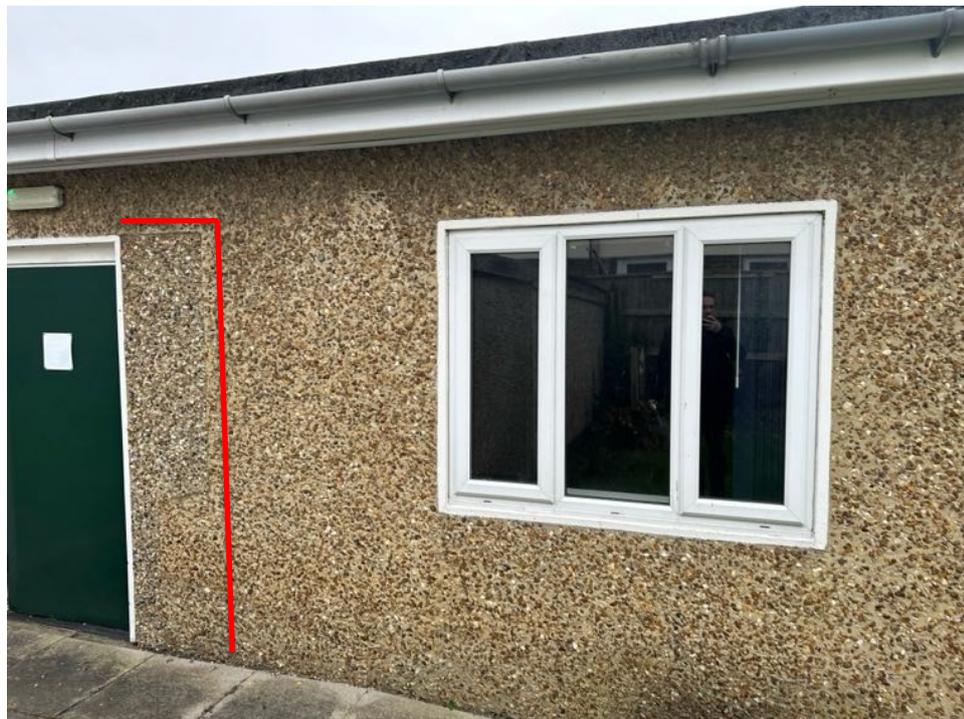
Photo showing a section of infilling and repair having been undertaken around doors to the rear left hand side.

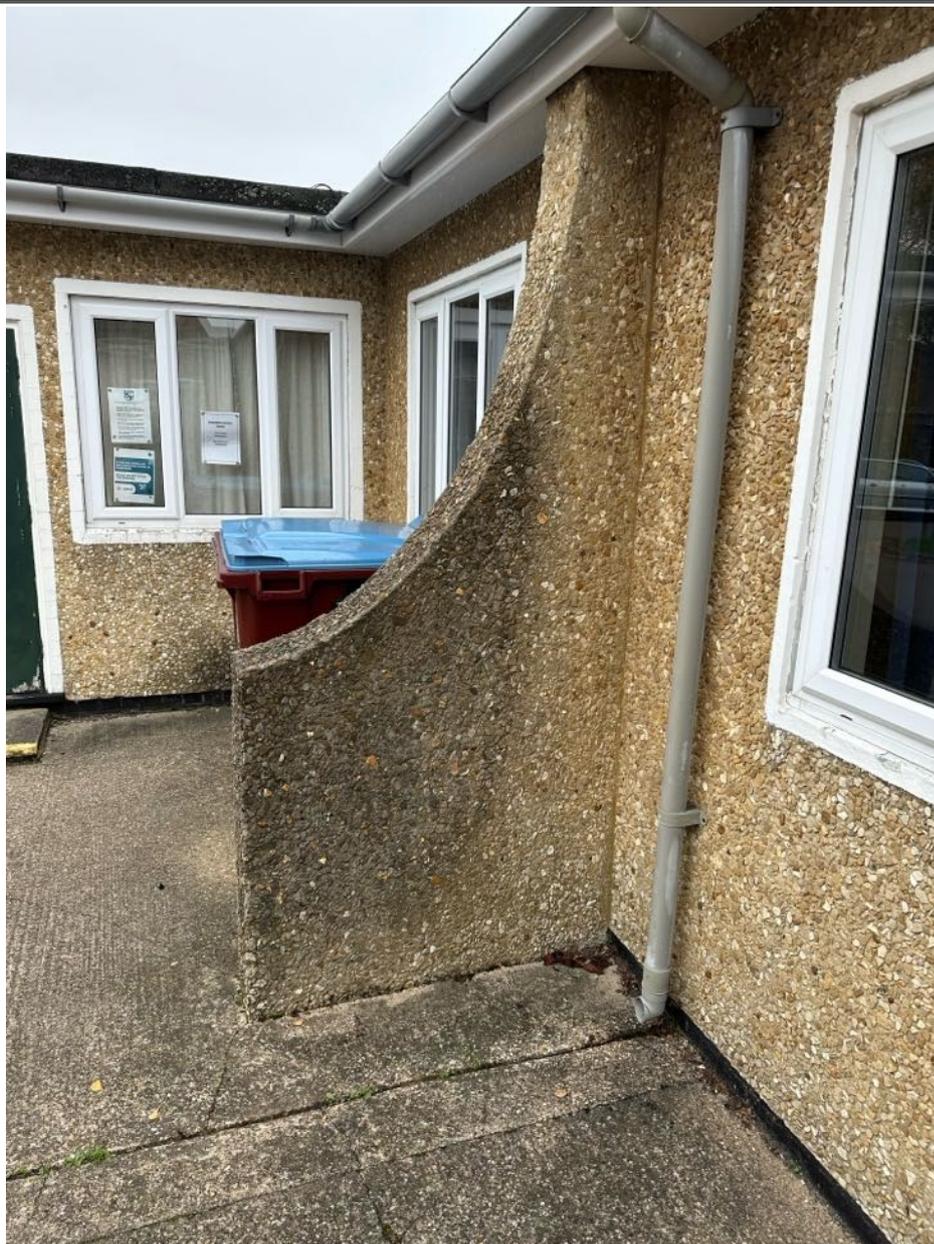
Photo showing concrete buttress to the right hand side which is providing lateral restraint to the walls
