STOTFOLD TOWN COUNCIL

6.5. Memorial Hall Condition Survey

SUBJECT: MEMORIAL HALL CONDITION SURVEY

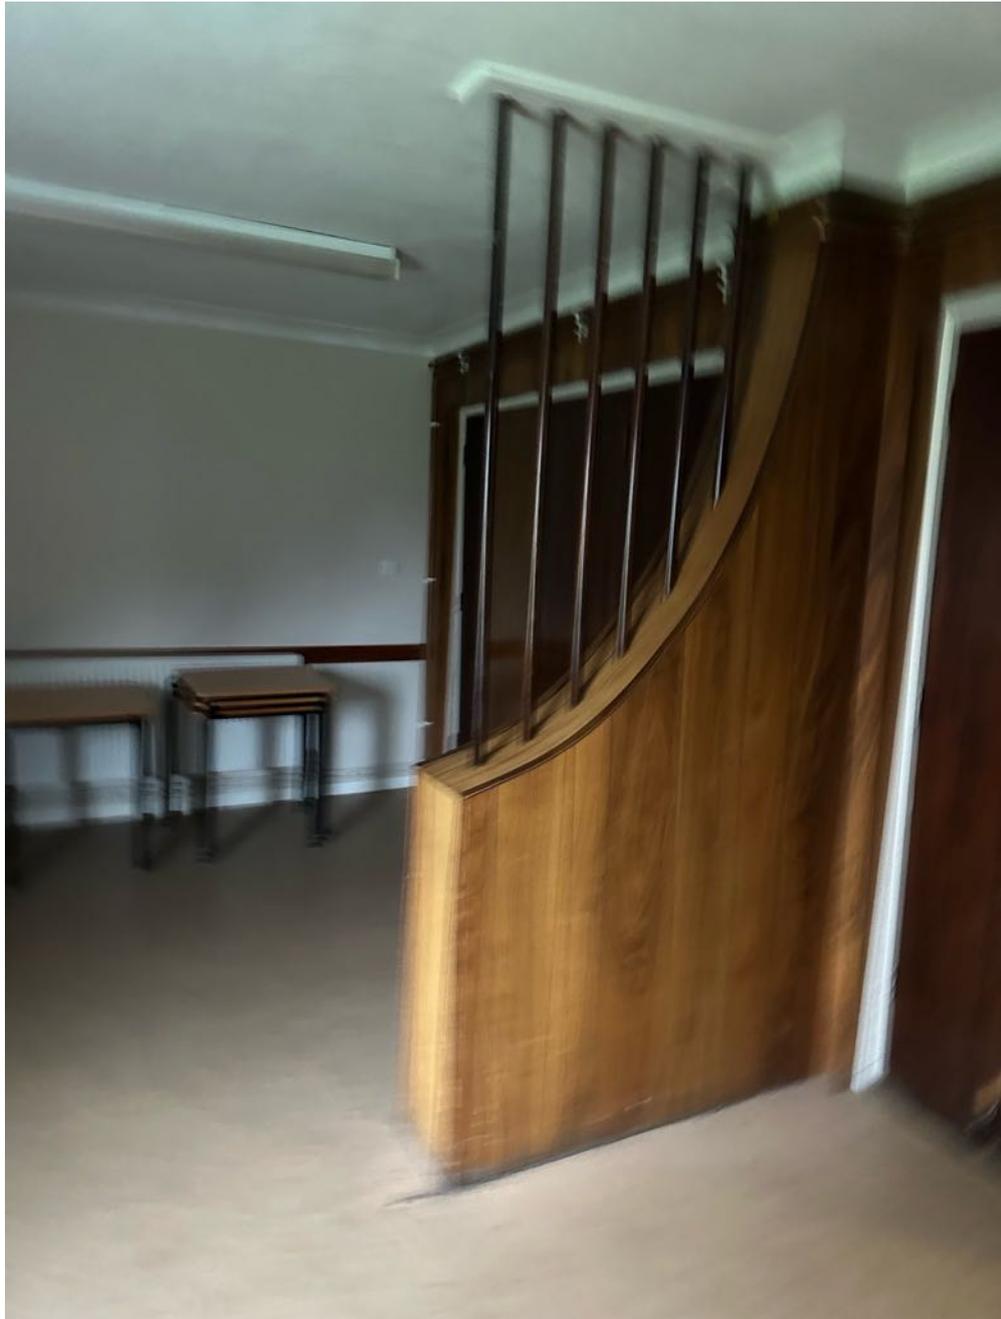
Photo showing Buttress to the Bar area. It is likely that this Buttress was located on the exterior leaf originally and the Bar area to the left hand side been added within the last 40-50 years.

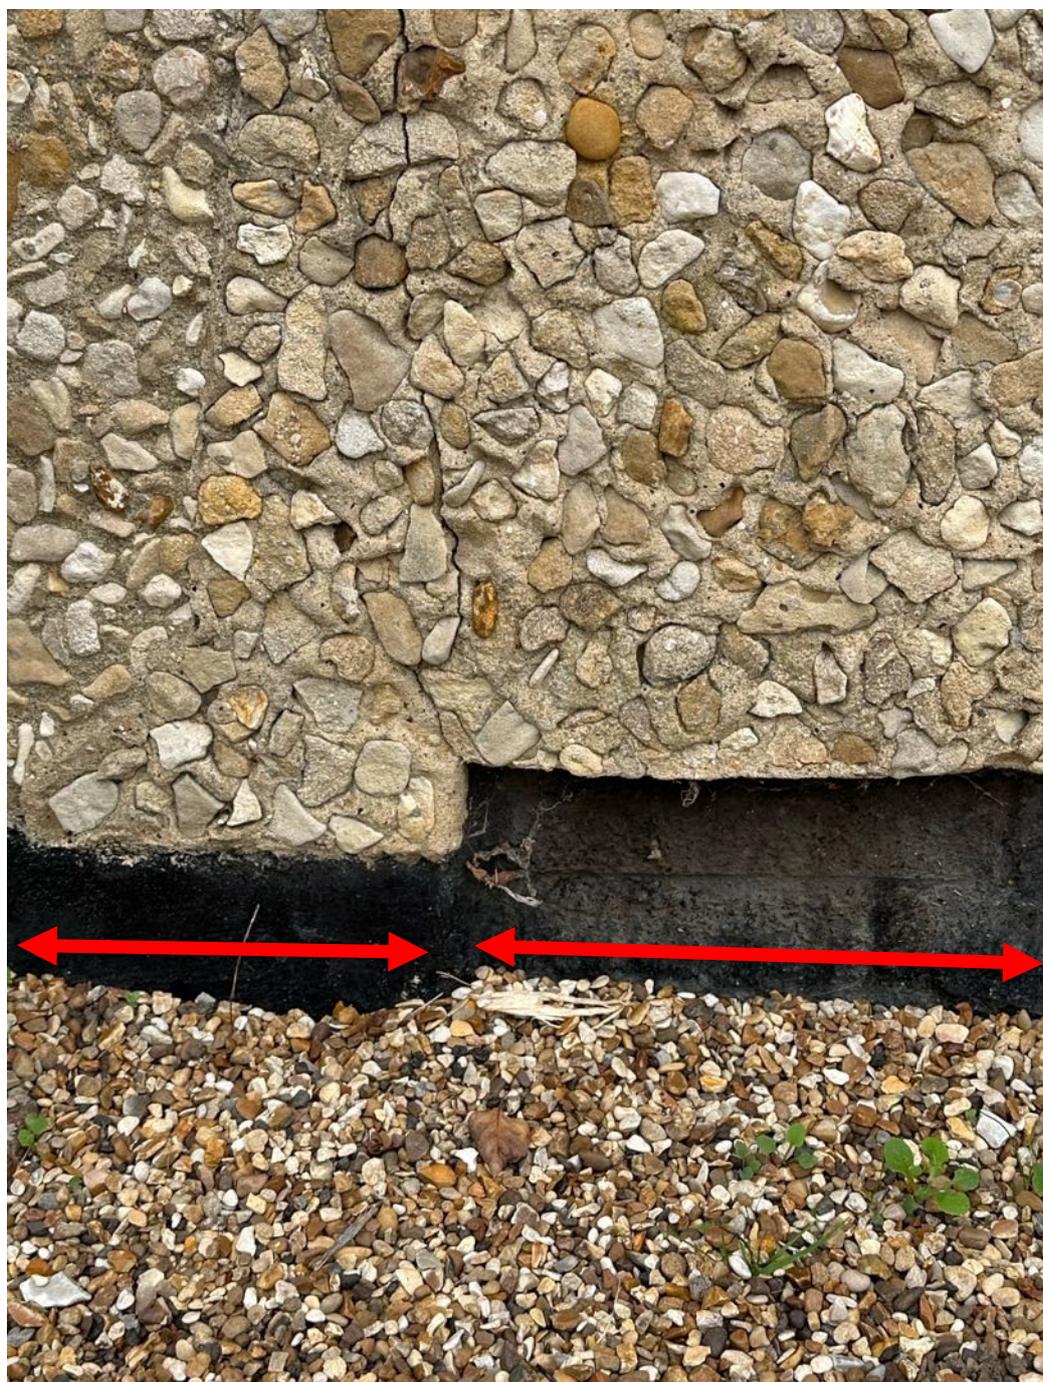
Some cracking occurs where we believe the kitchen has been extended historically with vertical cracking occurring at this junction. The concrete slab here meets brickwork at low level which reinforces our belief that this has been extended.

Photo showing a mix of solid concrete base to the walls and supporting brickwork where we believe extensions have occurred to the Hall.

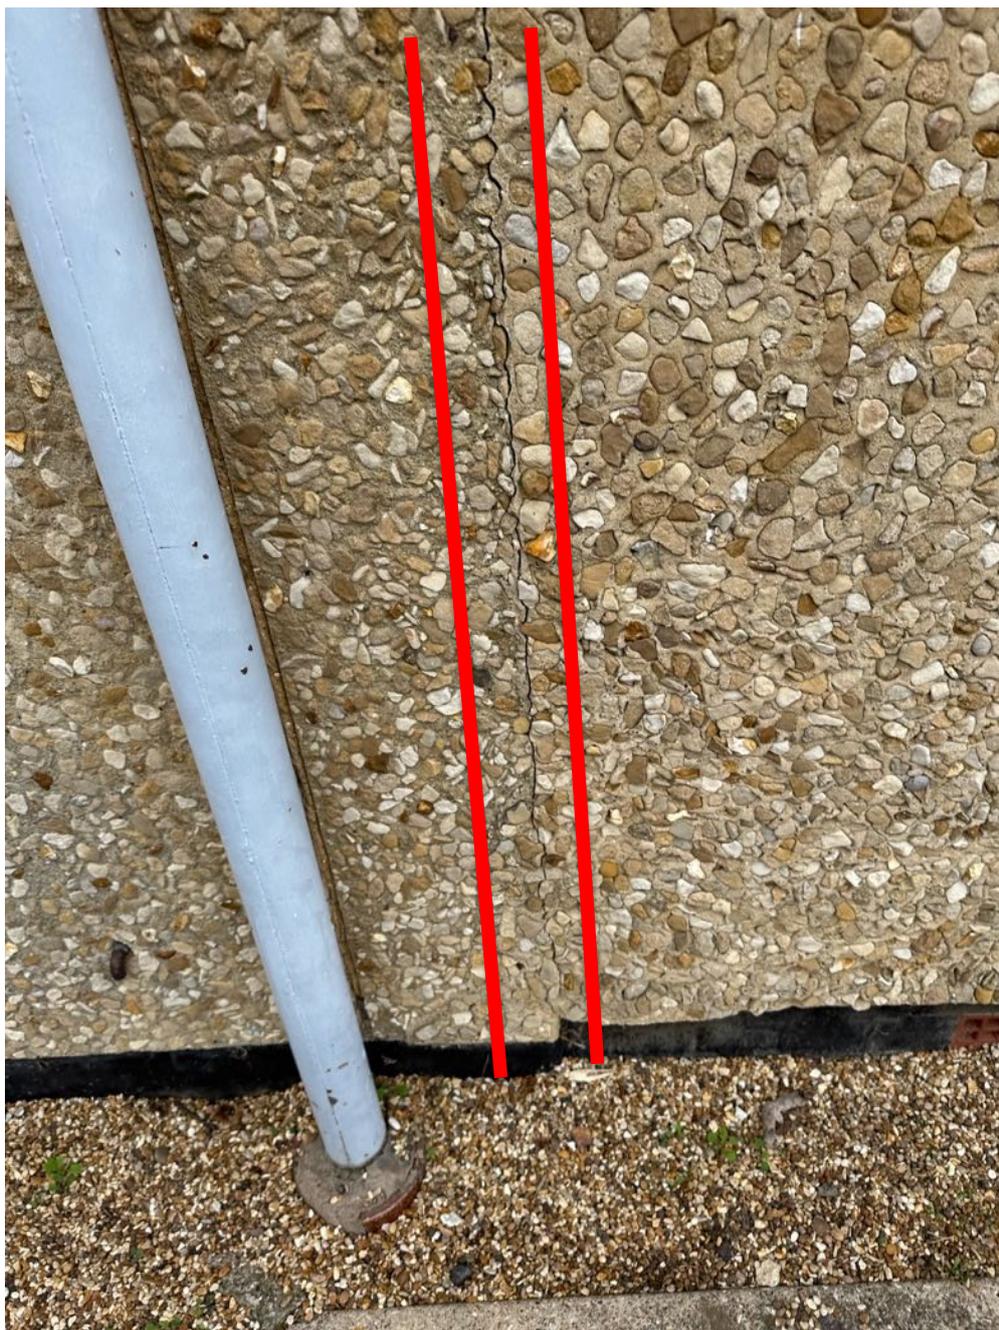
Photo showing vertical junction which could allow for water ingress, where extended.

With all vertical panel gaps to the building, we would suggest the use of a low modulus polysulphide mastic to be installed at these junctions. This should effectively prevent moisture damage to the property.

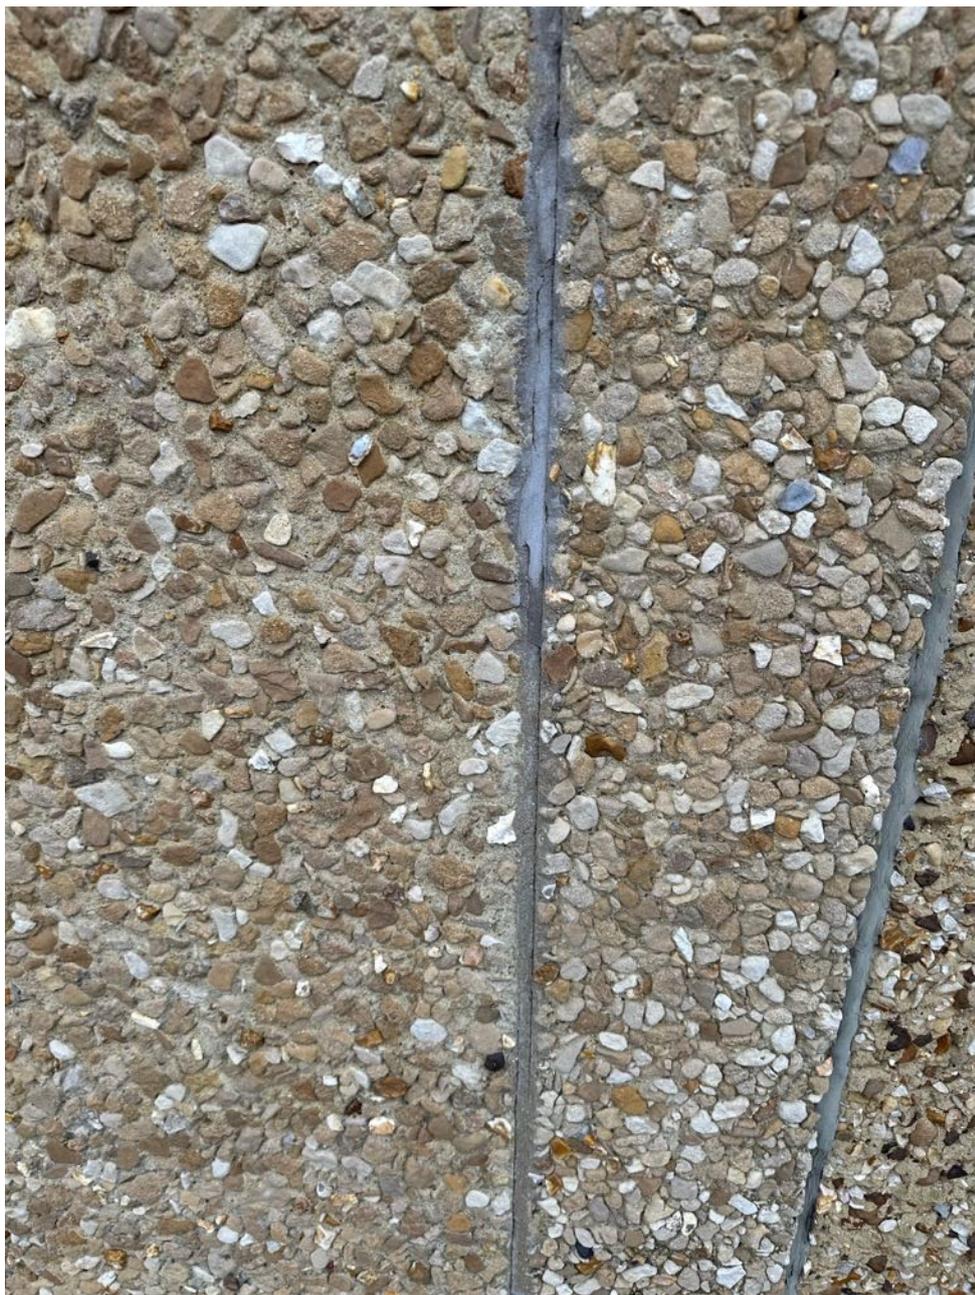
Photo showing hardened joints of which the left hand side is mortar and the right hand joint is polysulphide mastic. We recommend raking out all hardened vertical joints and installing mastic at these joints.

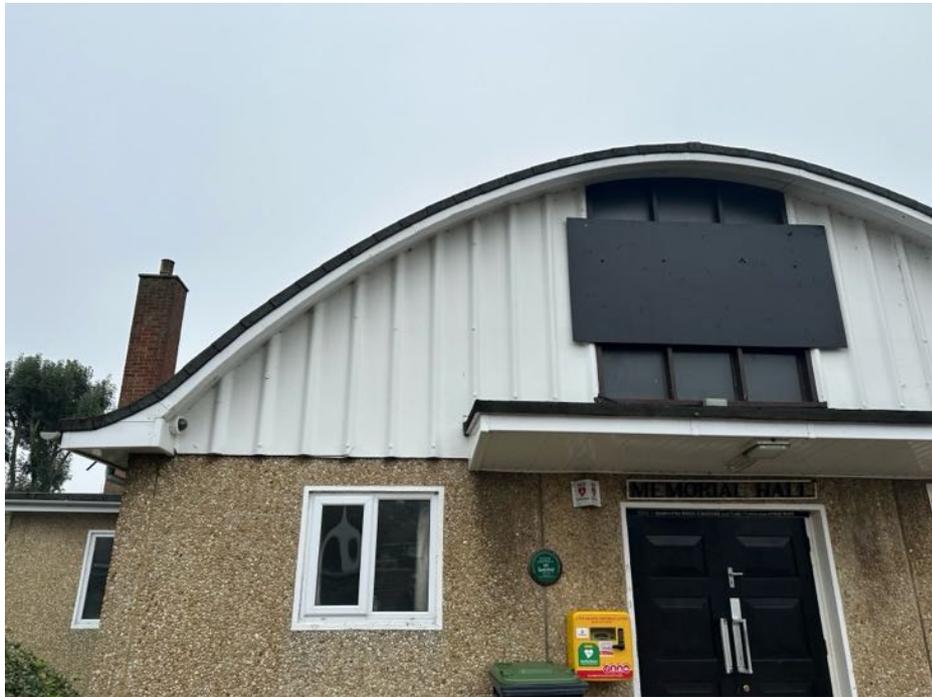
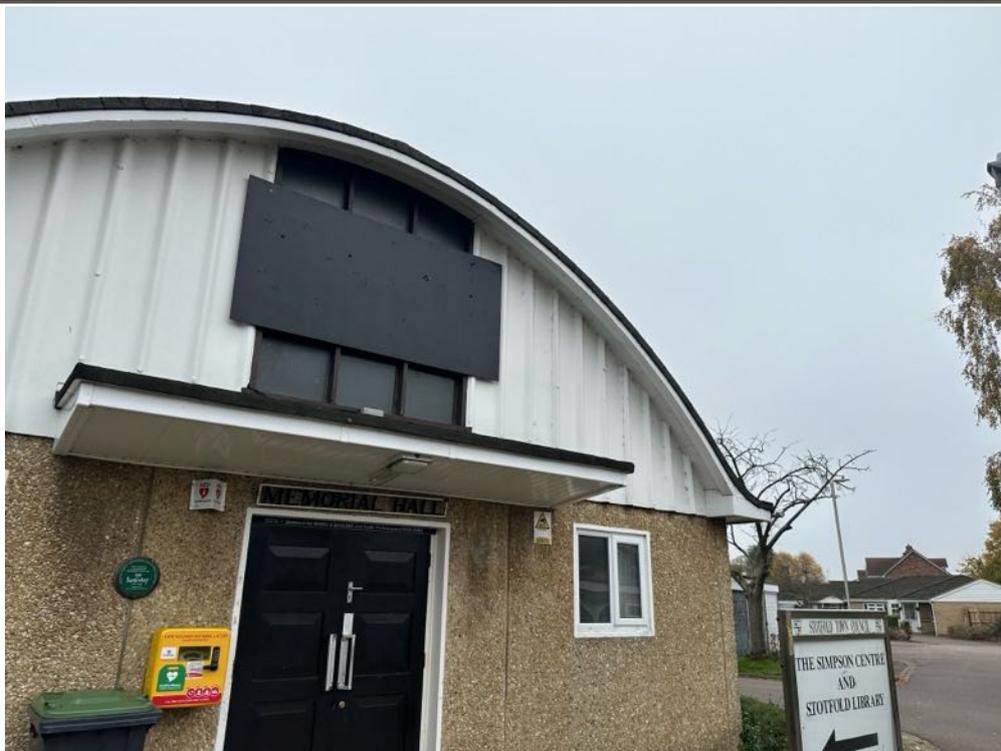
To both the front and rear curved sections of the structure, we noted that the panels are a potentially asbestos containing cement board.

Photo showing cladding panel to the front

To address these risks, it is critical to first conduct an asbestos survey, carried out by a licensed professional, to confirm the presence of asbestos in the panels. In cases where the panels are in good condition, encapsulation with a sealant or coating can prevent fibre release. Any work involving asbestos-containing panels should be undertaken by trained personnel following strict safety protocols. If removal is necessary, this must be carried out by licensed asbestos contractors using controlled methods to minimise the release of fibres into the environment. All work must adhere to the Control of Asbestos Regulations 2012 in the UK, including proper notification to relevant authorities and the safe disposal of asbestos waste.

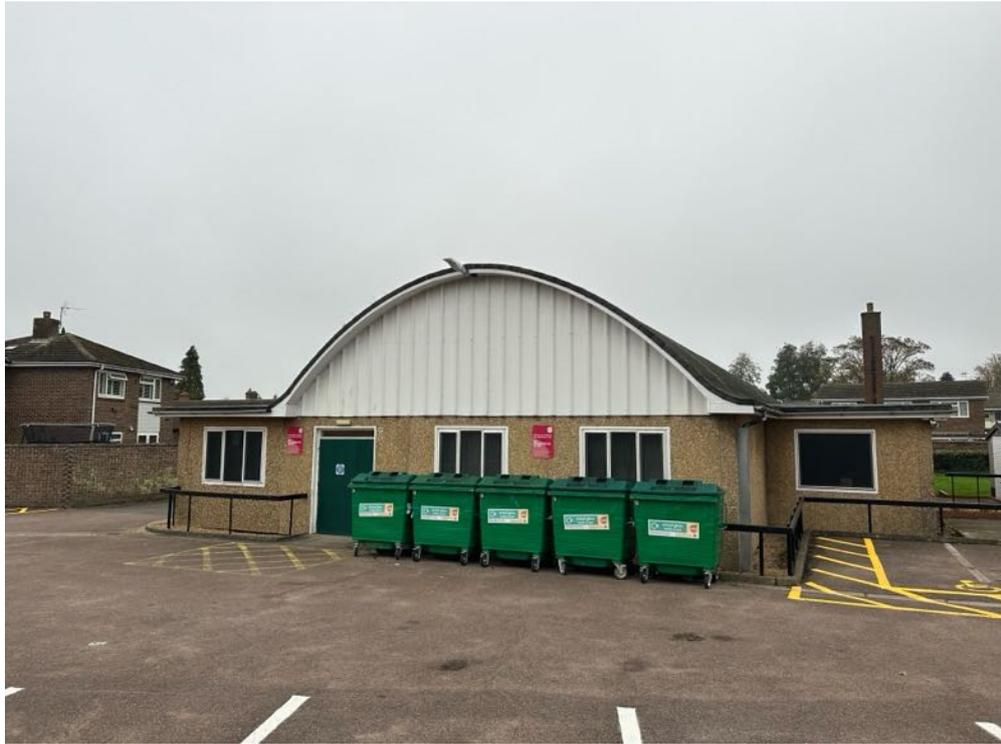
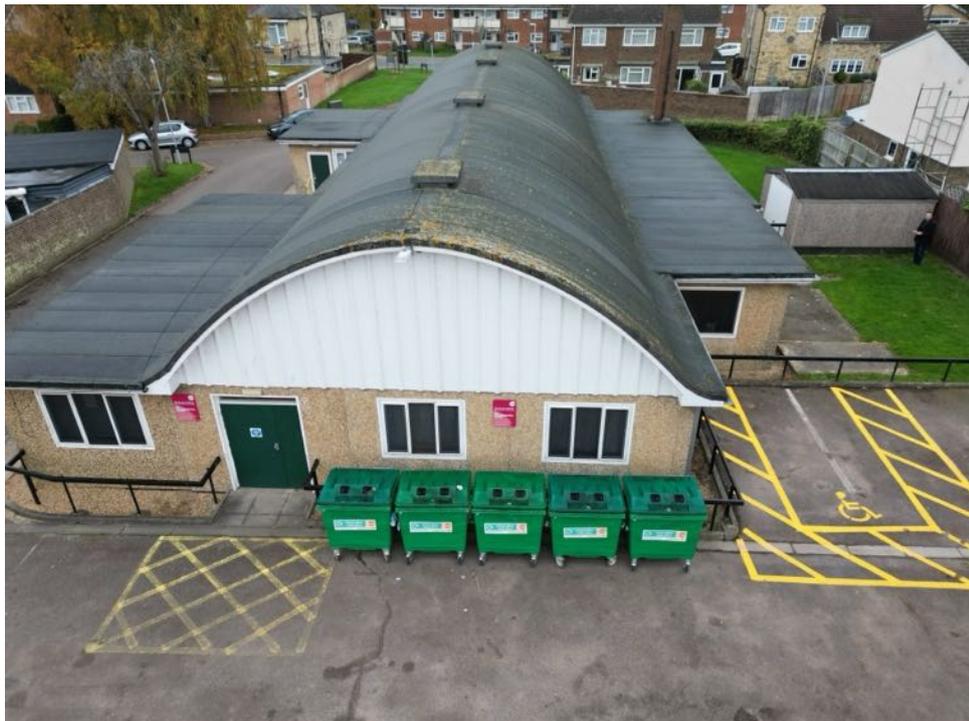
Photo showing cladding panel to the rear

It is our recommendation that you consider replacement of these panels with an insulated panel to improve the thermal performance of the structure.

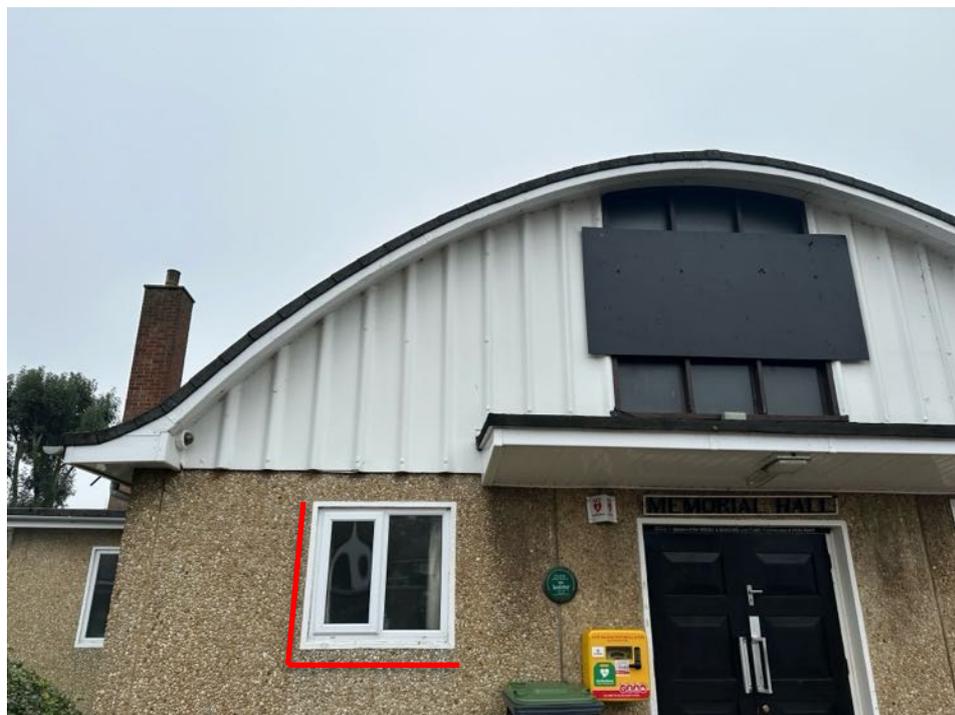
White UPVC double glazed windows exist within cement window reveals. Some cracking exists to these cement fillets. We would suggest that an epoxy layer be added around the window reveals where cracking to prevent water ingress and damage to the wall panels.

Photo showing the window surround to the front which is showing cracking between the window and surround panelled frame.

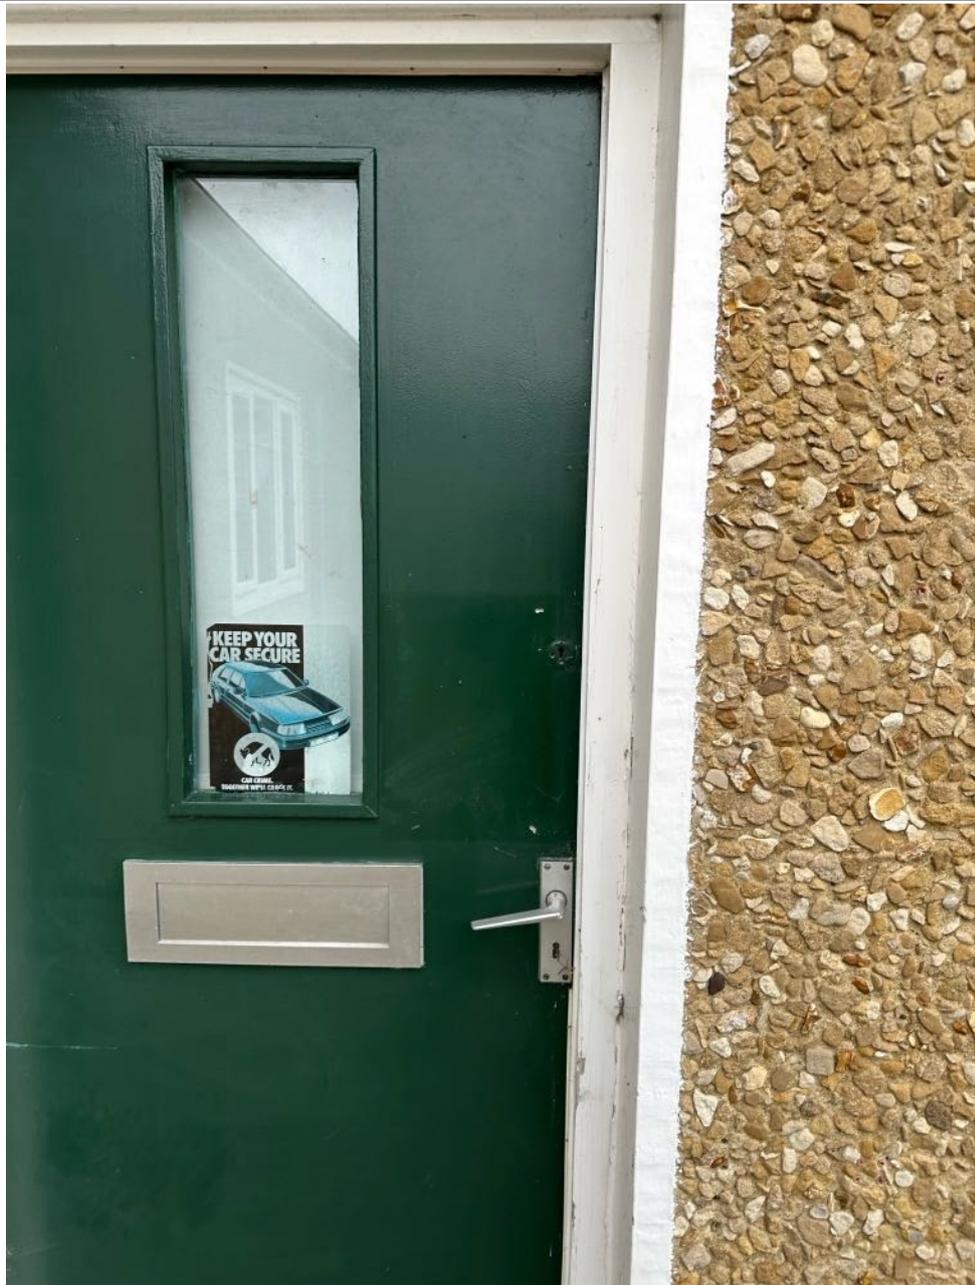
Photo showing door into the side store – note that we do not believe the glazing to this vision panel to be toughened glass. This could lead to break in or injury.

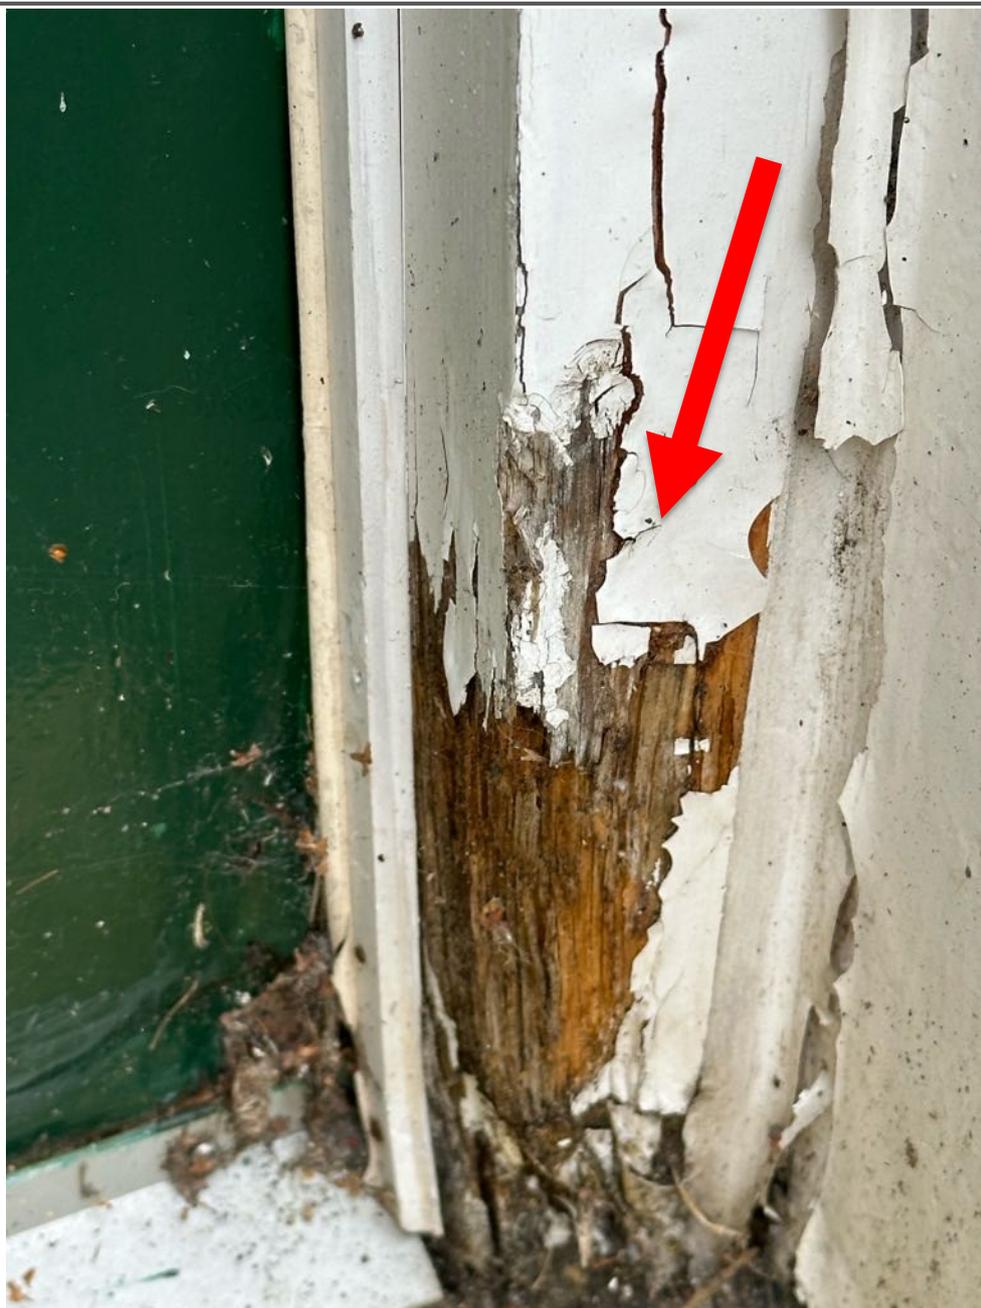
Photo showing timber decay to the door surround to the side store. We would suggest cutting out these areas of rot and splicing in new sections of timber.

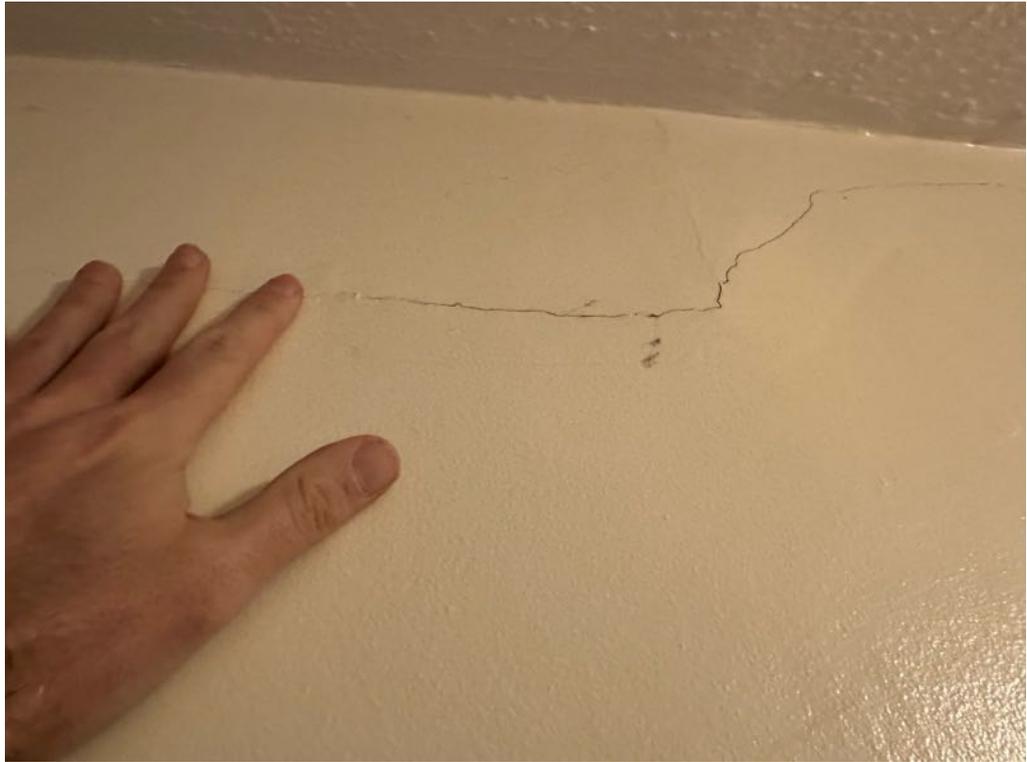
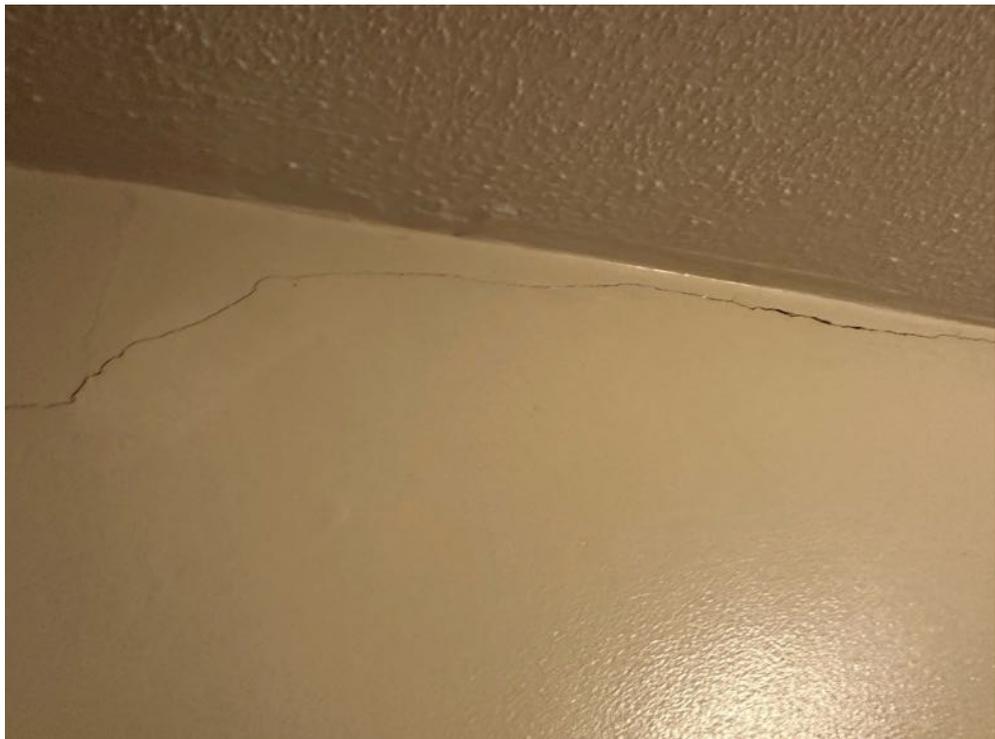
Where cracking exists to the beam over the entrance hallway, we would advise that structural engineering advice be sought on this as we suspect that the padstones are not adequately sized to support the curved load of the roof being placed here.

Walls are painted plaster on solid masonry. Where there is an arch support the roof structure above, padstones appear to have failed, leading to extensive cracking either side of the arches. Installation of new pad stones is advised. See photos.

Photo showing cracking pattern which is showing either side of the arch through to the Hallway.

Photo showing extent of cracking

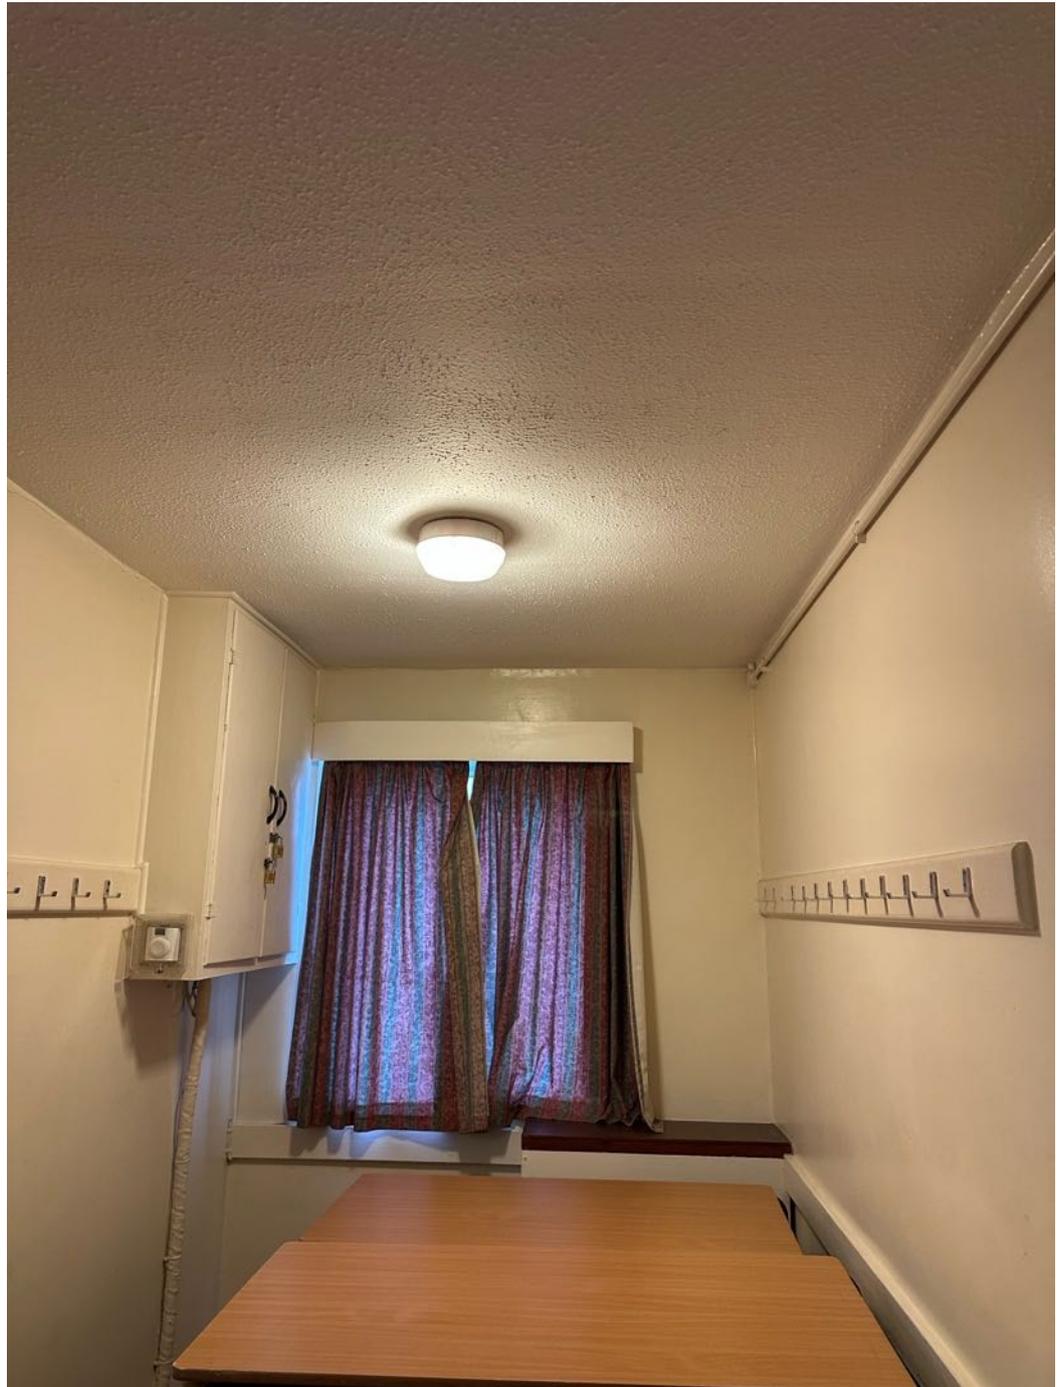
The ceiling is a textured ceiling coating which potentially contains white asbestos or 'Chrysotile'. Chrysotile - In the UK, the use of chrysotile in textured ceiling coatings, also known as "Artex," poses significant health risks due to the presence of asbestos. Chrysotile is a type of asbestos, and exposure to asbestos fibres can result in serious health conditions. These include lung cancer, mesothelioma (a rare form of cancer that affects the lining of the lungs and other organs), and asbestosis (a chronic lung disease caused by asbestos fibres).

Photo showing textured ceiling coating.

such as asbestos testing, removal, or encapsulation, is essential to minimise the risks and ensure the safety of occupants and any workers on site.

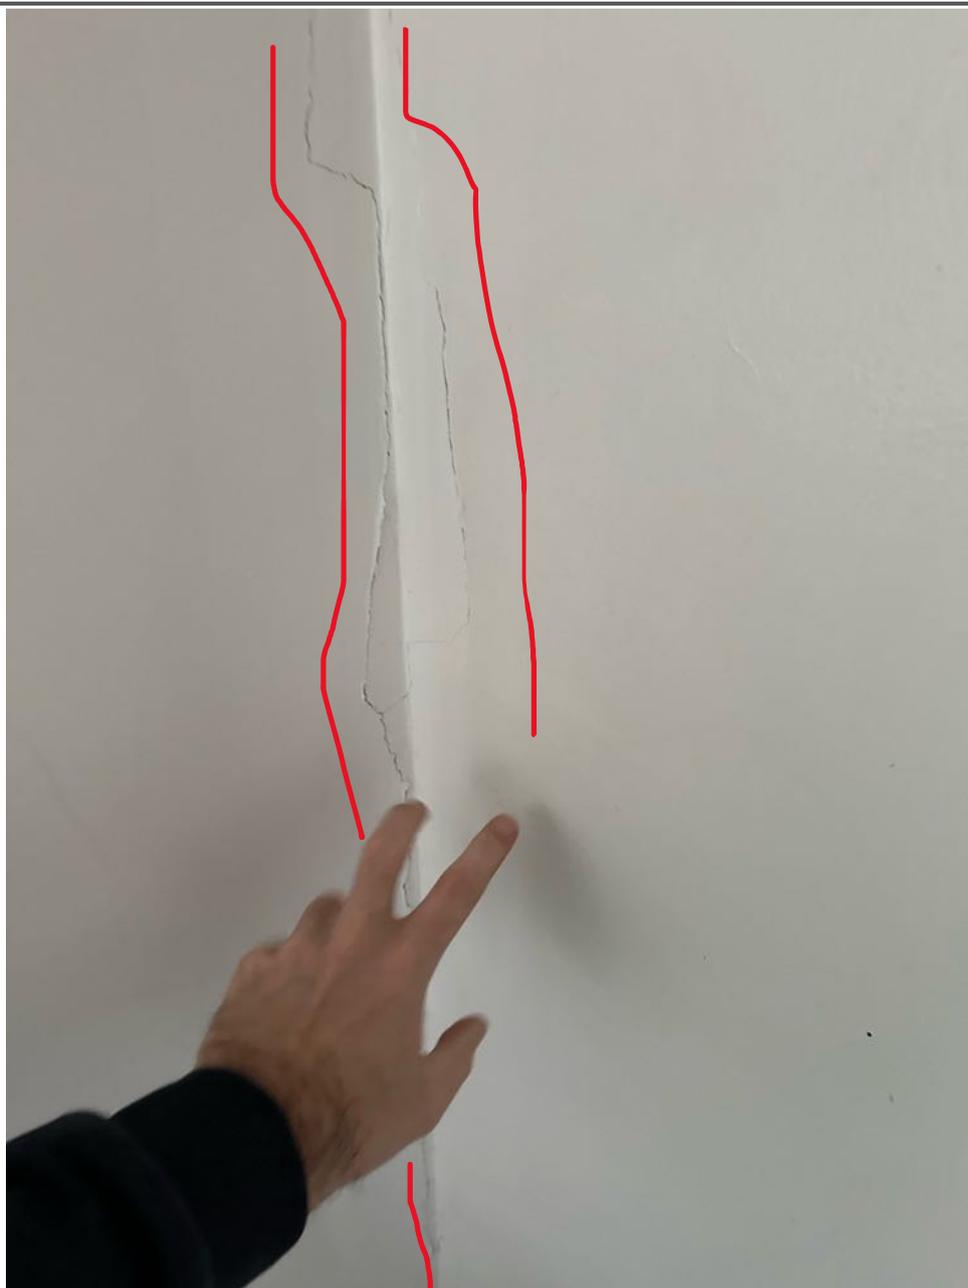
Photo showing vertical cracking to the corner of the WC wall

The Various cracks and gaps observed at wall junctions which can be filled with a flexible filler.

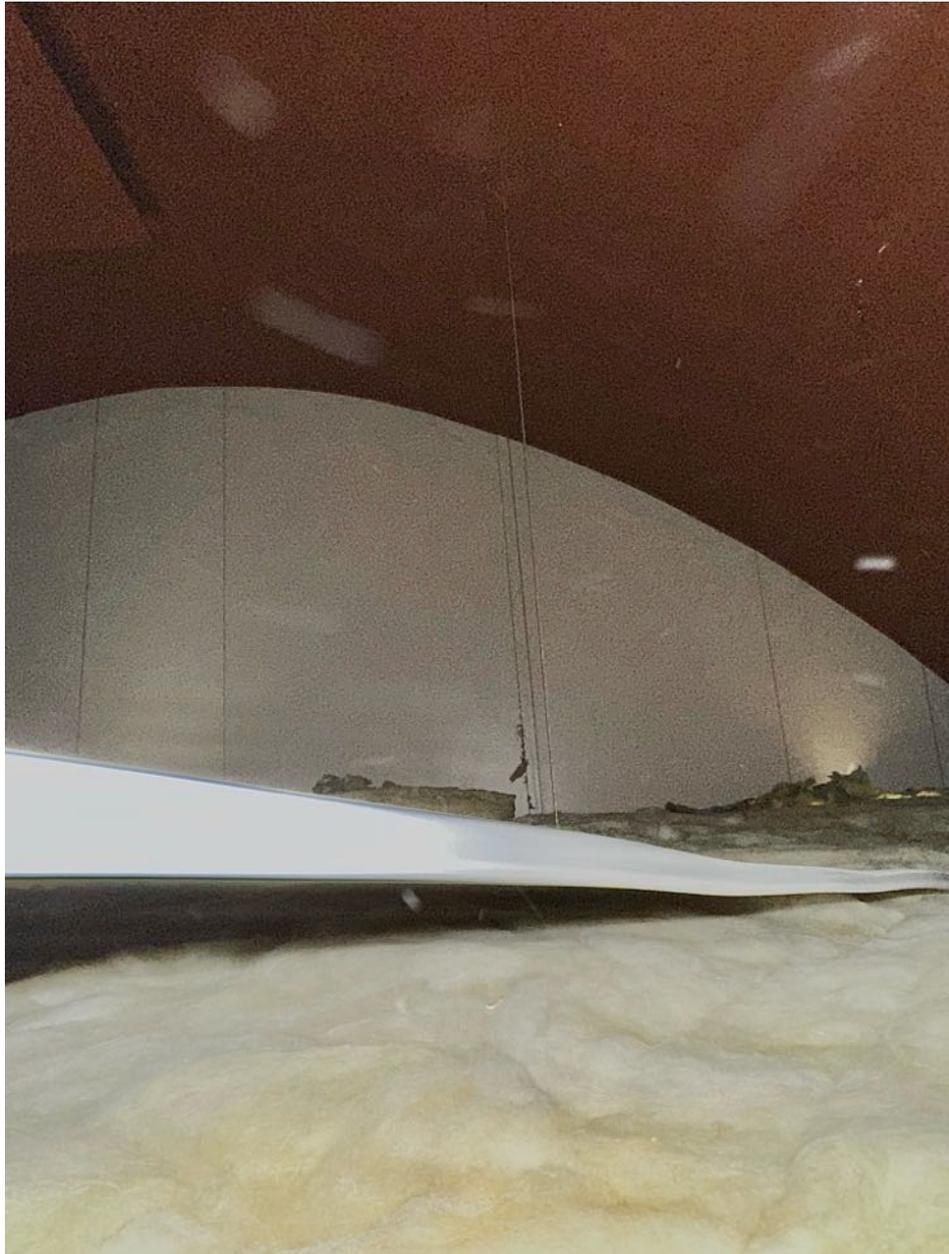
The ceiling is suspended panels. This was lifted and we noted no obvious signs of any water ingress form the roof above. See photos.

Photo showing no obvious signs of defect over the suspended ceiling

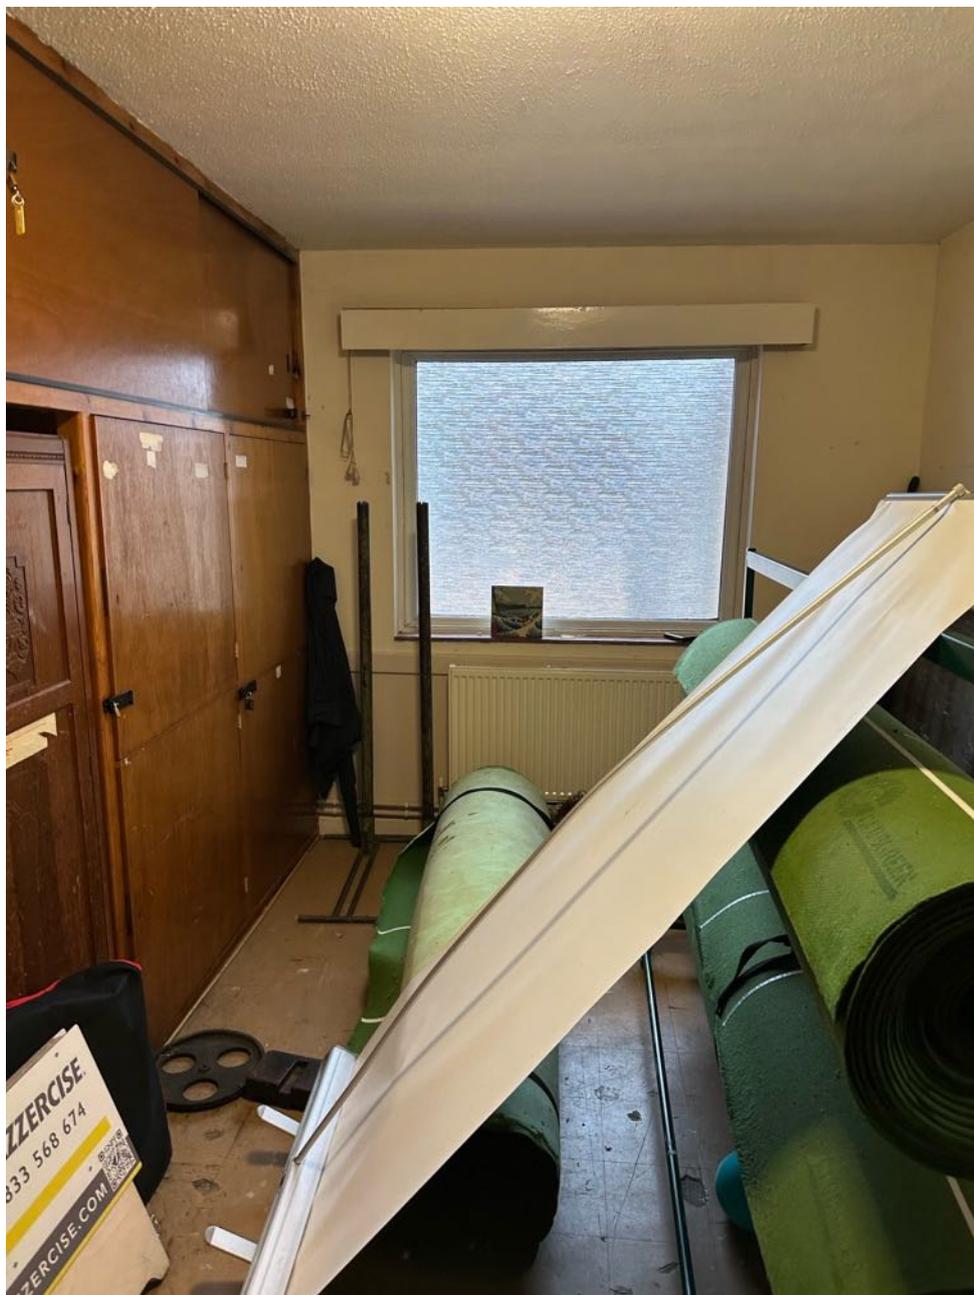
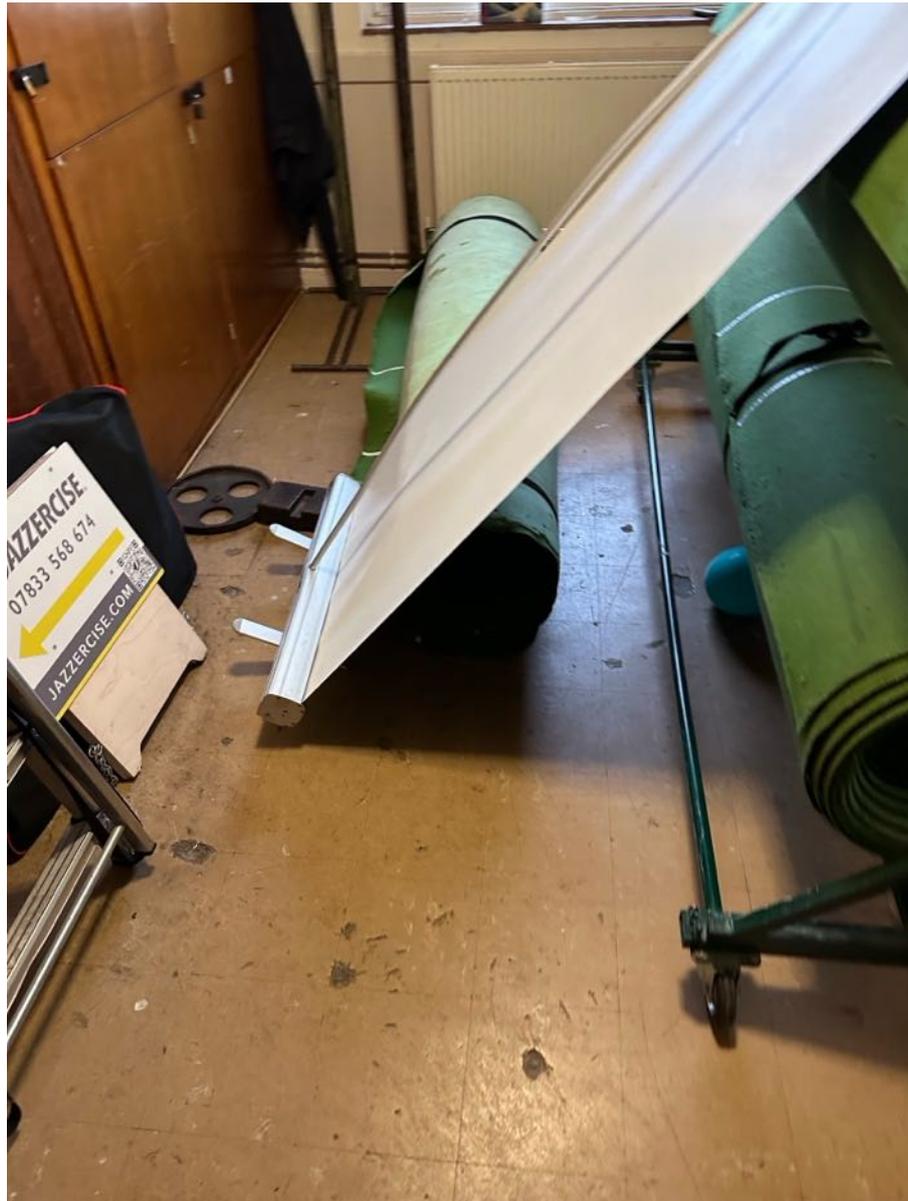
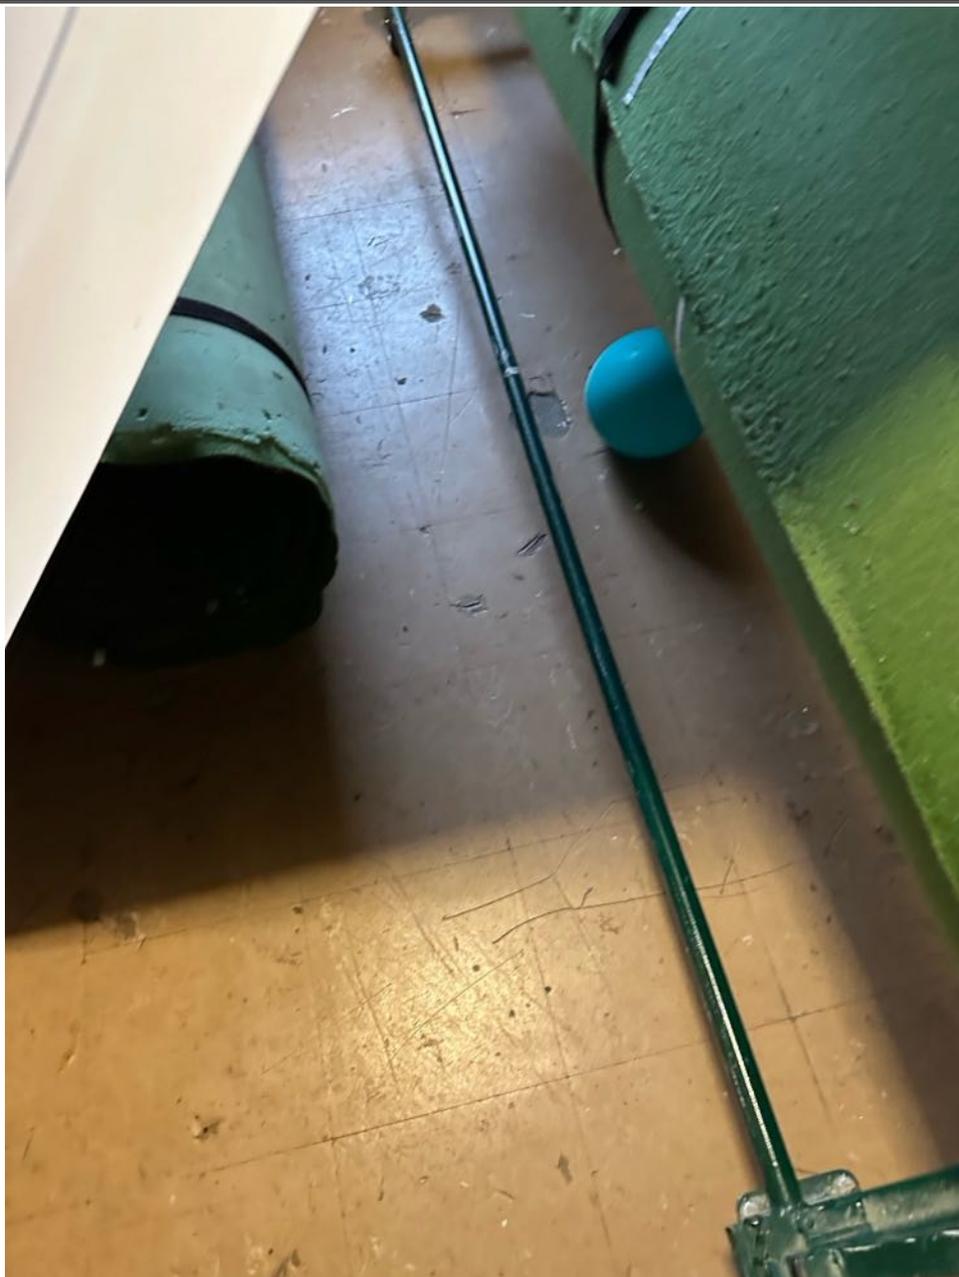
There are various areas of potentially asbestos containing material, and we are of the opinion the thermoplastic floor tiles in the various store areas, are in particularly poor order and could potentially allow fibres to become airborne. As such, you may wish to consider seeking further specialist advice however, the safe encapsulation if this floor covering is ultimately advised. This should be done in a manner and material to ensure that the surface is sufficiently hard wearing enough to withstand the uses of the Hall including stacking of chairs and tables etc.

Photo showing generally poor condition of the thermoplastic floor tiles with numerous chips noted

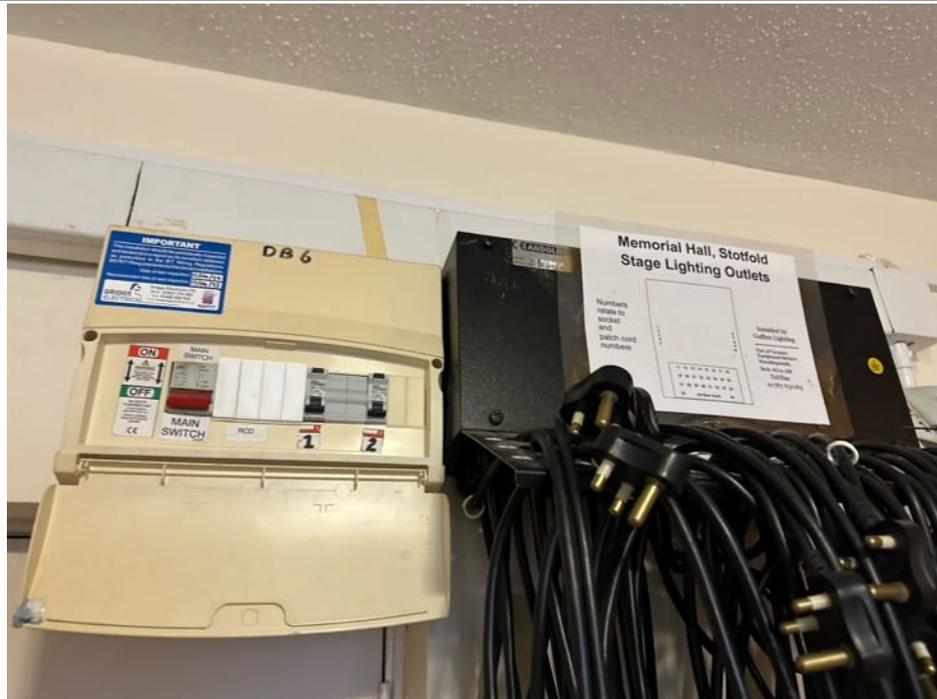
Further inspection of the electrical installation is warranted by a specialist as we believe that residual current device protection is missing from the installation.

Photo showing on of numerous distribution boards for the electrics. We would comment that there does not appear to be any residual current device protection to the boards. We suggest having a separate NICEIC registered electricians report undertaken.
