STOTFOLD TOWN COUNCIL

6.5. Memorial Hall Condition Survey

SUBJECT: MEMORIAL HALL CONDITION SURVEY

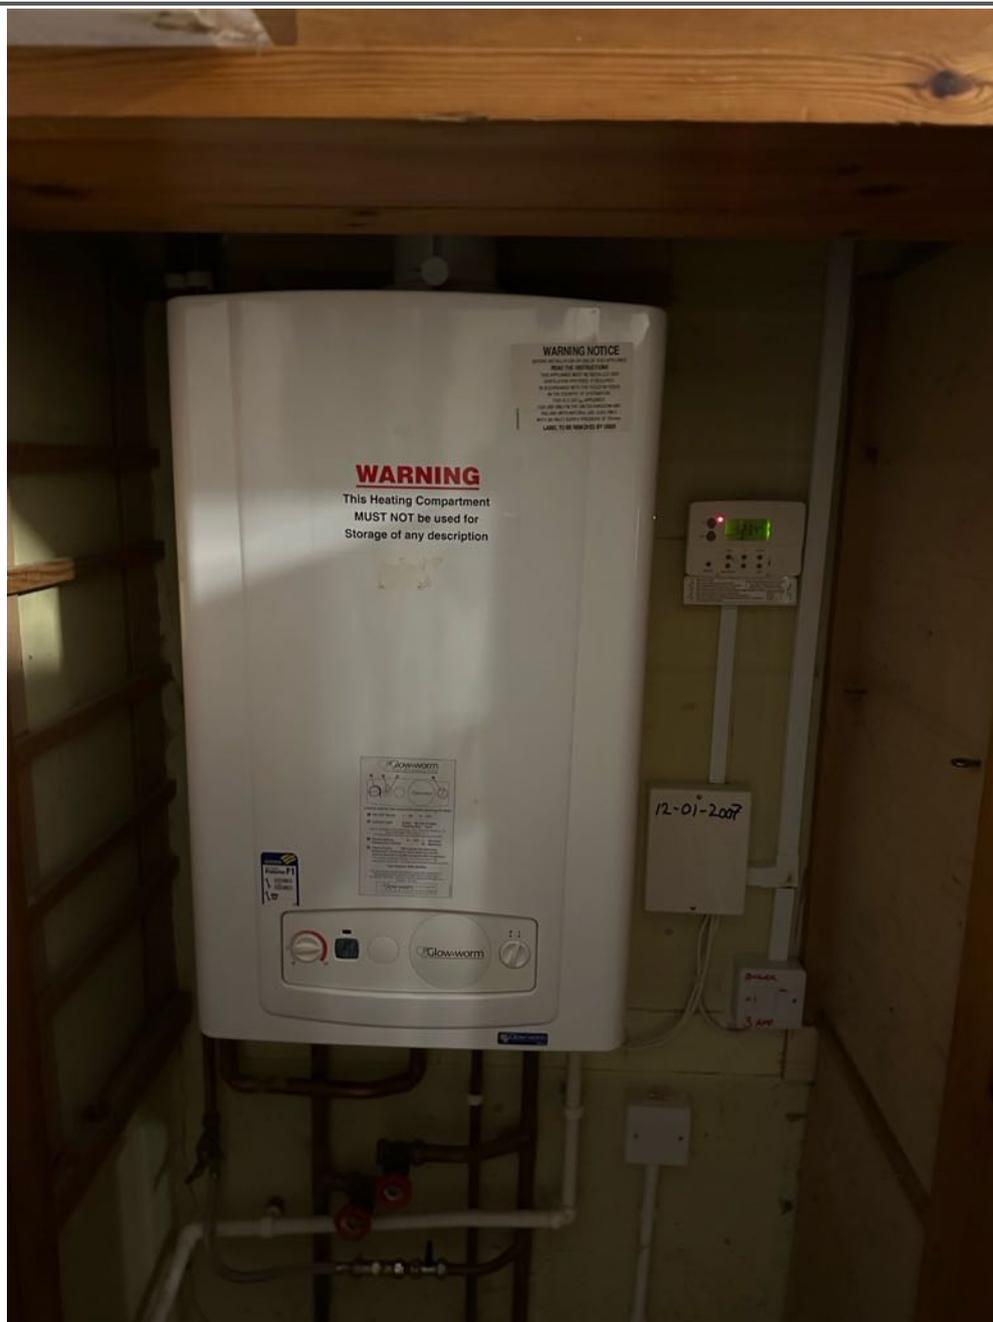
The Glow Worm boiler visually is circa 5-10 years old, and we would suggest budgeting for its replacement in the next future as current British Gas Guidance is to replace Gas Burning boilers at 10-year intervals.

Photo showing Glow Worm Boiler which was clearly operable at the time of our visit.

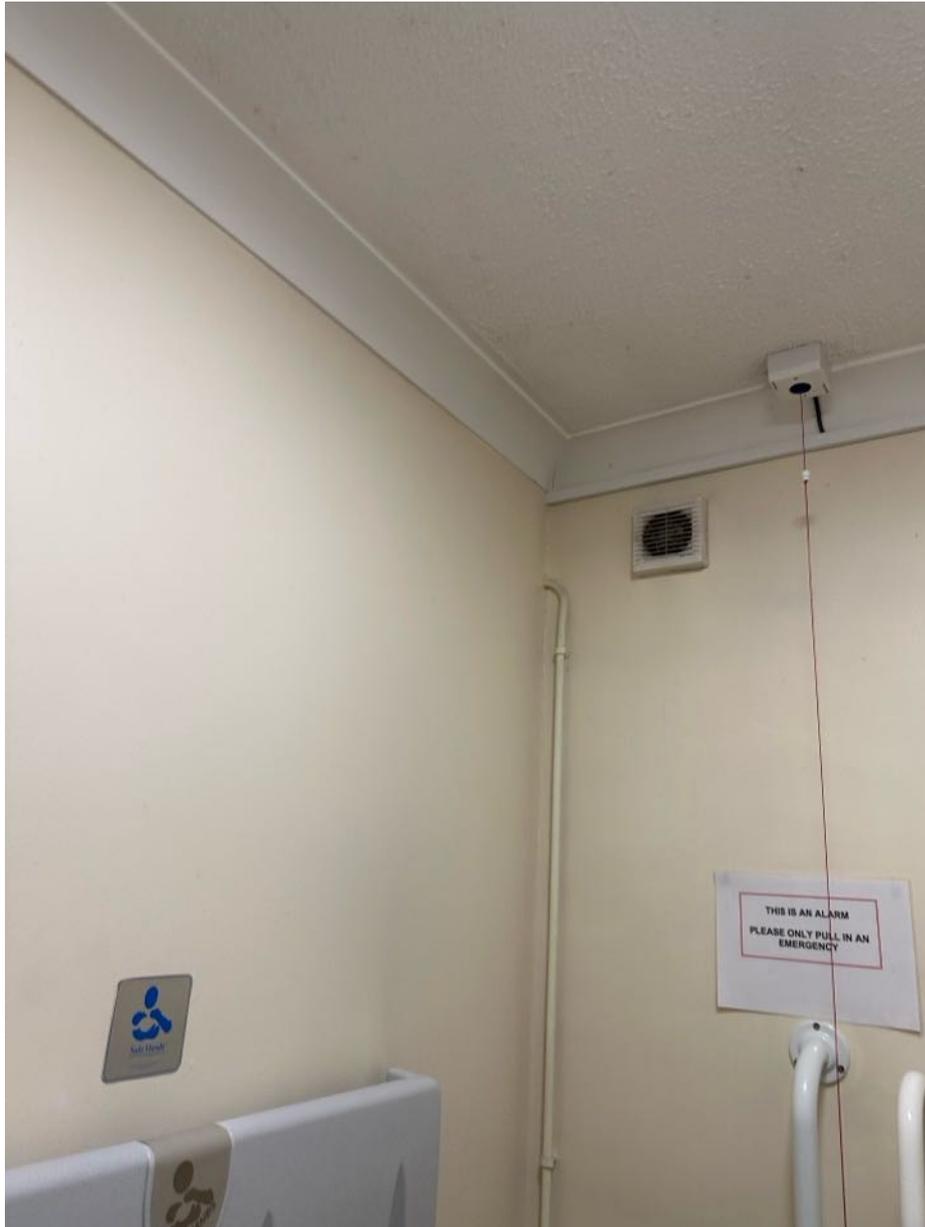
Photo showing mechanical extraction to the WC which was operable at the time of our visit
