STOTFOLD TOWN COUNCIL

6.5. Memorial Hall Condition Survey

SUBJECT: MEMORIAL HALL CONDITION SURVEY

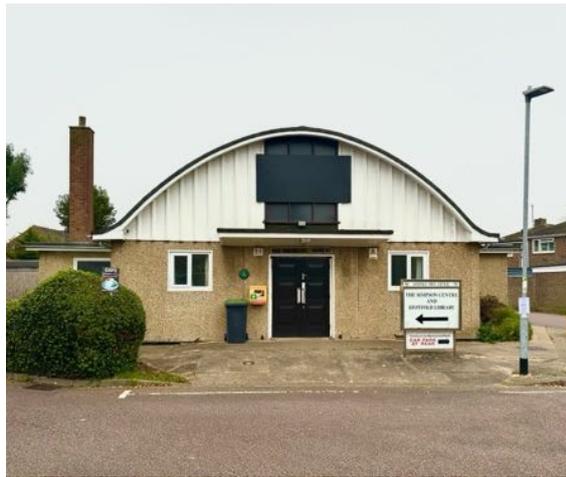
Photo showing memorial hall to the front

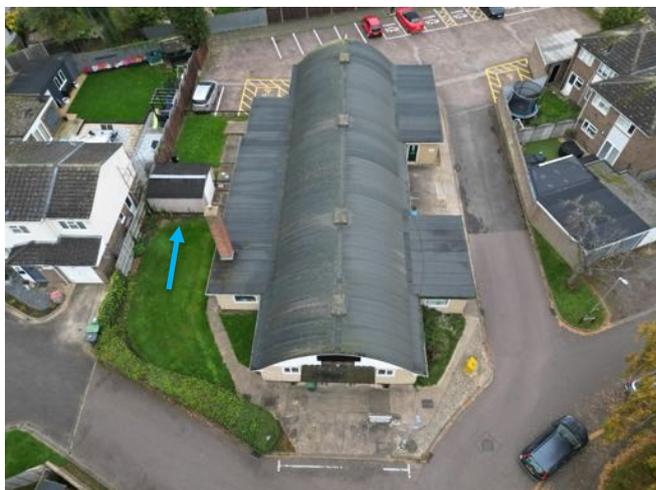
Photo showing an aerial view of the site with the Garage/ Storage structure shown to the left hand side, highlighted by blue arrow

Please note, we believe that the Memorial Hall has been extended to both the left and right hand sides historically which can be seen by the timber encased Buttress situated to the left hand side bar area.

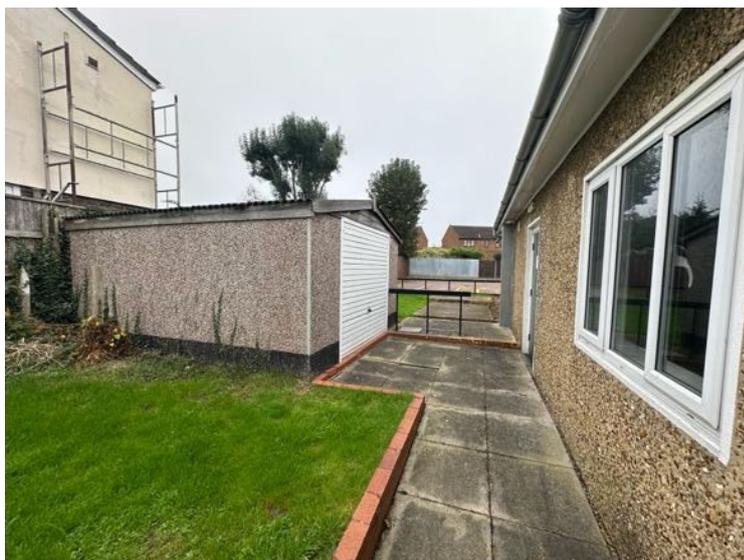
The various parking barriers and rails surrounding the site appear to be in reasonable order with no immediate for improvement. Painting of the metal handrails adjacent to the garage will likely need undertaking at around 10 year intervals. Some thought to the users of the site should be given specifically around contrasting colours on handrails. Compliance with Part M of the Building Regulations around accessibility is advised generally around the site.

Photo showing handrails to the left hand side of the site.

Note that the plant growth to the Garage/ Storage structure should be removed in the near future.

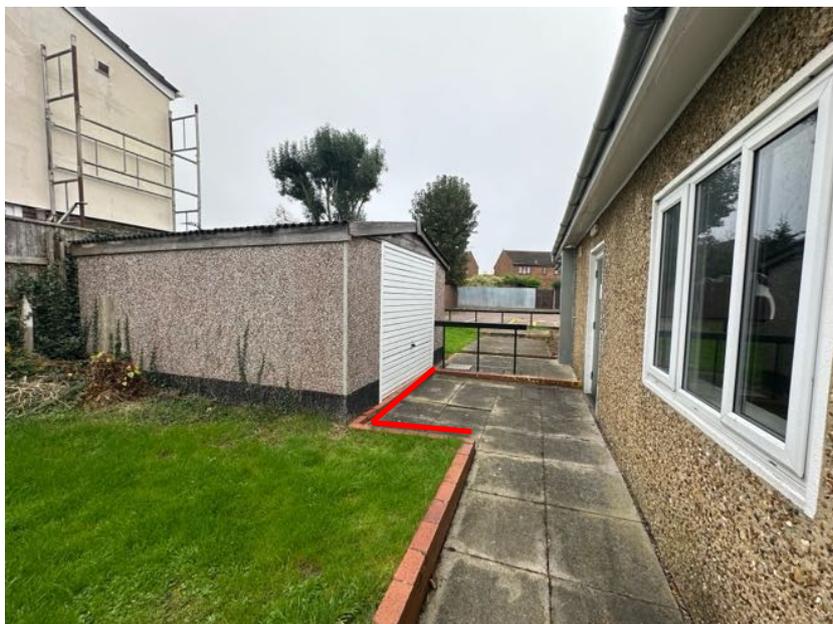
To the front of the Garage/ Storage area, there are some uneven pavers which could leading to ponding water which in the winter months could lead to freezing. We would suggest lifting this and levelling of the pavers.

Photo showing area of uneven paving

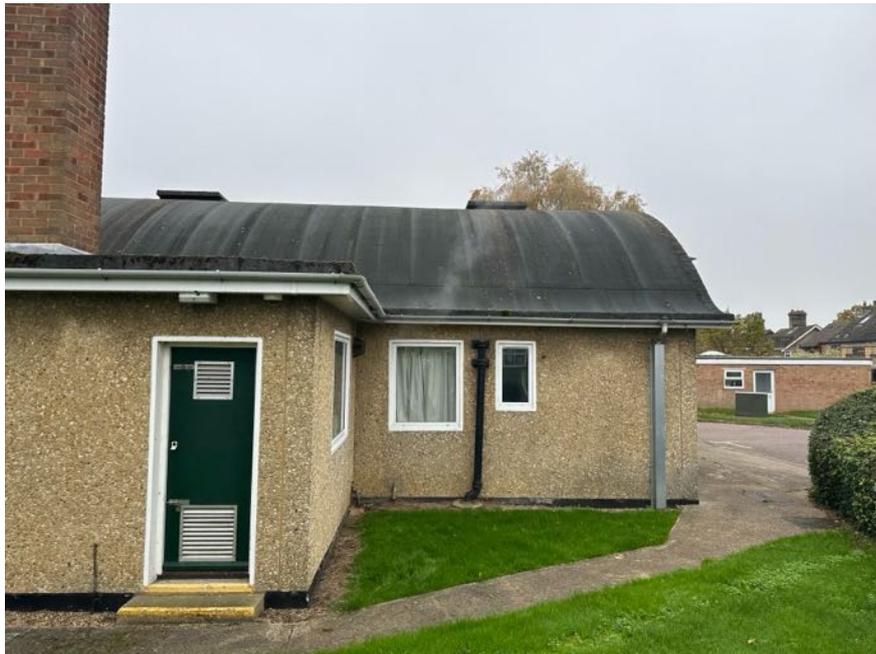
Along the ridge line of the curvature of the roof

Photo showing curvature of the roof

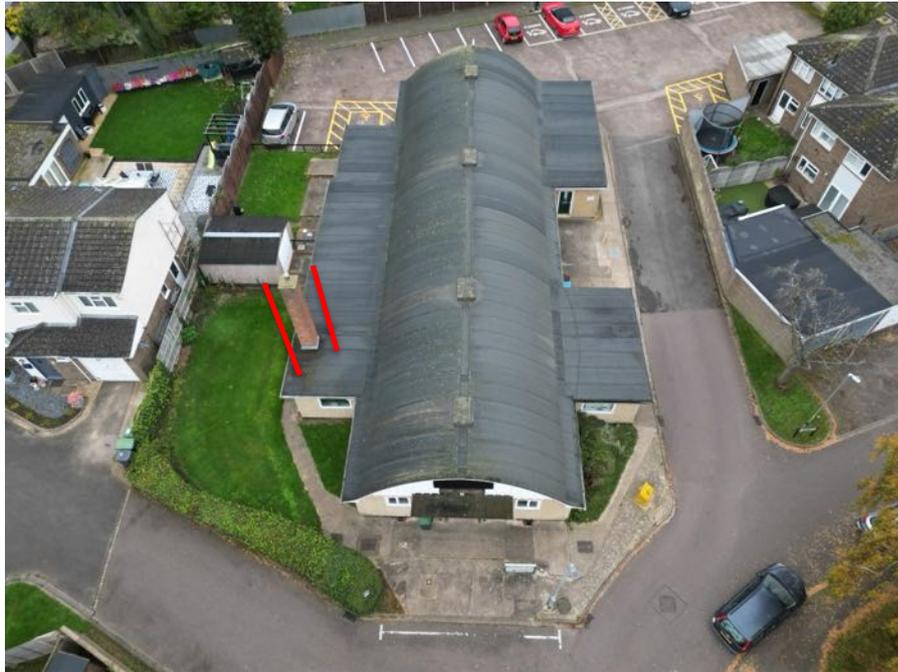
Where there is a chimney penetration in the roof to the left hand side, we believe that this flue is now defunct.

Photo showing the chimney flue to the left had side which we believe was connected to a potentially asbestos containing flue which has now been disconnected.

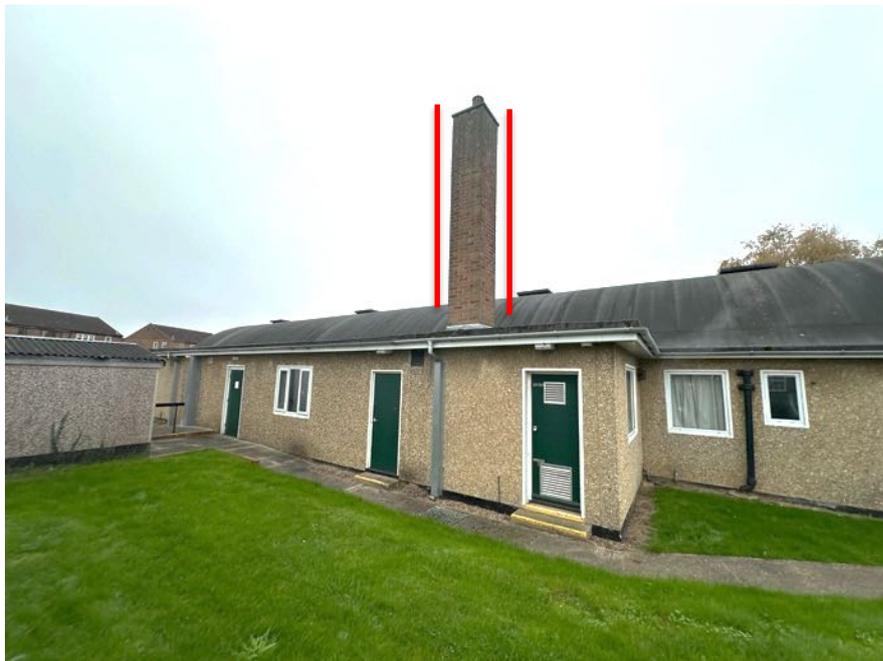
Photo showing brick built chimney which may have potentially asbestos flue lining and flue vent.

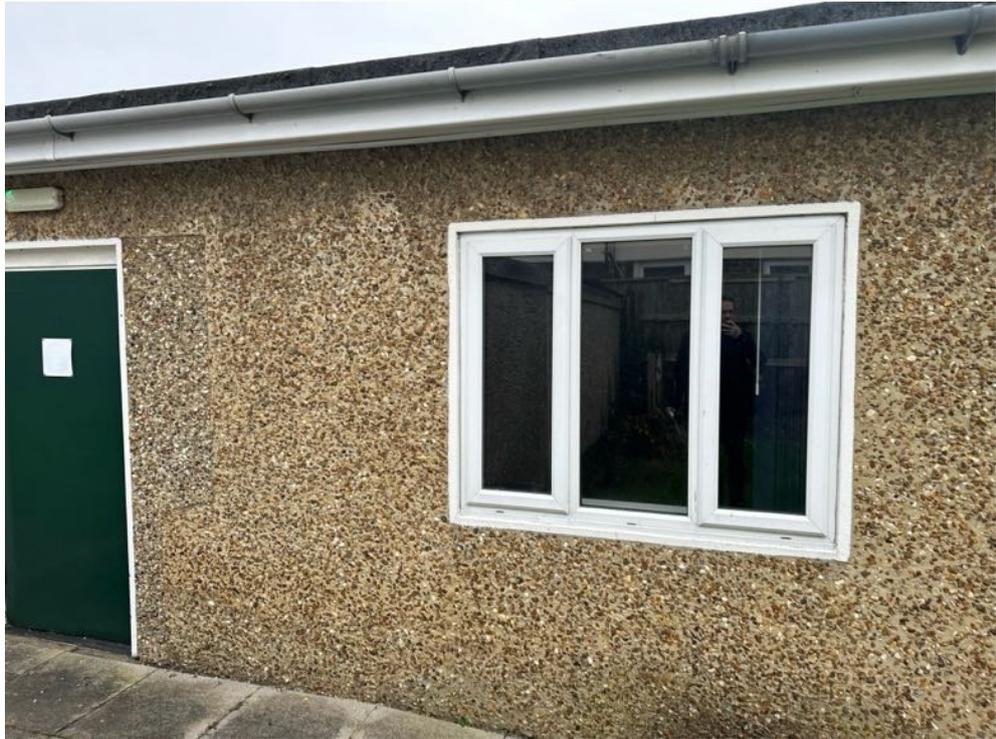
Photo showing Double Glazed UPVC windows

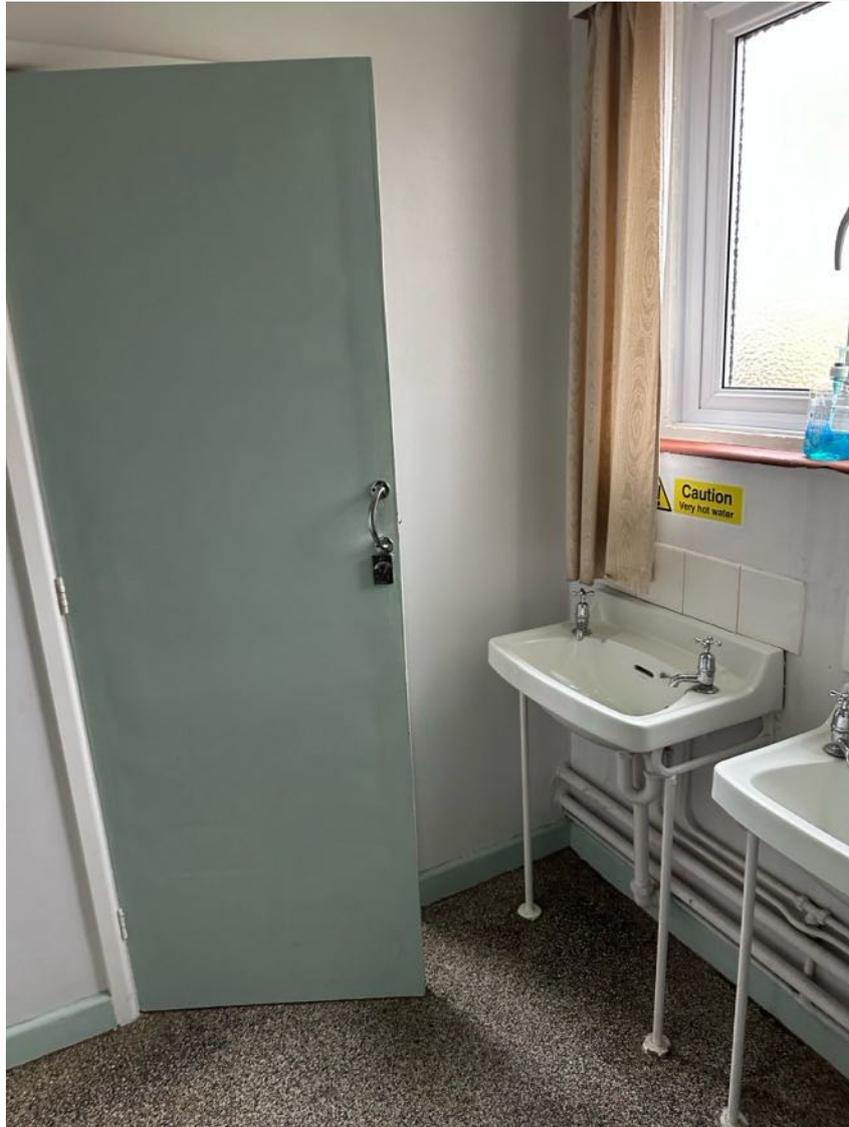
Women's WC The flooring in the Women's WC is a grip vinyl floor and appears to be free of any obvious defects.

Photo showing Women's WC

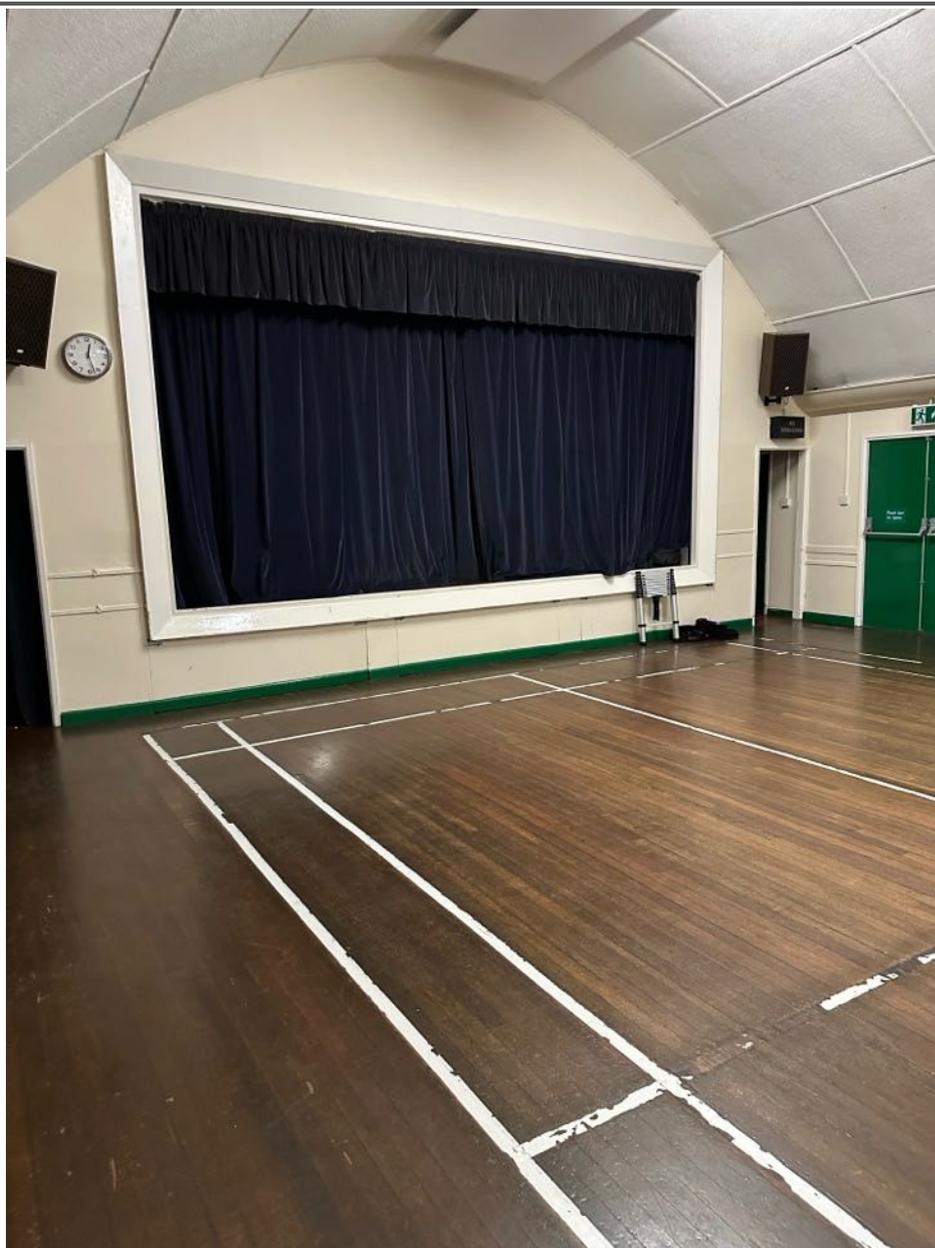
The hall floor is strip hardwood timber on battens below. The flooring is thought to be original. Peeling varnish and line markings for what we assume to be badminton court leads us to recommend the sanding back of the floor surfaces in the next 5 years, failure to do so may lead to damage occurring to the timbers.

Photo showing the Hall

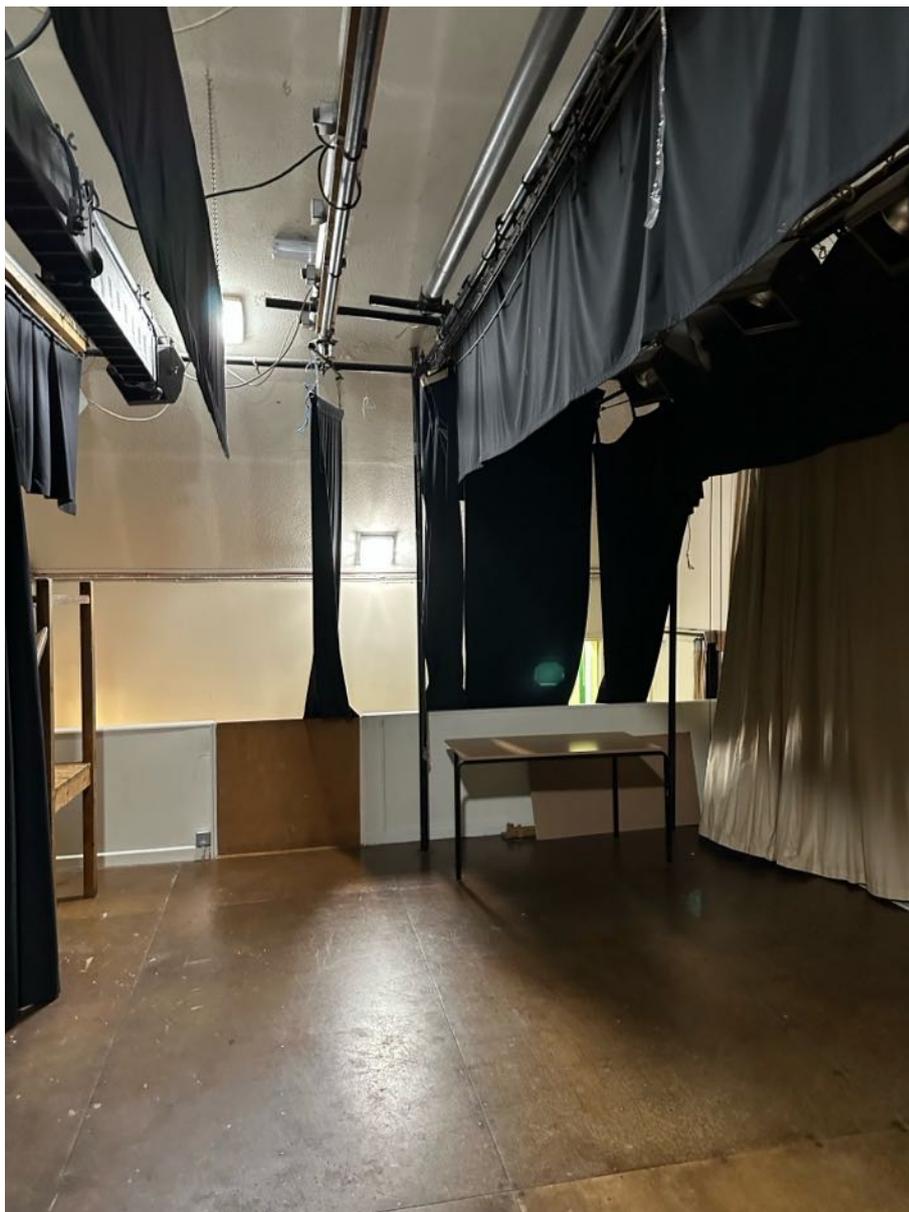
The stage equipment including lighting was not tested. The steps leading up to the stage were even to tread underfoot.

Photo showing Theatre space

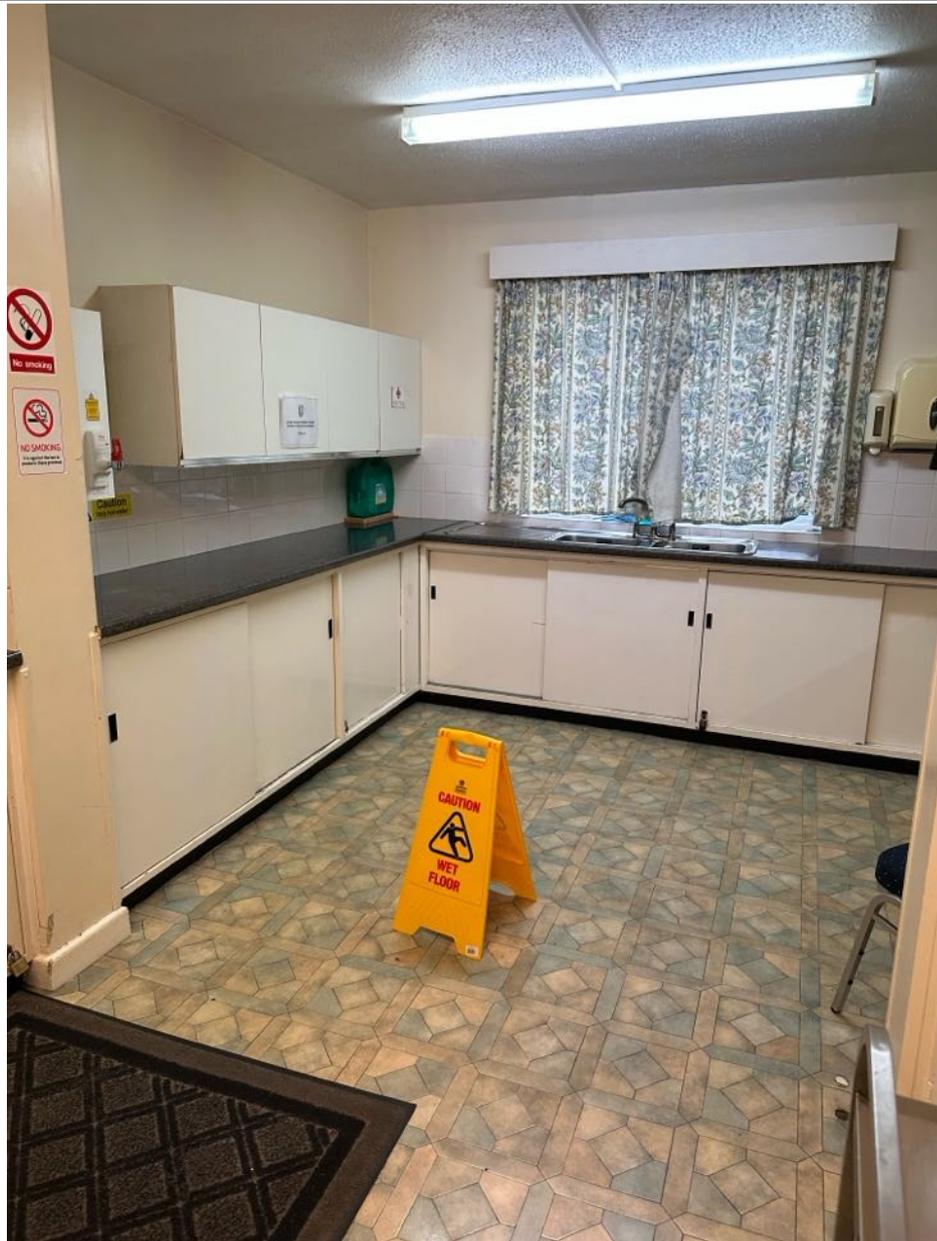
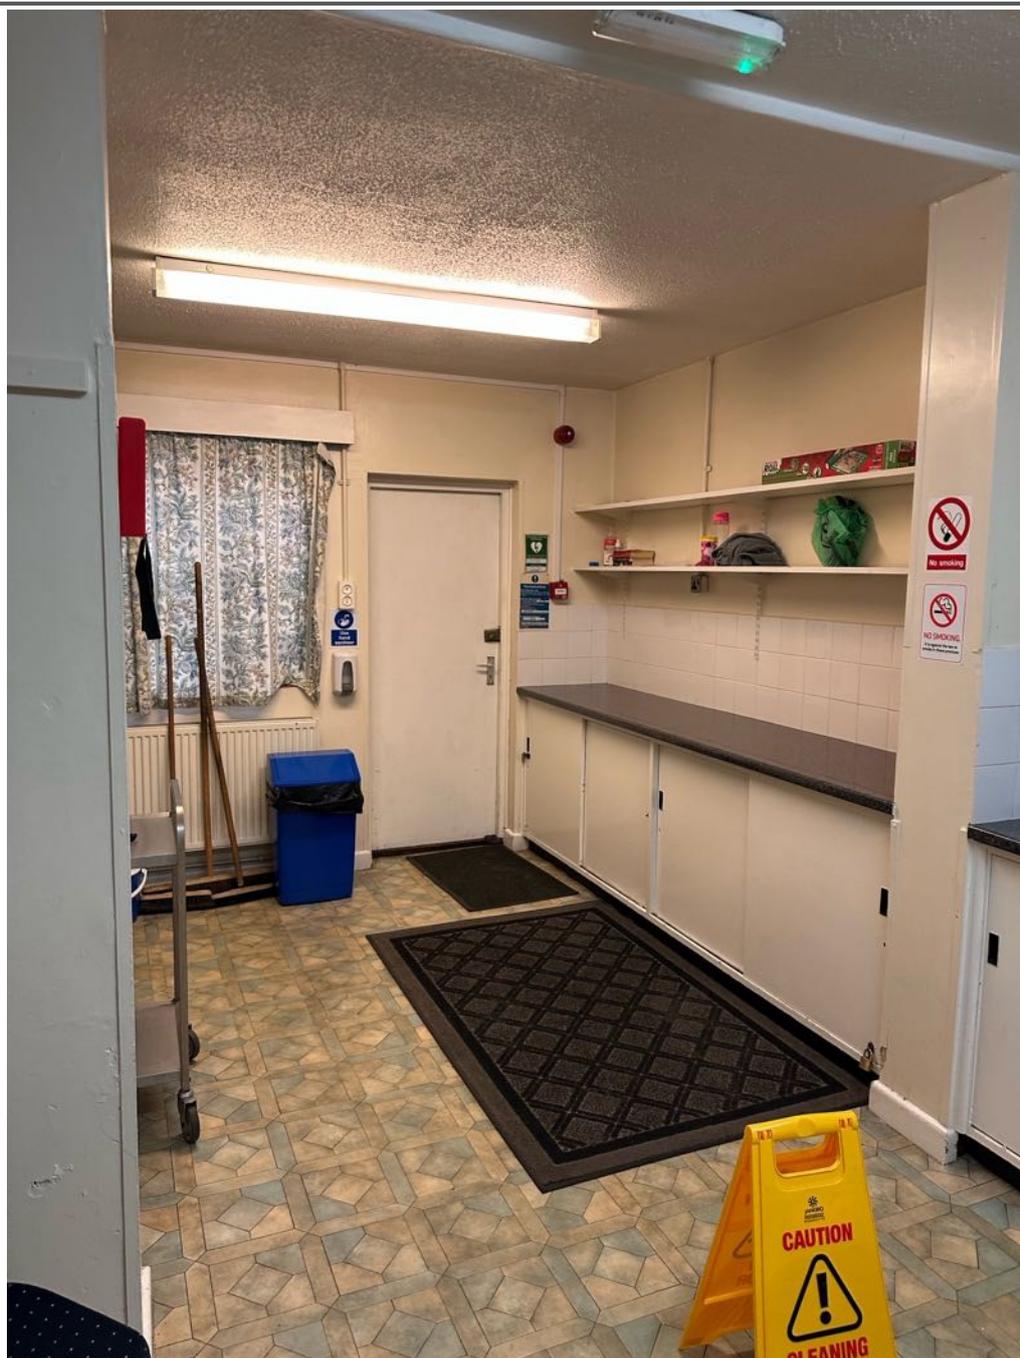
The flooring here is vinyl on solid concrete slab and we assume that thermoplastic floor tiles would be represent below the slab.

Thermoplastic floor tiles are a potentially asbestos containing material but generally safe if left untouched. There is also a possibility that there may be a herringbone pattern parquet block, similar to those seen in other parts of the hall. The flooring was considered to be generally even to tread with no signs of compaction of the concrete floor slab below.

Photo showing Kitchen

Photo showing kitchen

We would suggest replacement of the flooring with a grip vinyl to be correctly lapped in the corners.

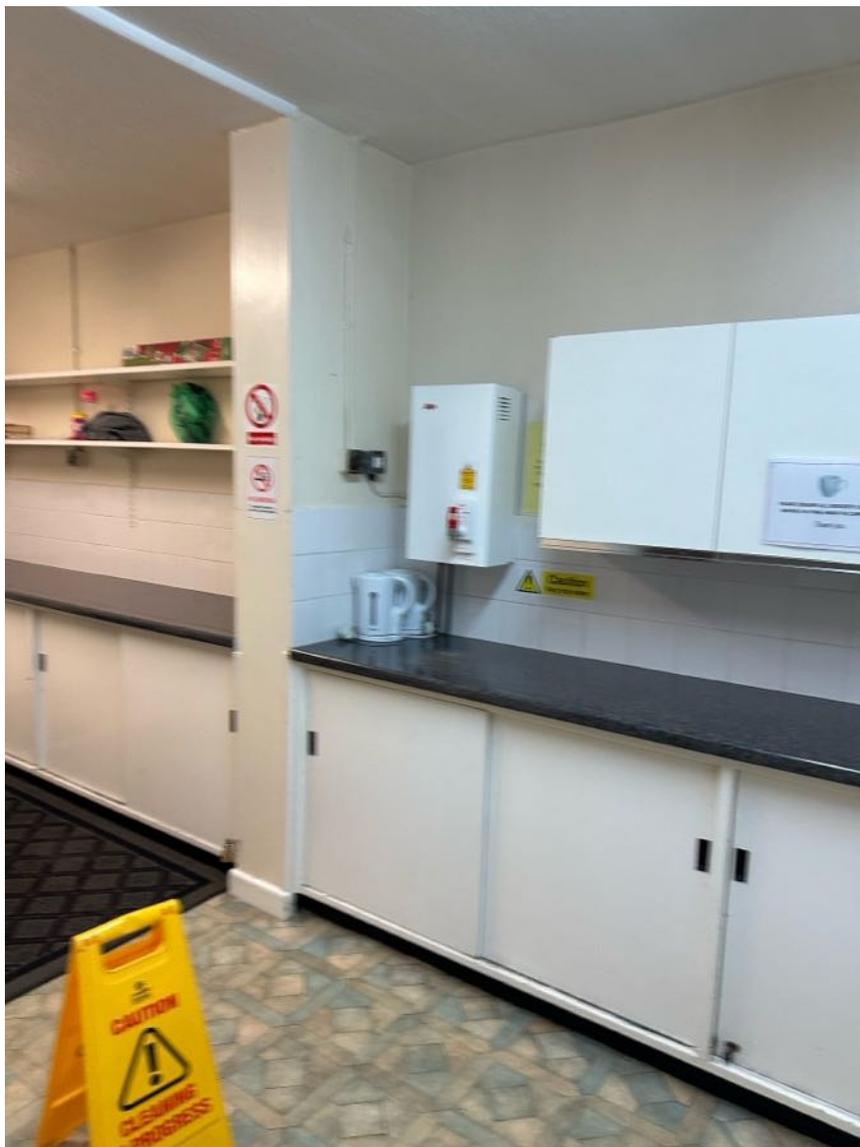
The walls are painted plaster on solid masonry and part tiled with painted plasterboard on timber studwork to the front walls. We believe that the kitchen has been extended historically. General cracking and crazing of the aged plaster

Photo showing kitchen

around the rear door and window was noted. We would suggest hacking back plaster to masonry and replastering and redecorating here within the next 5 years

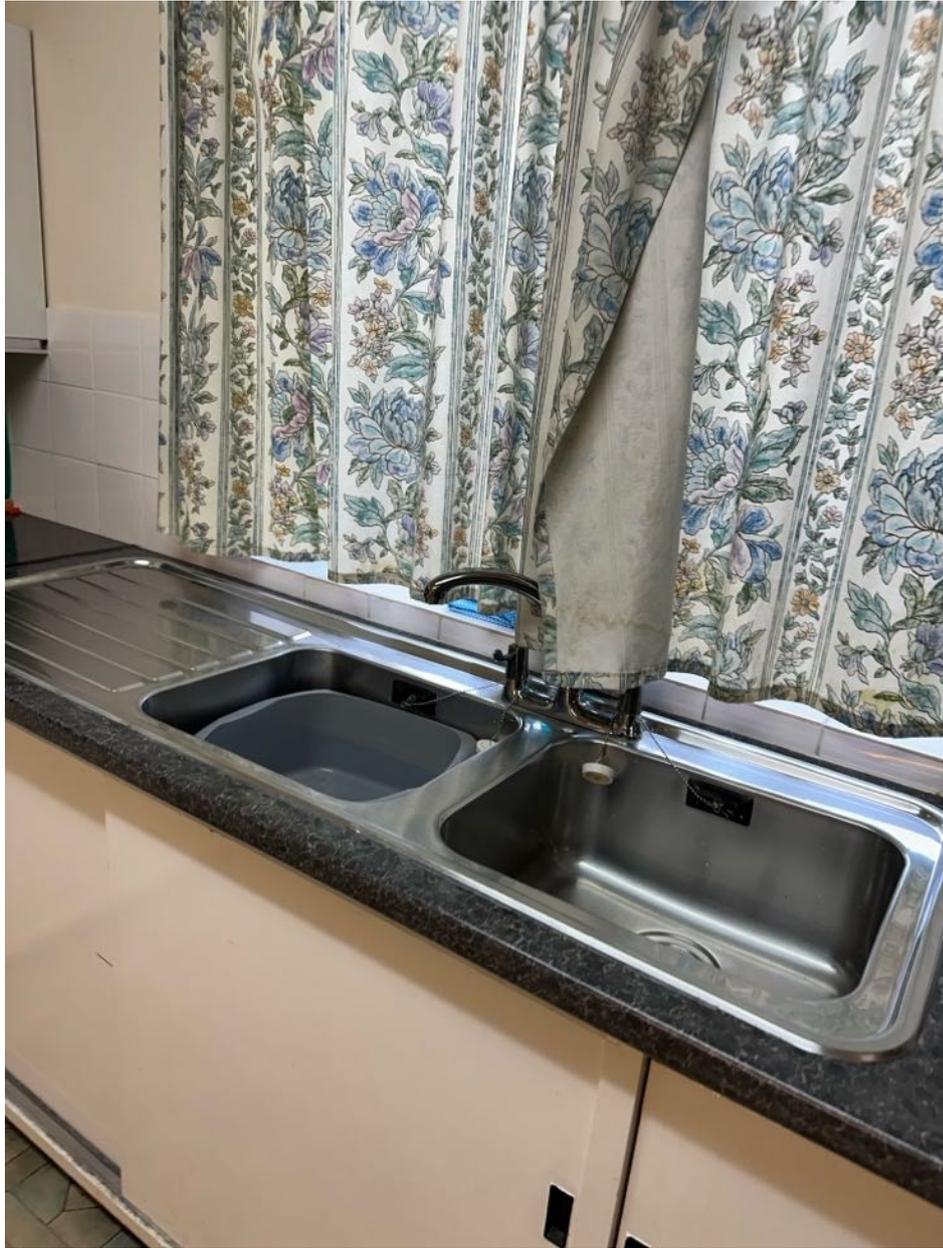
Ceiling is painted textured ceiling coating on plasterboard. This is a potentially asbestos containing material. No obvious cracking exists here. As a general comment, the flat roofed sections are unlikely to have sufficient insulation by modern standards.

Photo showing the sink

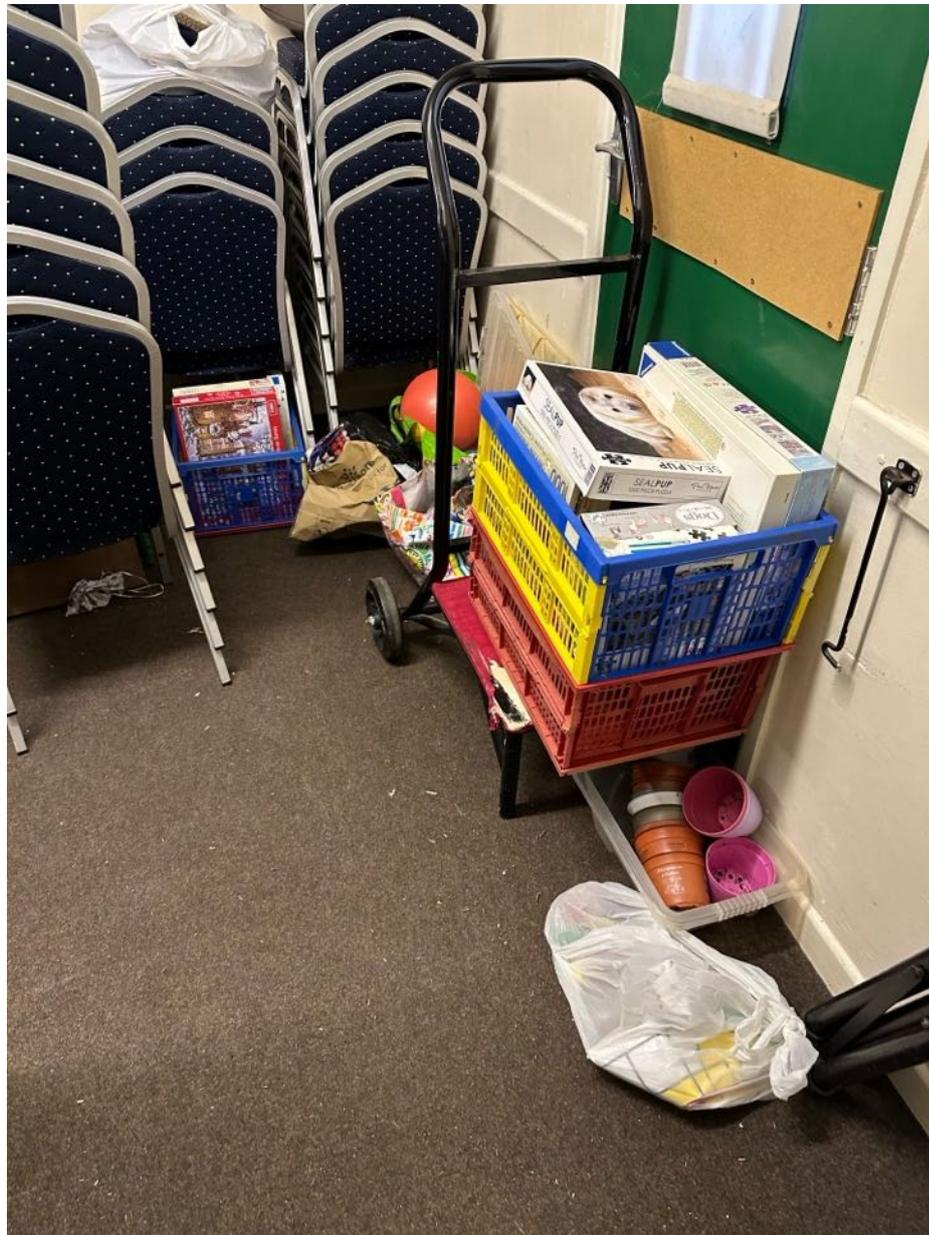
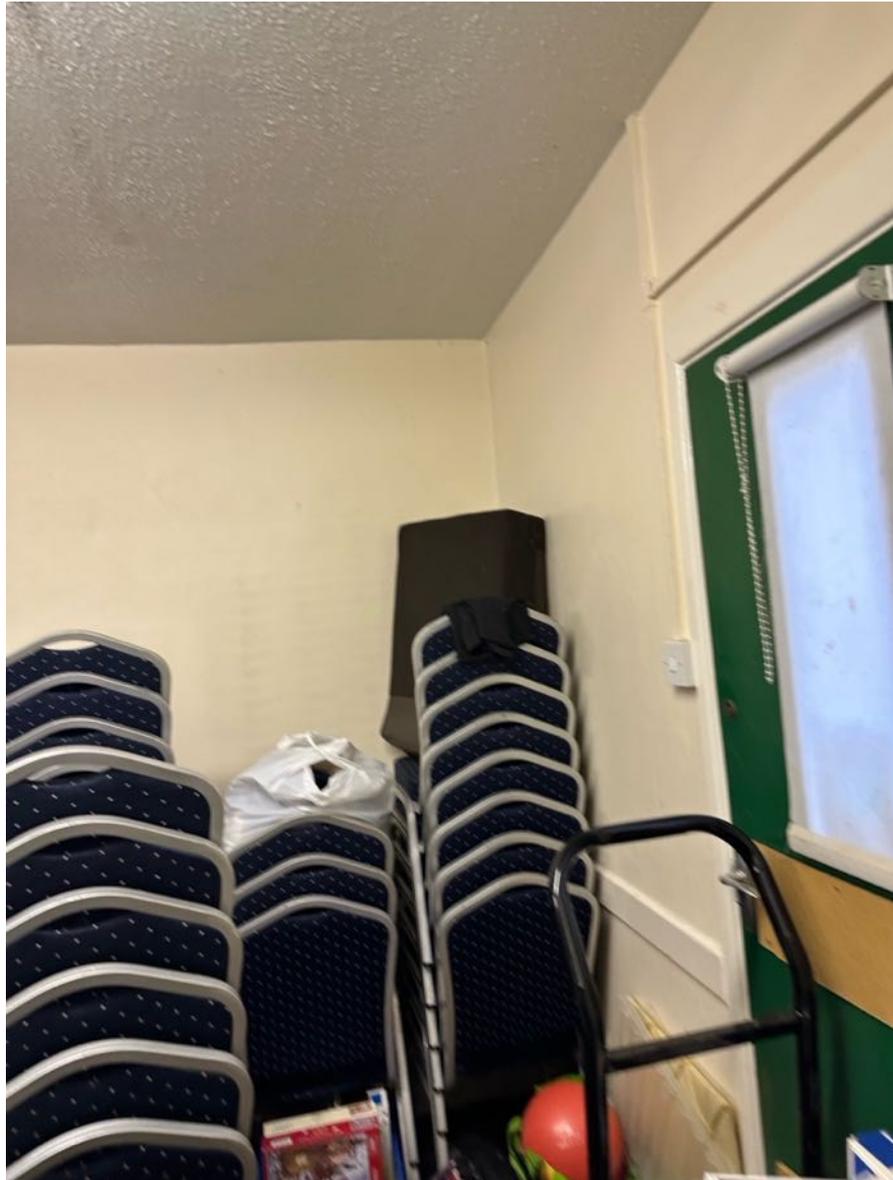
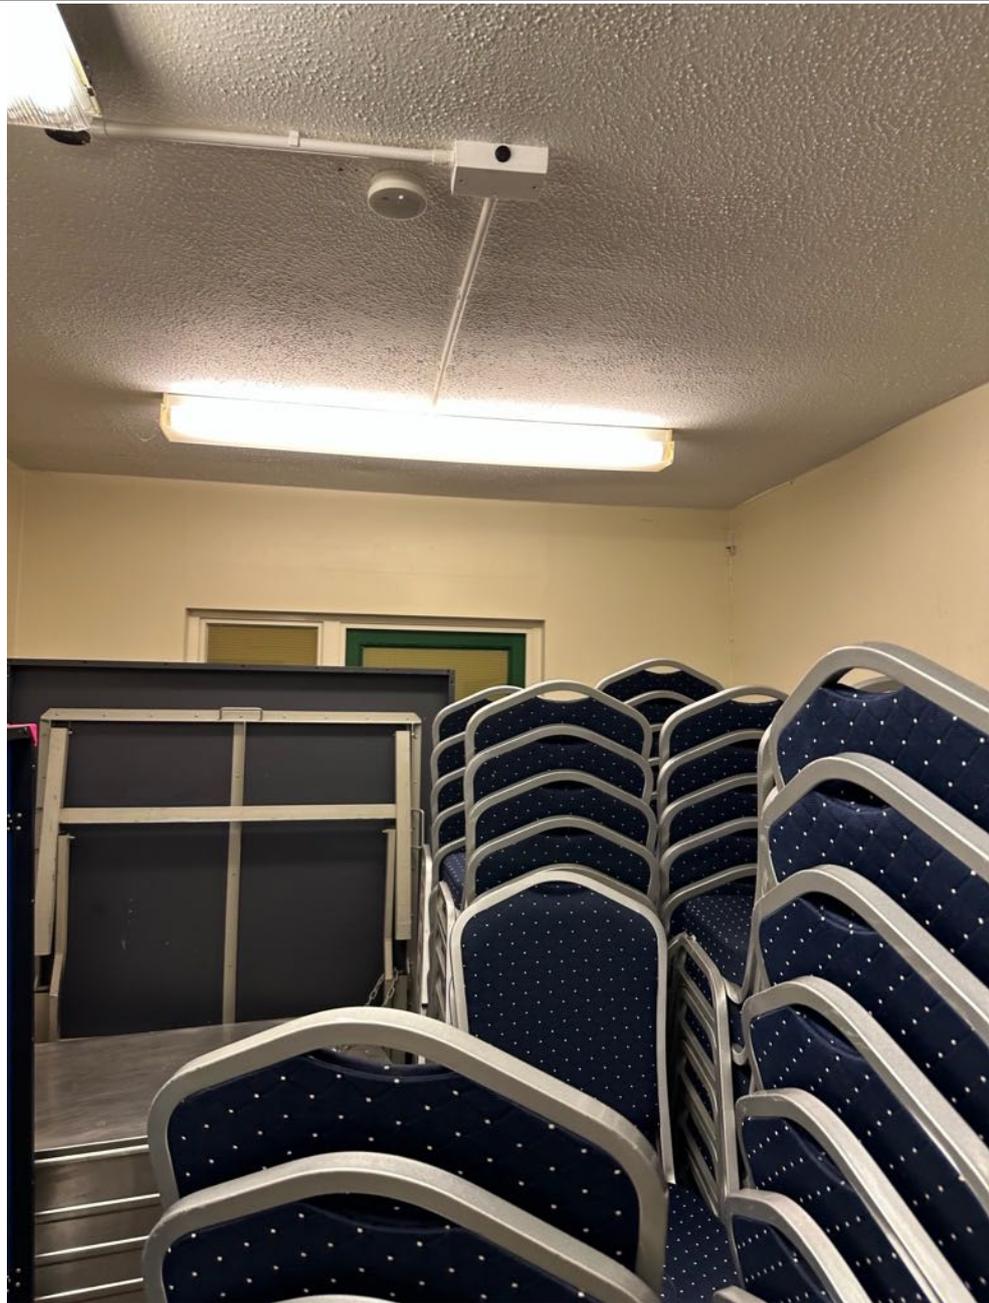
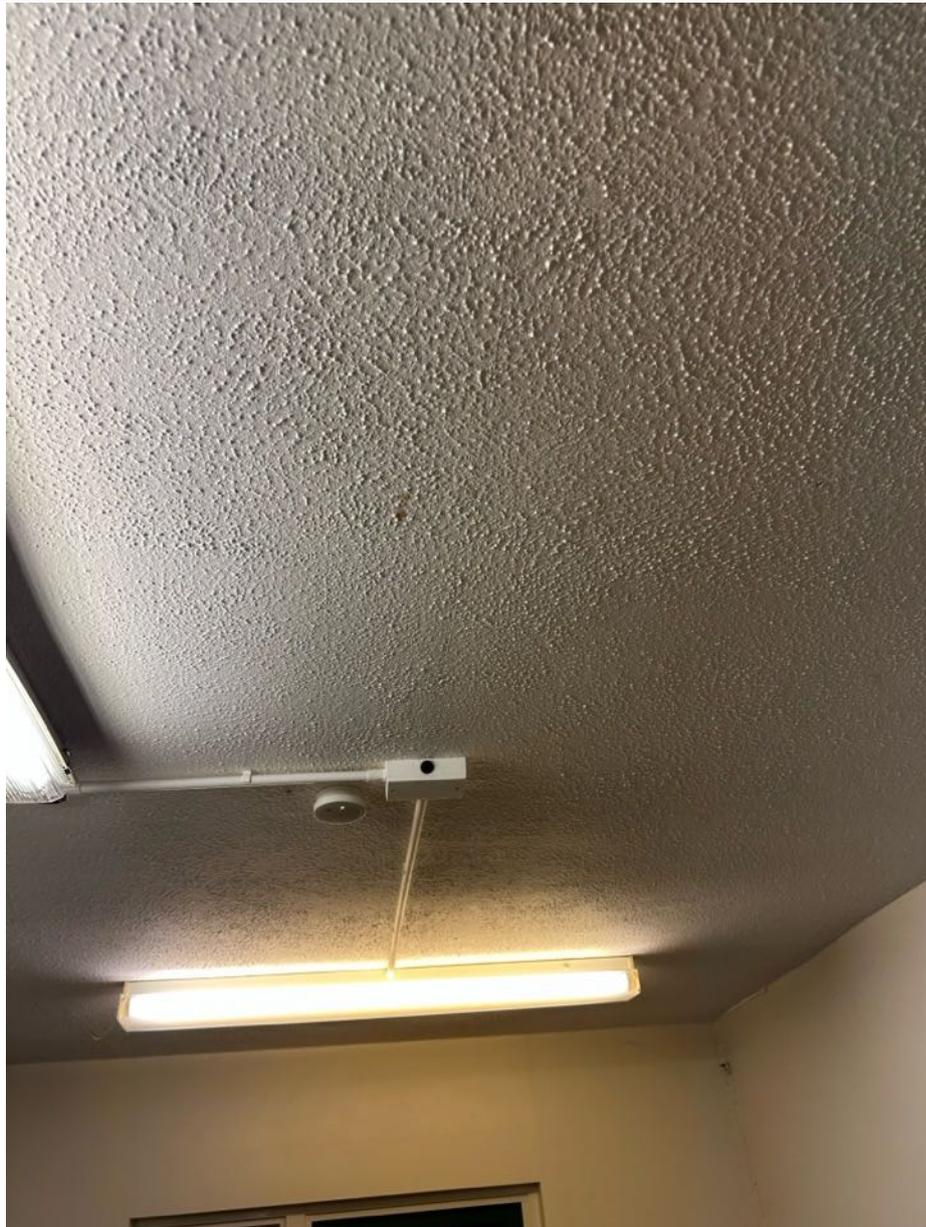
Store area right hand side The flooring here is carpet on concrete and largely obscured by chairs and tables.
No obvious defects were observed. Wall are painted plaster on solid masonry and plasterboard.

Photo showing store area

No obvious defects to the walls were present. The ceiling is painted textured ceiling coating. See our comments elsewhere regarding this being a potentially asbestos containing material.

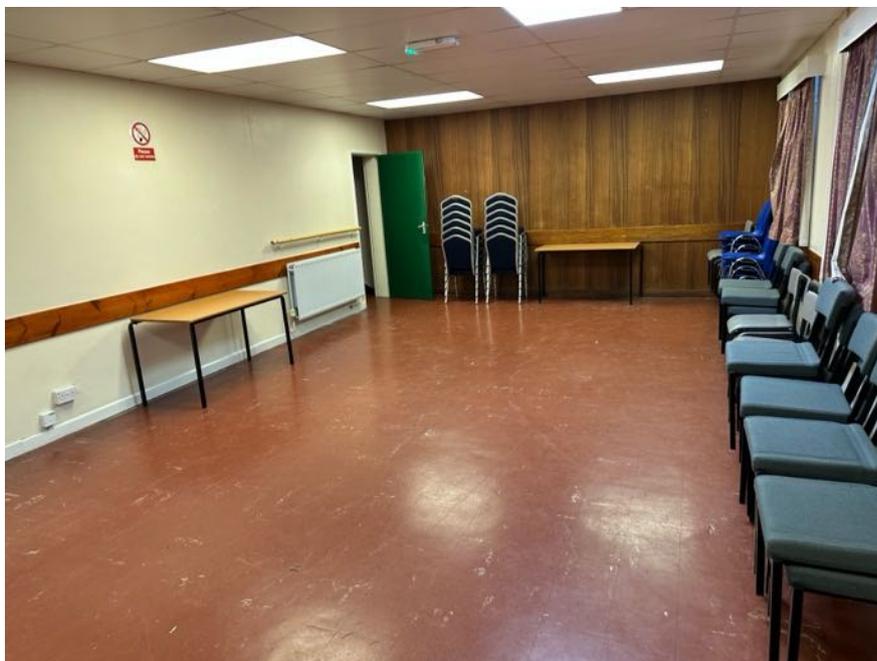
There are various areas of potentially asbestos containing material, and we are of the opinion the thermoplastic floor tiles in the various store areas, are in particularly poor order and could potentially allow fibres to become airborne. As such, you may wish to consider seeking further specialist advice however, the safe encapsulation if this floor covering is ultimately advised. This should be done in a manner and material to ensure that the surface is sufficiently hard wearing enough to withstand the uses of the Hall including stacking of chairs and tables etc.

Rear Meeting Area Flooring here is thermoplastic floor tiles with multiple fractured areas observed. You may wish to seek further specialist advice on this. Consider safe encapsulation.

Photo showing meeting area to the rear

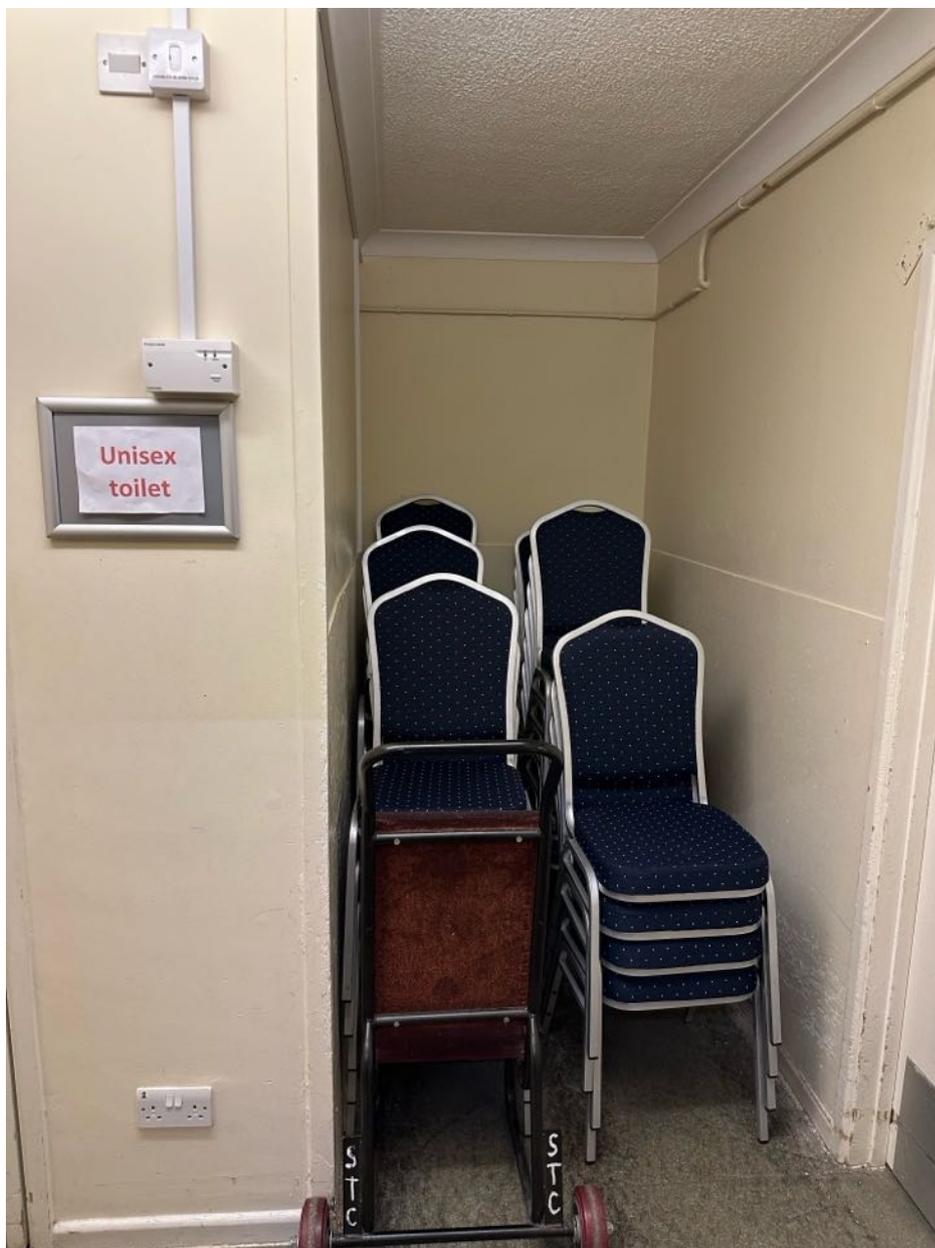
The flooring is a grip vinyl floor showing more wear by the chair store area, this section will likely need to be replaced before the wc. The walls are painted plaster on plasterboard and solid masonry. Various plaster digs and scuffs exist to the walls in the store area,

Photo showing store area
