STOTFOLD TOWN COUNCIL

6.5. Memorial Hall Condition Survey

SUBJECT: MEMORIAL HALL CONDITION SURVEY

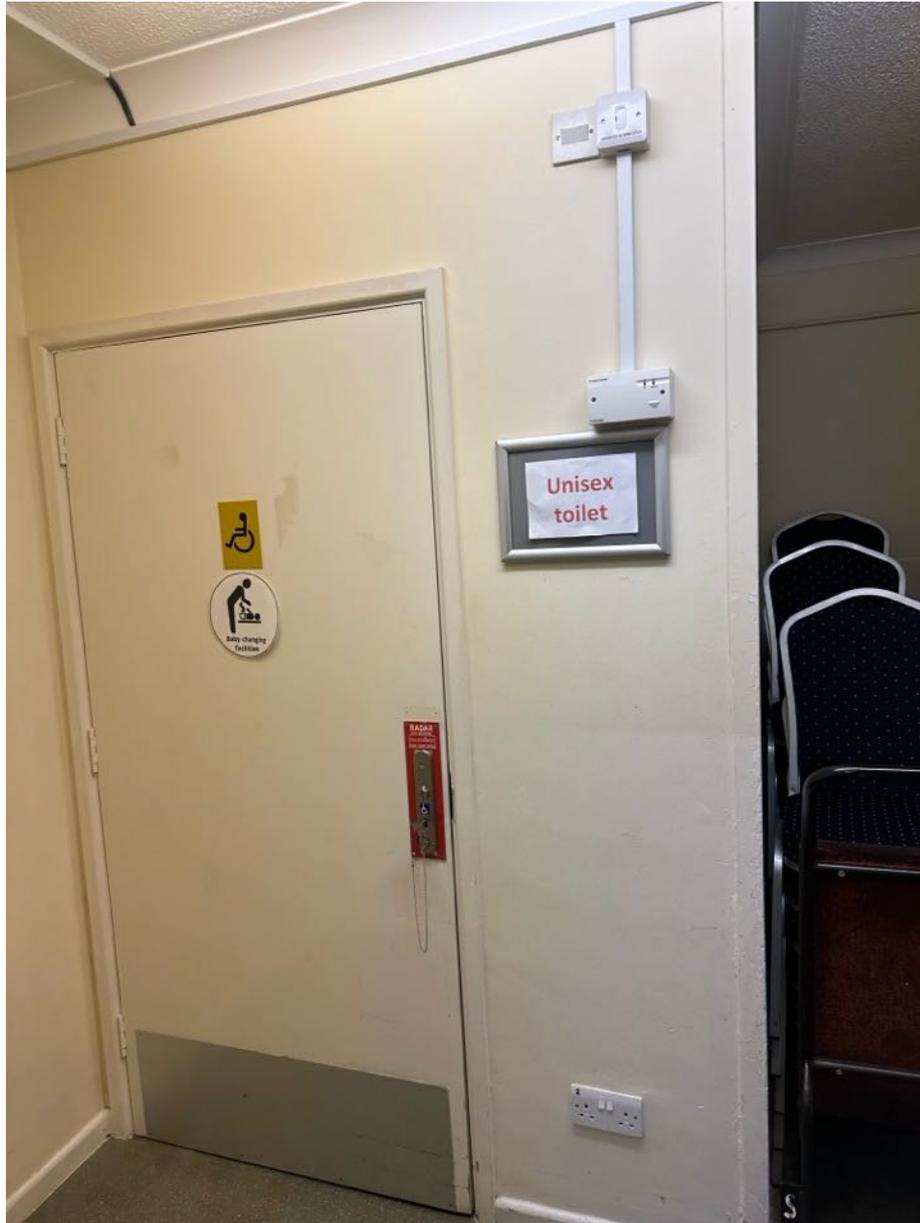
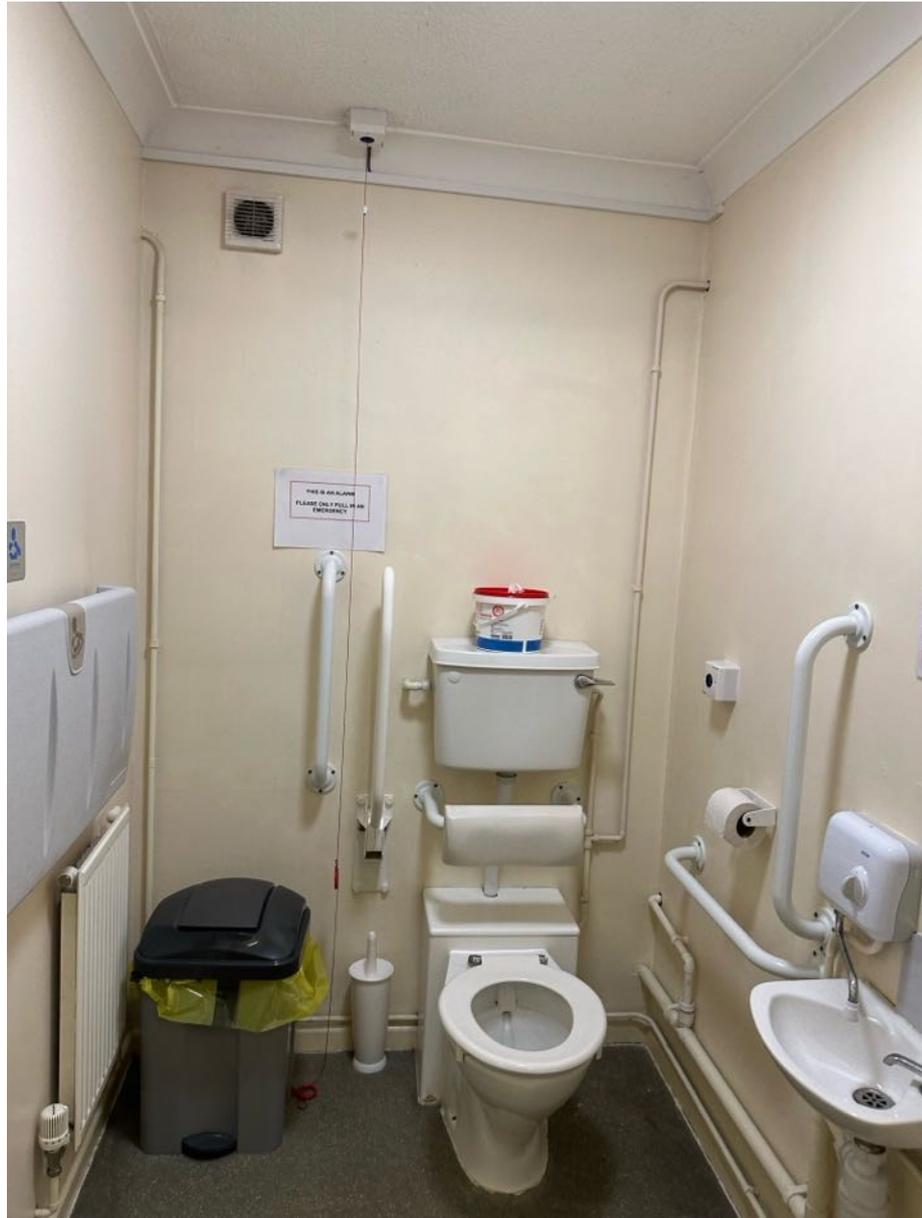
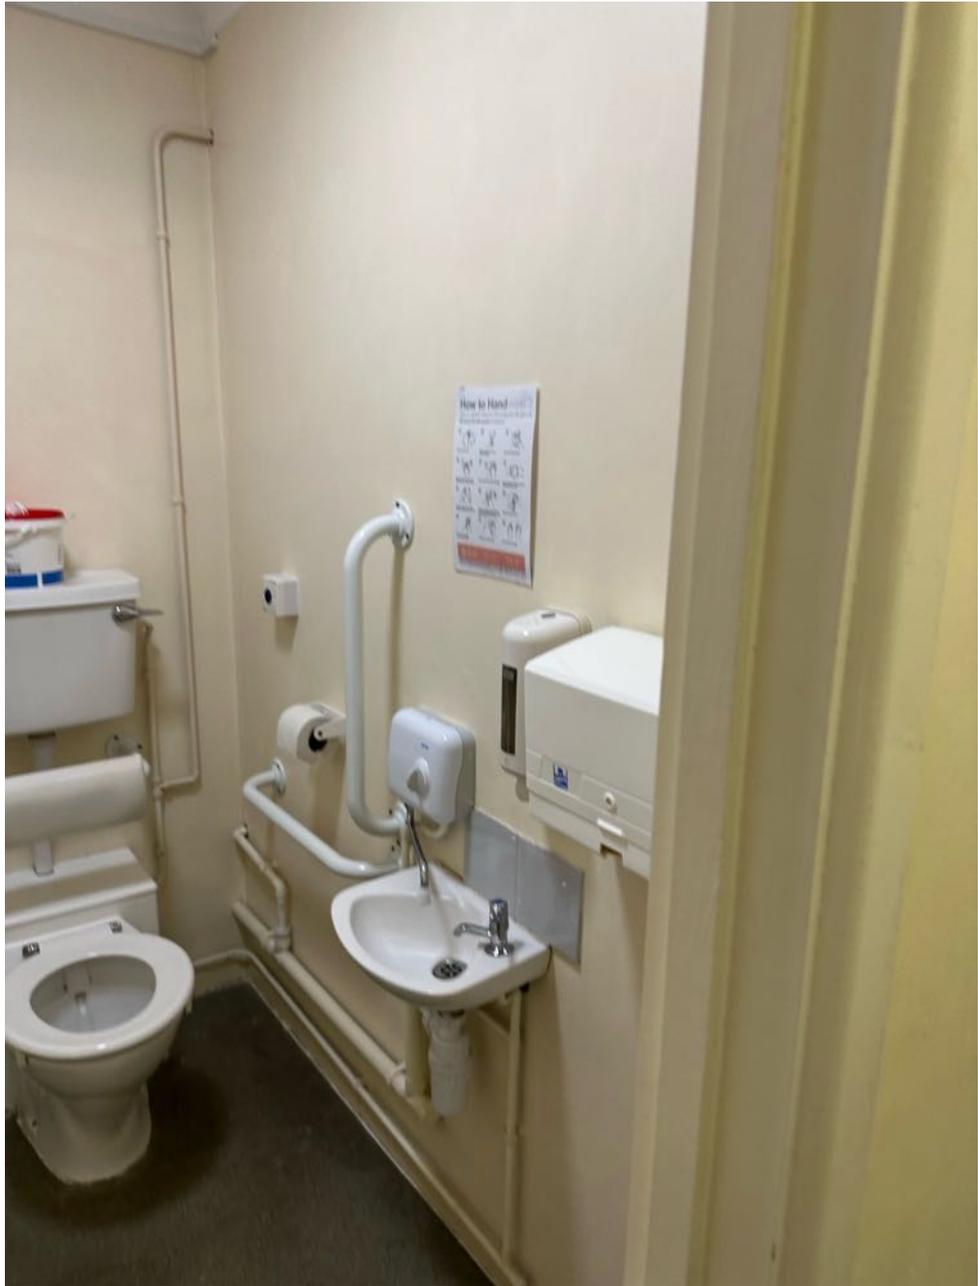
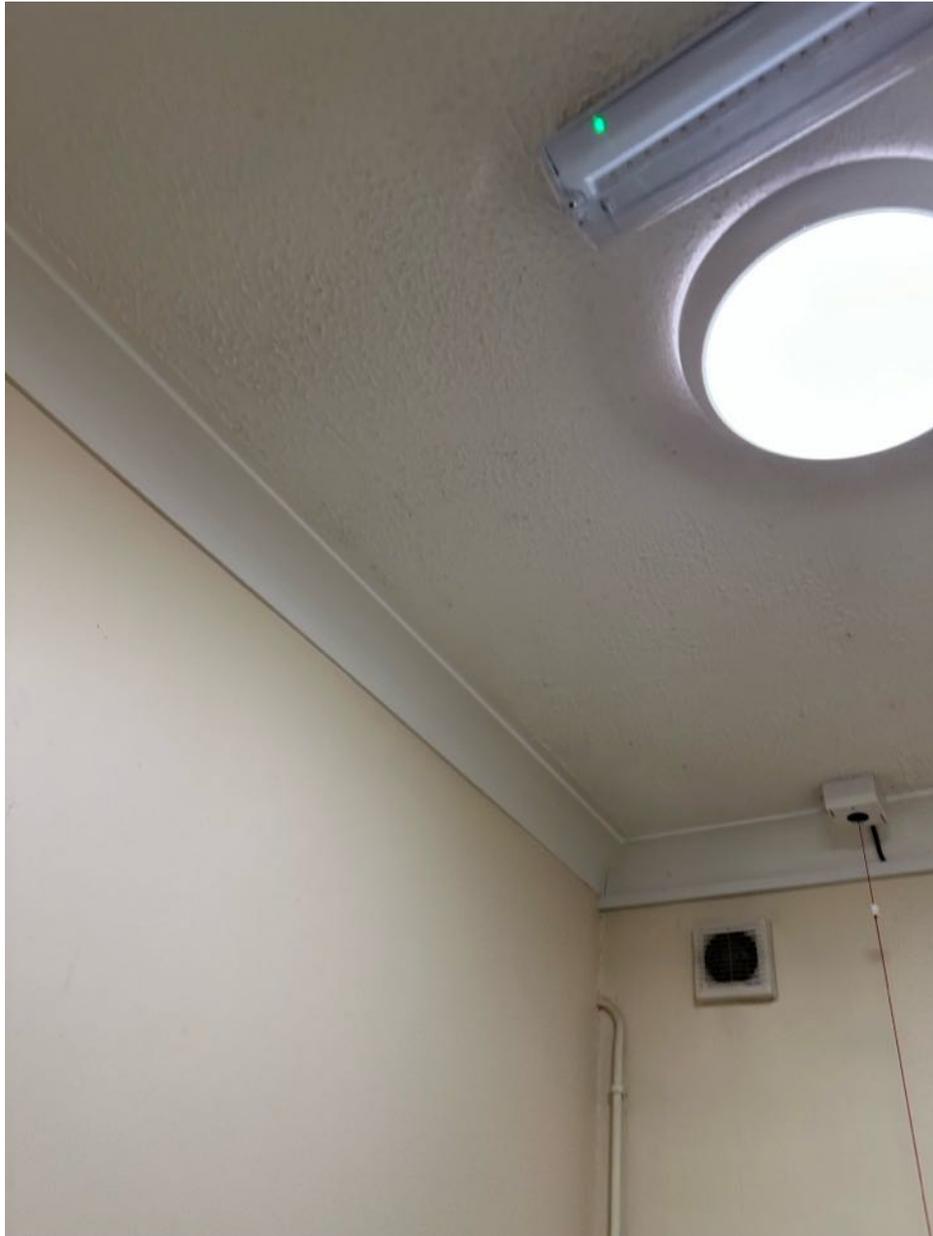
Photo showing Disability WC

Sanitaryware includes wc, cistern and wall mounted sink. All were operable on good pressure.

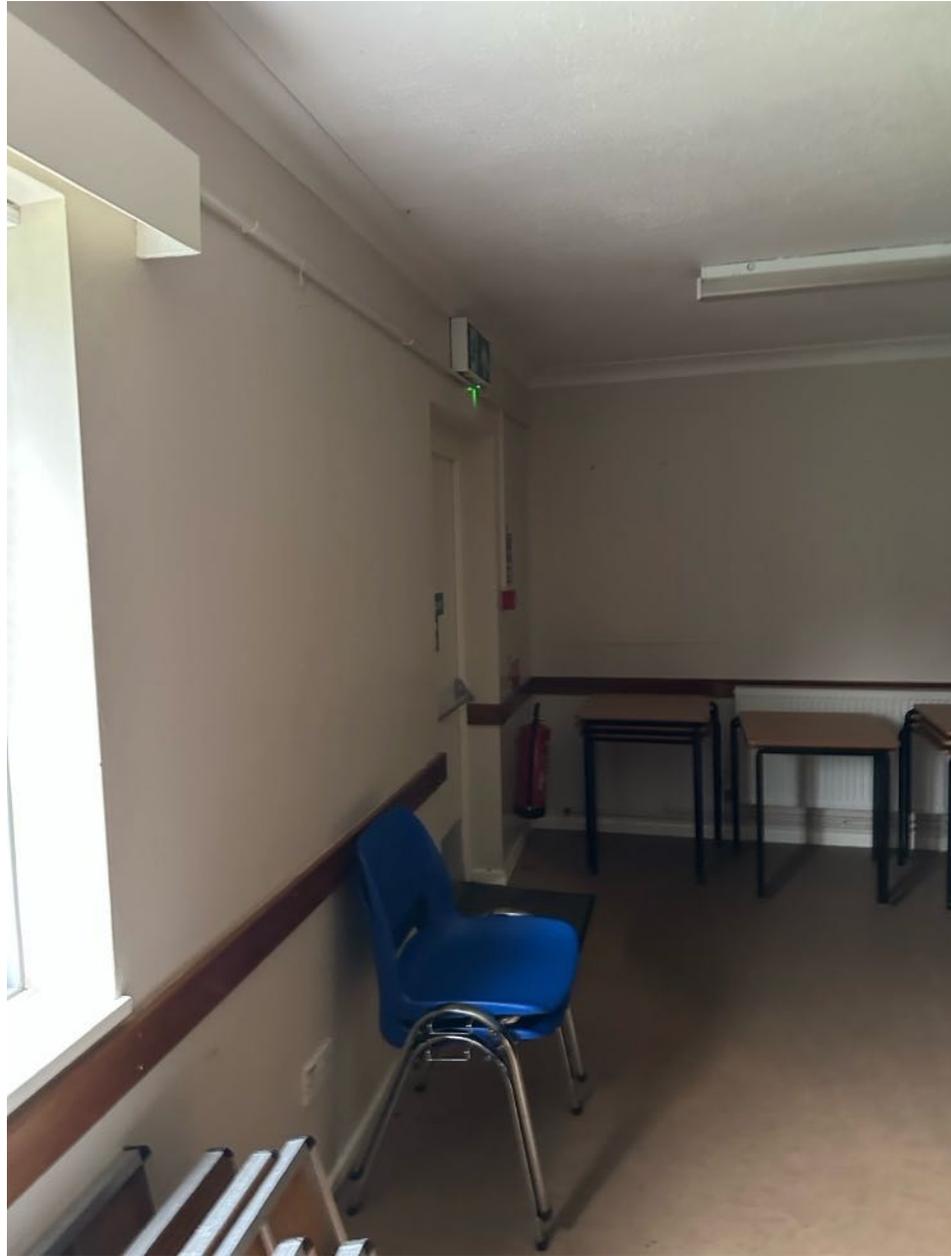
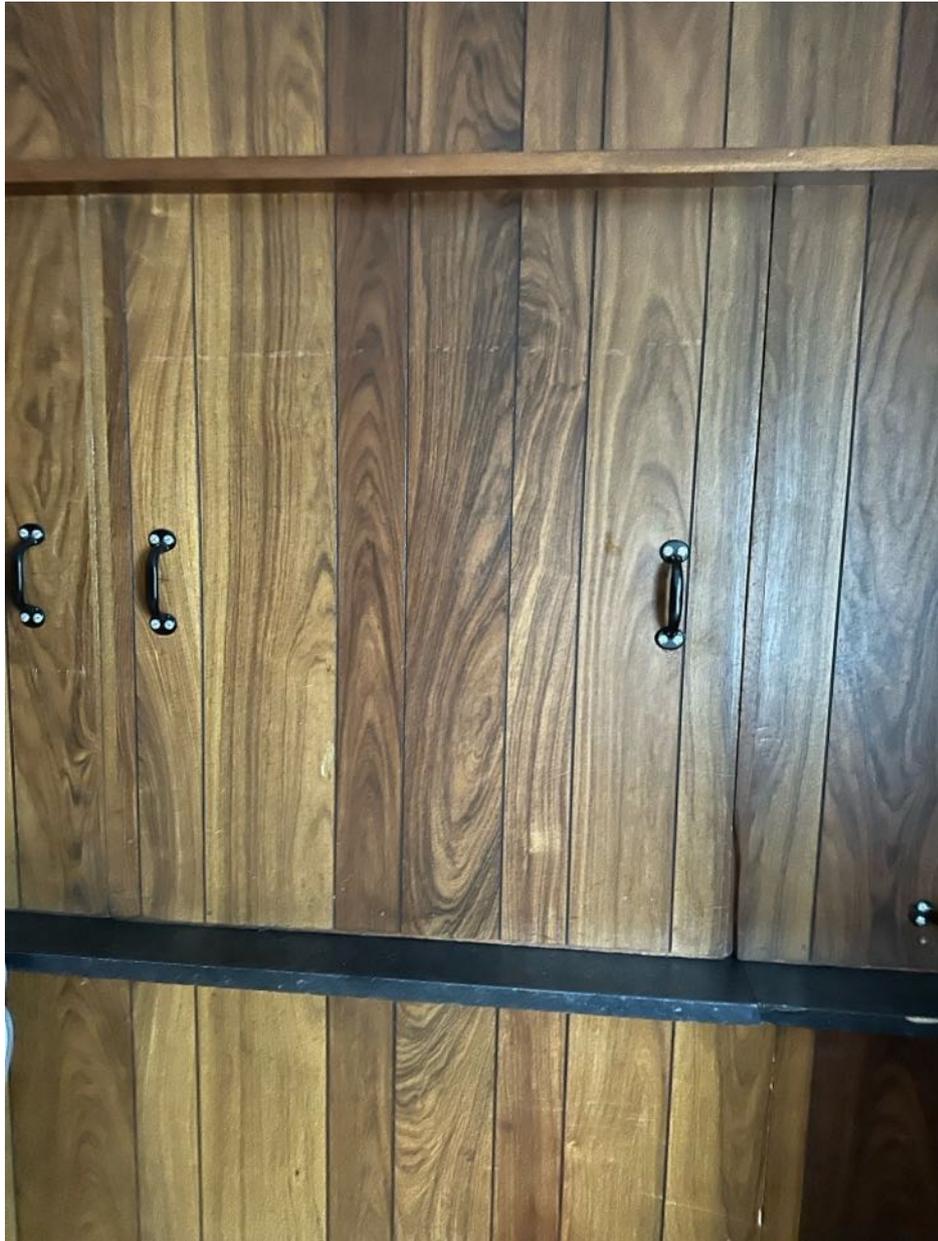
Left hand side bar area The flooring is grip vinyl on concrete. No obvious defects observed. Walls are part timber clad and part painted plaster on solid, masonry. No obvious defects were observed.

Photo showing Bar Area

The ceiling is a textured ceiling coating and appeared free of any obvious defects. UPVC windows were very stiff in operation
